Application for Planning Approval

DA2023/106

110 YELLOW BRICK ROAD, OLD BEACH

DWELLING

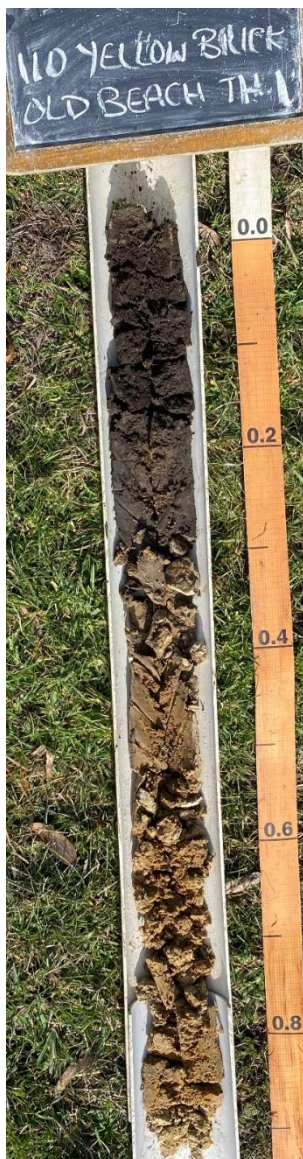
SOIL PROFILES – Test Hole 1

Depth (m)	Horizon	Description and field texture grade	Soil Classifn.
0.0 – 0.15	A1	Very dark brown (10YR 2/2), Sandy Clay Loam , moist firm friable consistency, moderate medium angular blocky structure breaking to strong fine angular structure, common roots.	SC
0.15 – 0.30	B2 ₁	Very dark greyish brown (10YR 3/2), Sandy Light Clay , massive, moist soft consistency, few roots.	CH
0.3 – 0.5	B2 ₂	Brown (10YR 5/3), Sandy Light Clay , massive, moist firm consistency, abundant dolerite rocks and gravels.	CH
0.5 – 0.85	BC ₁	Yellowish brown (10YR 5/4), Gritty Sandy Light Clay , strong medium angular blocky structure, slightly moist firm consistency, abundant rocks and gravels.	CH
0.85 – 0.9	BC ₂	Refusal on weathered dolerite gravels.	Gw

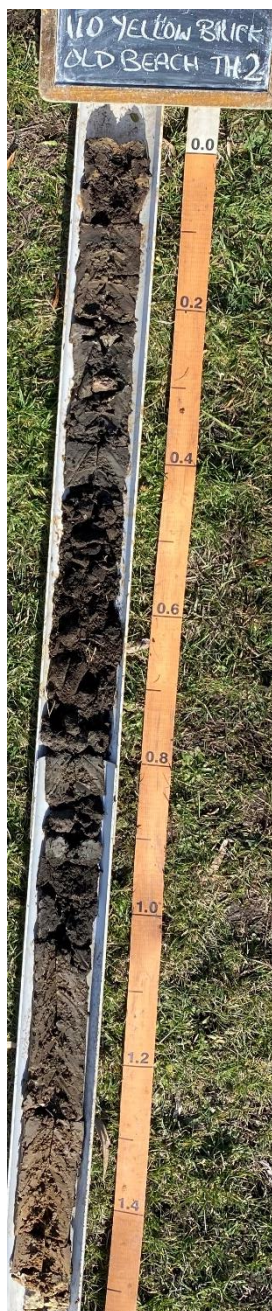
SOIL PROFILES – Test Hole 2

Depth (m)	Horizon	Description and field texture grade	Soil Classifn.
0.0 – 0.95	FILL	Mixed fill from site A1 TH1 and Very dark greenish grey (10Y 3/1), Sandy Light Clay , massive, moist soft to firm consistency.	SC/CH
0.95 – 1.05	A1	Very dark brown (10YR 2/2), Sandy Clay Loam , moist firm friable consistency, moderate medium angular blocky structure breaking to strong fine angular structure, common roots.	SC
1.05 – 1.5	B2	Brown (10YR 5/3), Sandy Light Clay , massive, moist firm consistency.	CH
1.5 – 1.55	C	Refusal on dolerite rocks, probable boulders.	GC

The field DCP1 data indicates that the bearing capacity of the soil is at a suitable strength below 1.4 m. However, the competent dolerite boulders at approximately 1.9 m would be the recommended foundation material.

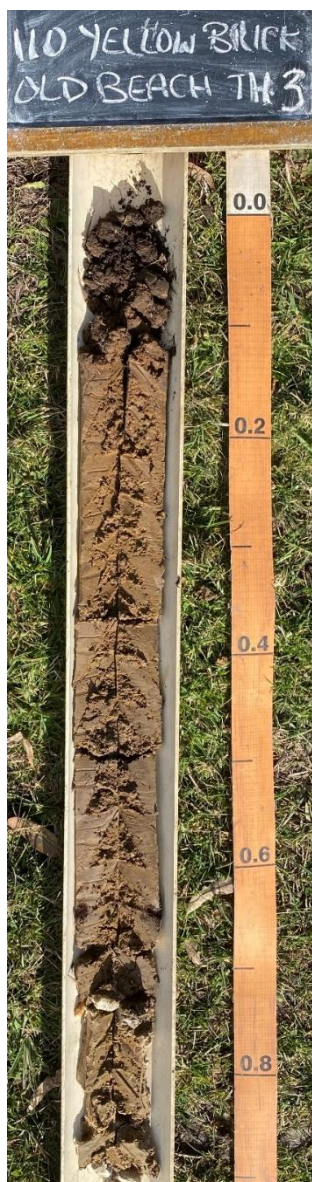
SOIL PROFILES – Test Hole 3

Depth (m)	Horizon	Description and field texture grade	Soil Classifn.
0.0 – 0.1	A1	Very dark brown (10YR 2/2), Sandy Clay Loam , moist firm friable consistency, moderate medium angular blocky structure breaking to strong fine angular structure, common roots.	SC
0.1 – 0.9	B2	Brown (10YR 5/3), Sandy Light Clay , massive, moist firm consistency.	CH
@ 0.9	C	Refusal on dolerite rocks, probable boulders.	GC

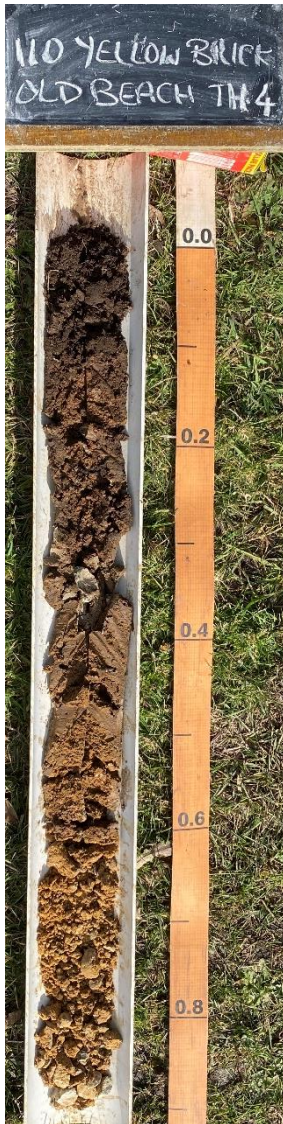
SOIL PROFILES – Test Hole 4

Depth (m)	Horizon	Description and field texture grade	Soil Classifn.
0.0 – 0.1	A1	Very dark brown (10YR 2/2), Sandy Clay Loam , moist firm friable consistency, moderate medium angular blocky structure breaking to strong fine angular structure, common roots.	SC
0.1 – 0.3	B2 ₁	Brown (7.5YR 4/3), Gravelly Light Clay , moist soft consistency, moderate medium angular blocky structure.	CH
0.3 – 0.6	B2 ₂	Brown (10YR 5/3), Sandy Light Clay , massive, moist firm consistency, abundant dolerite rocks and gravels.	CH
0.6 – 0.9	Cw	Brownish yellow (10YR 6/6), Sandy Light Clay , strong fine angular structure, slightly moist firm consistency, common dolerite gravels, refusal on dolerite boulder.	CH

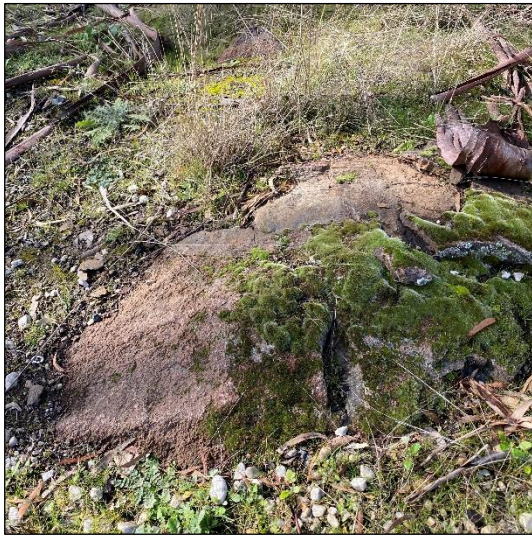
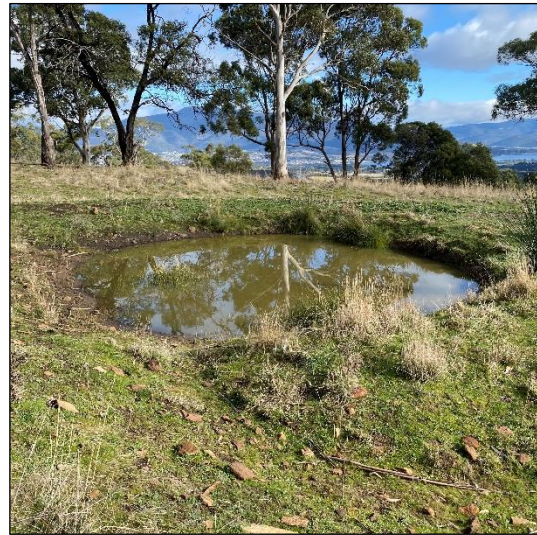
Left Image: Dolerite likely boulder outcrop. **Right Image:** On-site freshwater dam

These moderately shallow to moderately deep soils are formed from clayey colluvium derived Jurassic dolerite. Assessment of the site and surrounding areas revealed dolerite boulders at the surface in multiple locations as well as below the soil profiles. Water present in an established freshwater dam on site was relatively clear indicating no signs of clay in suspension.

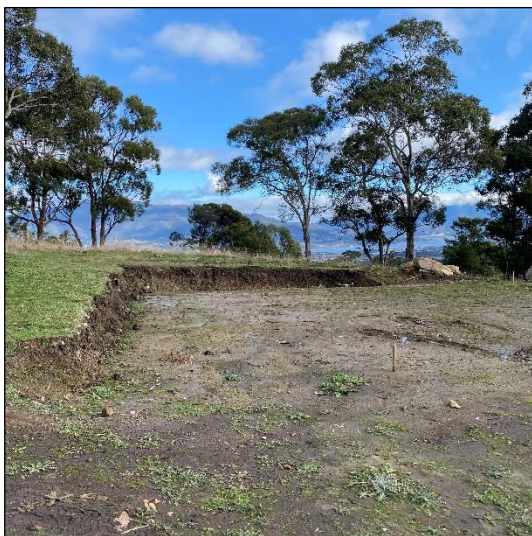
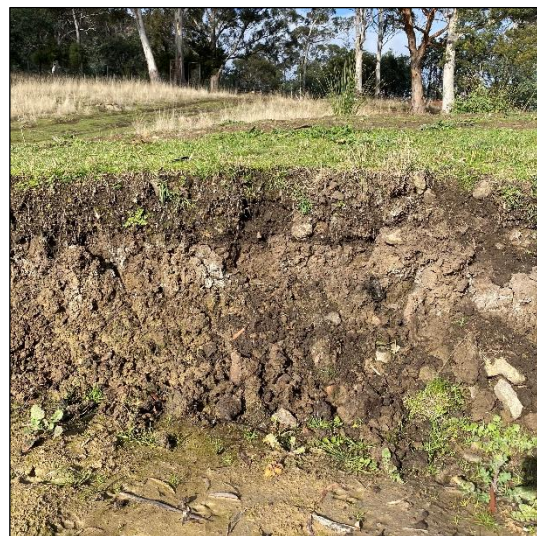
Left Image: Cutting and part of raised filled area. **Right Image:** Close up of cutting.

The dispersive soil assessment of the property considers the proposed construction area, and notes that minimal modification of the site had already taken place, including clearing of, non-natural, established trees and shallow earthworks to form a level pad for the proposed shed.

Where a minor cutting and levelled pad of uncontrolled fill has taken place, the disturbed soil did not show any signs of dispersion.
