# Application for Planning Approval

**DA2025/065**

**63 MILLVALE ROAD, DROMEDARY**

**LANDSCAPING & EARTHWORKS**

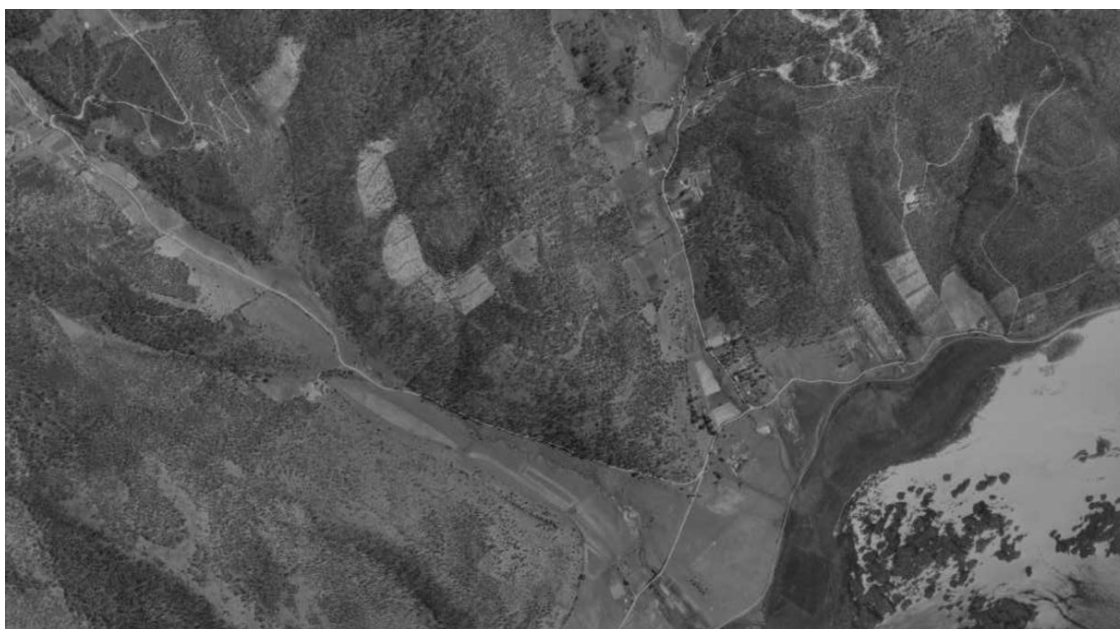
**Figure 1.2a – Aerial image taken at the end of 1969. The image indicates that the lower slopes and valley floor were cleared, but the upper slopes appear thinner than the current vegetation coverage, potentially due to a combination of livestock grazing and timber or firewood harvesting. (Source: LIST Map; Aerial Photo Image 0538-125.jp2 dated 18 December 1969)**

Whilst historically some livestock bush grazing or selective logging forestry operations may have taken place, such activities appear to have occurred for some time (Figure 1.2a). The majority of the site is best described as natural environment or vegetation management area with the site around the dwelling the only cleared space, which is consistent with the surrounding properties.

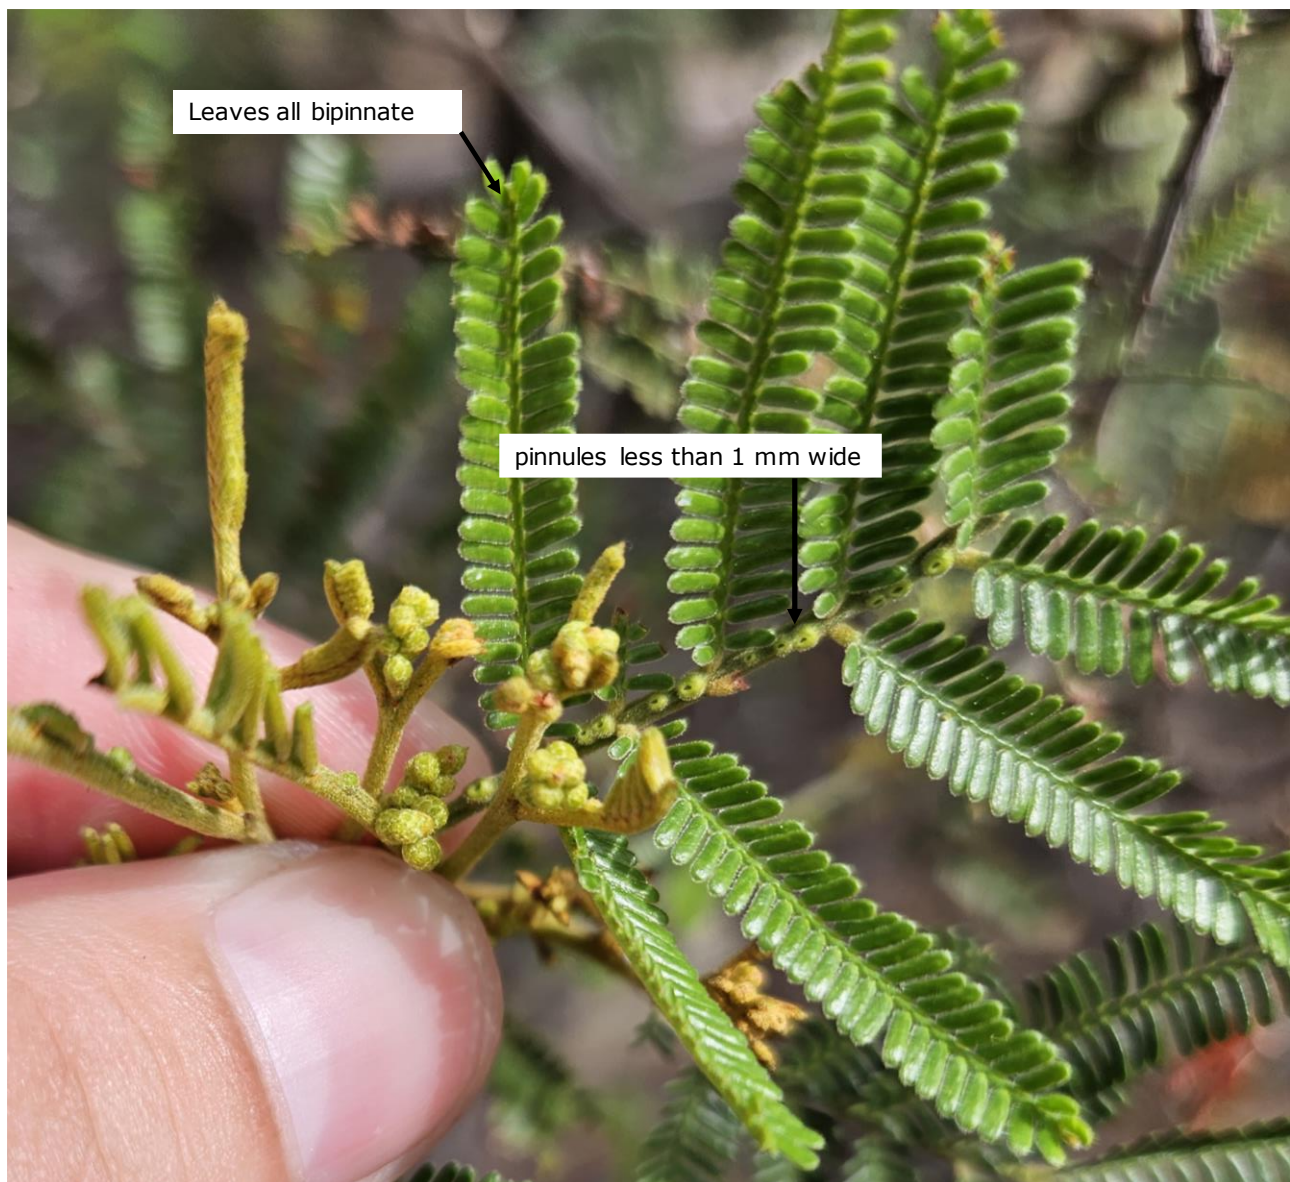
**Figure 2** *Acacia mearnsii* identifying features.

The dominant vegetation species within the area of the proposal to be cleared was an *acacia sp.*, more specifically *Acacia mearnsii* (Black Wattle). This species of wattle is commonly confused with the silver wattle; however, *A. mearnsii* has pairs of pinnules while the silver wattle only has one, see Figure 2. The vegetation in the area of the proposal is unlikely to be classified as a threatened vegetation community. A portion of the vegetation is on modified land according to TASVEG 4.0, the site visit also indicated that the vegetation in the development area is sparse.
