Application for Planning Approval

13A COMPTON ROAD, OLD BEACH

DWELLING & OUTBUILDING

AP2025-2425 - PROPOSED BACON RESIDENCE
 13a Compton Road,
 OLD BEACH

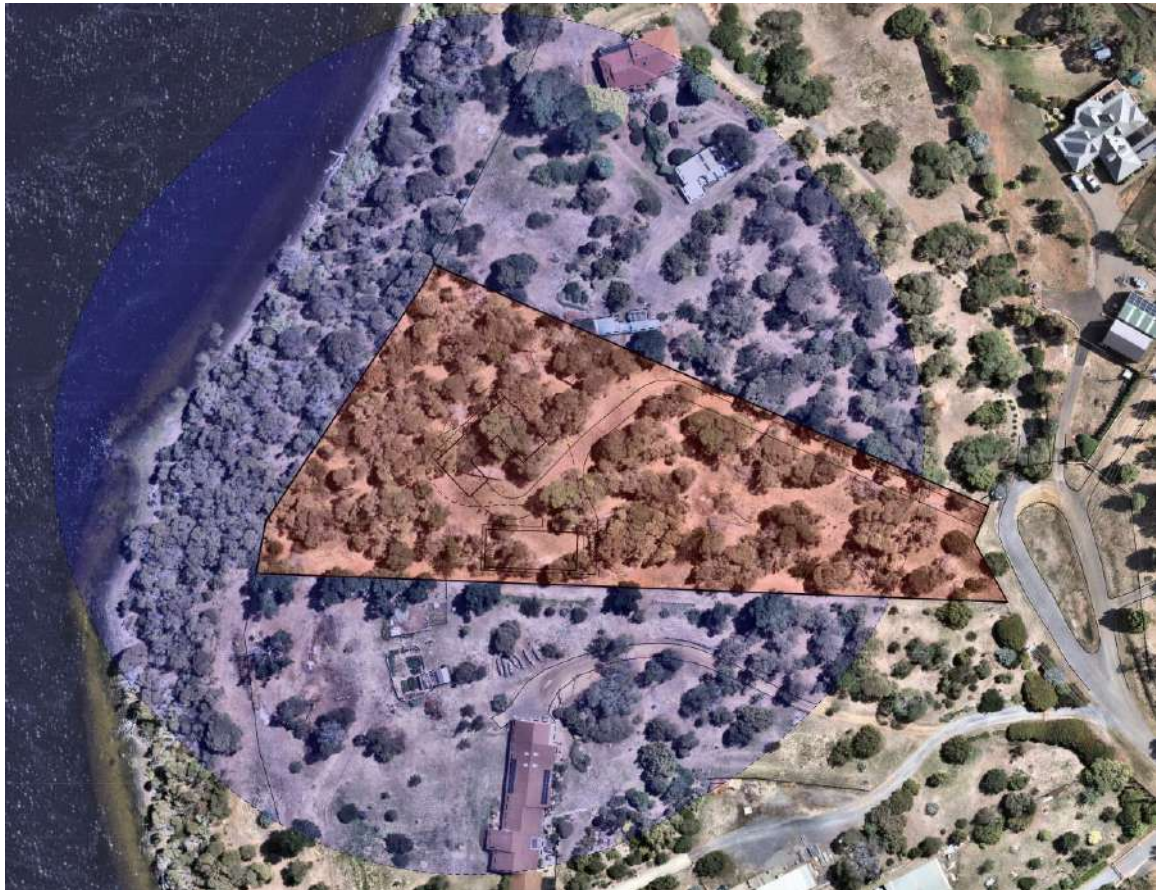
Figure 2. Aerial Image of Vegetation on development site & adjacent land

The aerial photo shown below (Figure 2) shows the extent of vegetation on the development site and the adjacent properties with 100m of the development site.

The bushfire prone vegetation types outside of the proposed development area were assessed (refer to Table 1) and described as Grassland (G22) and Woodland (B05). The vegetation has been classified in accordance with AS3959-2018 Section 2 (Method 1), Table 2.3 and figure 2.3 for vegetation within 100m of the development site boundary.

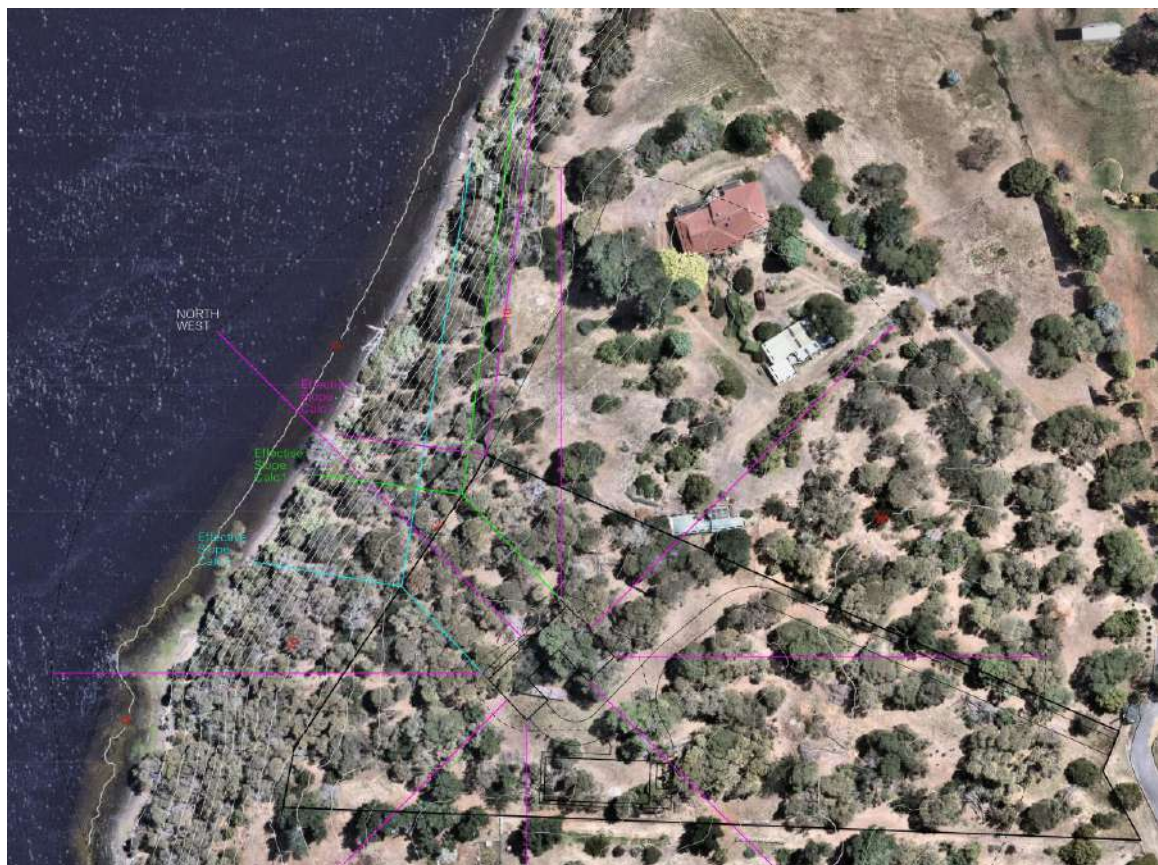
Figure 3. Effective Slope Calculation (NW)

Head Fire Width	Length	Change in RL	Slope Ratio	Slope Degrees
Effective Slope Calc 1	35.1m	100m	12m	1:8.33	7°D/S
Effective Slope Calc 2	35.1m	100m	12m	1:8.33	7°D/S
Effective Slope Calc 3	34.8m	100m	12m	1:8.33	7°D/S

From these calculations an effective slope to be used for Method 1 figures in Table 1 (below) in the NW direction is a 7°D/S.

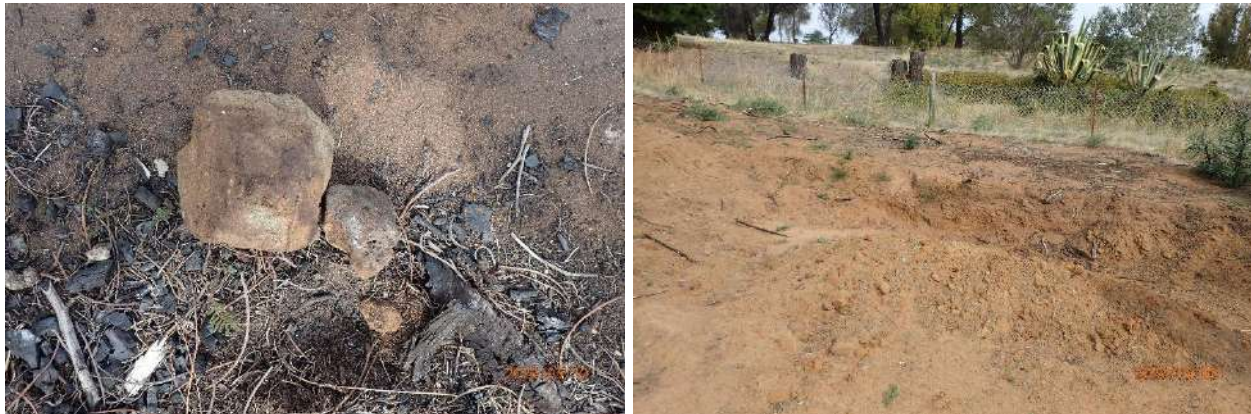
Plates 1 & 2. Geology and soils of site: LHS – exposed basalt; RHS – sandy upper soil horizon

Geology: while 1:250,000 scale geological mapping (Figure 6a) indicates that the subject title and surrounds as Mesozoic age “basalt (tholeiitic to alkalic) and related pyroclastic rocks” (Tb) and Cenozoic age “coastal sand and gravel” (Qps), 1:25,000 scale mapping (Figure 6b) indicates that the substrate is Cenozoic age “Pleistocene aeolian deposits” (geocode: Qpw) – site assessment indicated the site is on some form of basaltic substrate but with a very strong Aeolian influence from windblown sand (Plates 1 & 2): the geology is mentioned because of its influence on vegetation classification and potential for threatened flora (and to a lesser extent, threatened fauna).

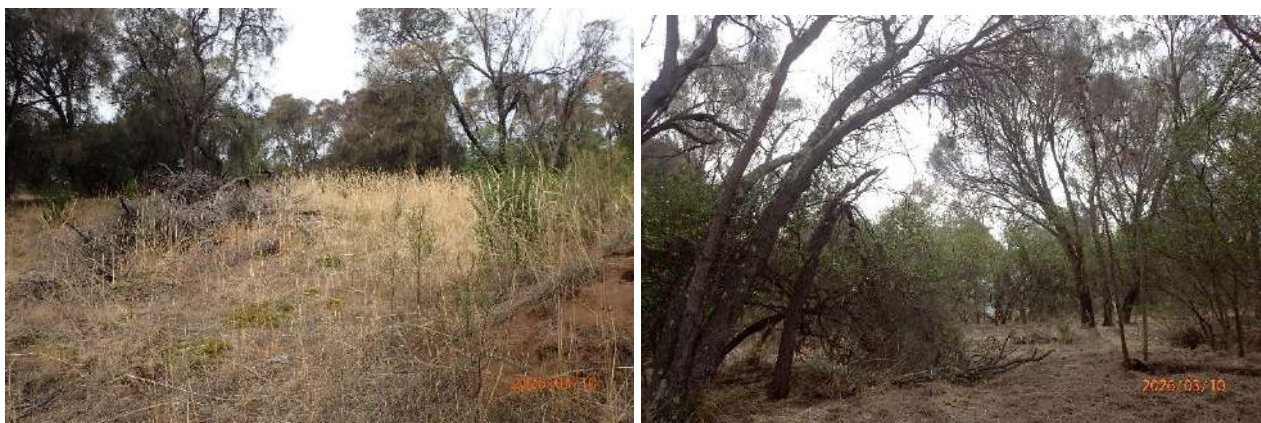
Plates 3 & 4. Forested parts of title: LHS – eastern part; RHS – western part

Current land use: lightly forested across most of title (Plates 3 & 4) except for the centre-western area of the title (proposed for development), where informal clearing has occurred over many years, with an informal fenceline clearing along most of the southern boundary (Plates 5 & 6) and an existing well-formed access track along the northern boundary (Plates 7 & 8).

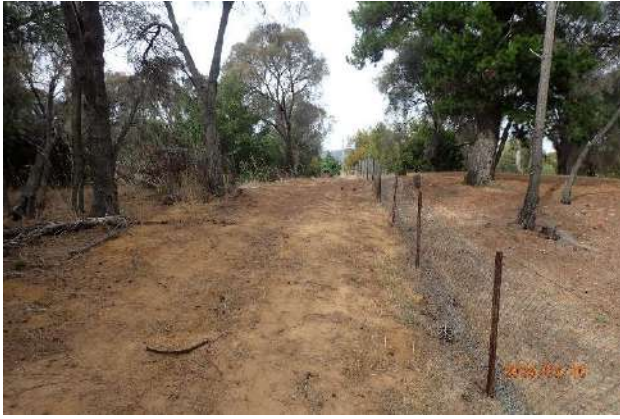
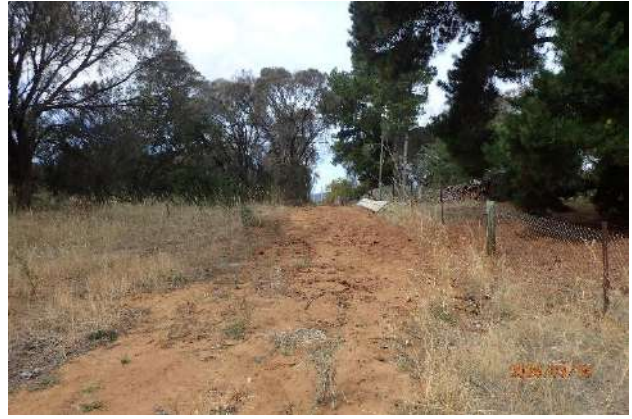
Plates 5 & 6. Views along southern boundary

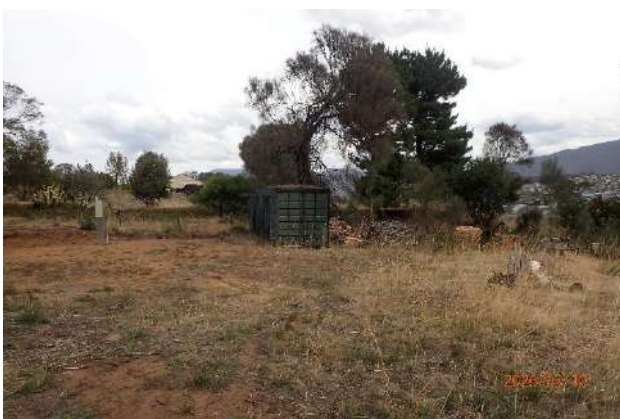
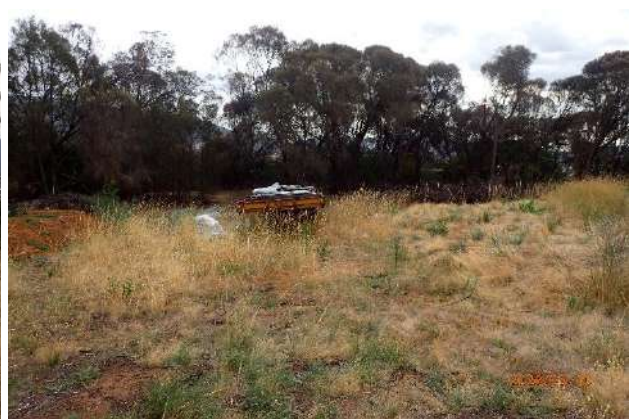
Plates 9-12. Views from approximate centre of cleared area on title looking north, east, south and west (from top left to bottom right)

The proposal is for a single residential dwelling and shed located in the north of the title with an associated hazard management area (Plates 9-12 show the current status of the parts of the title proposed for development)

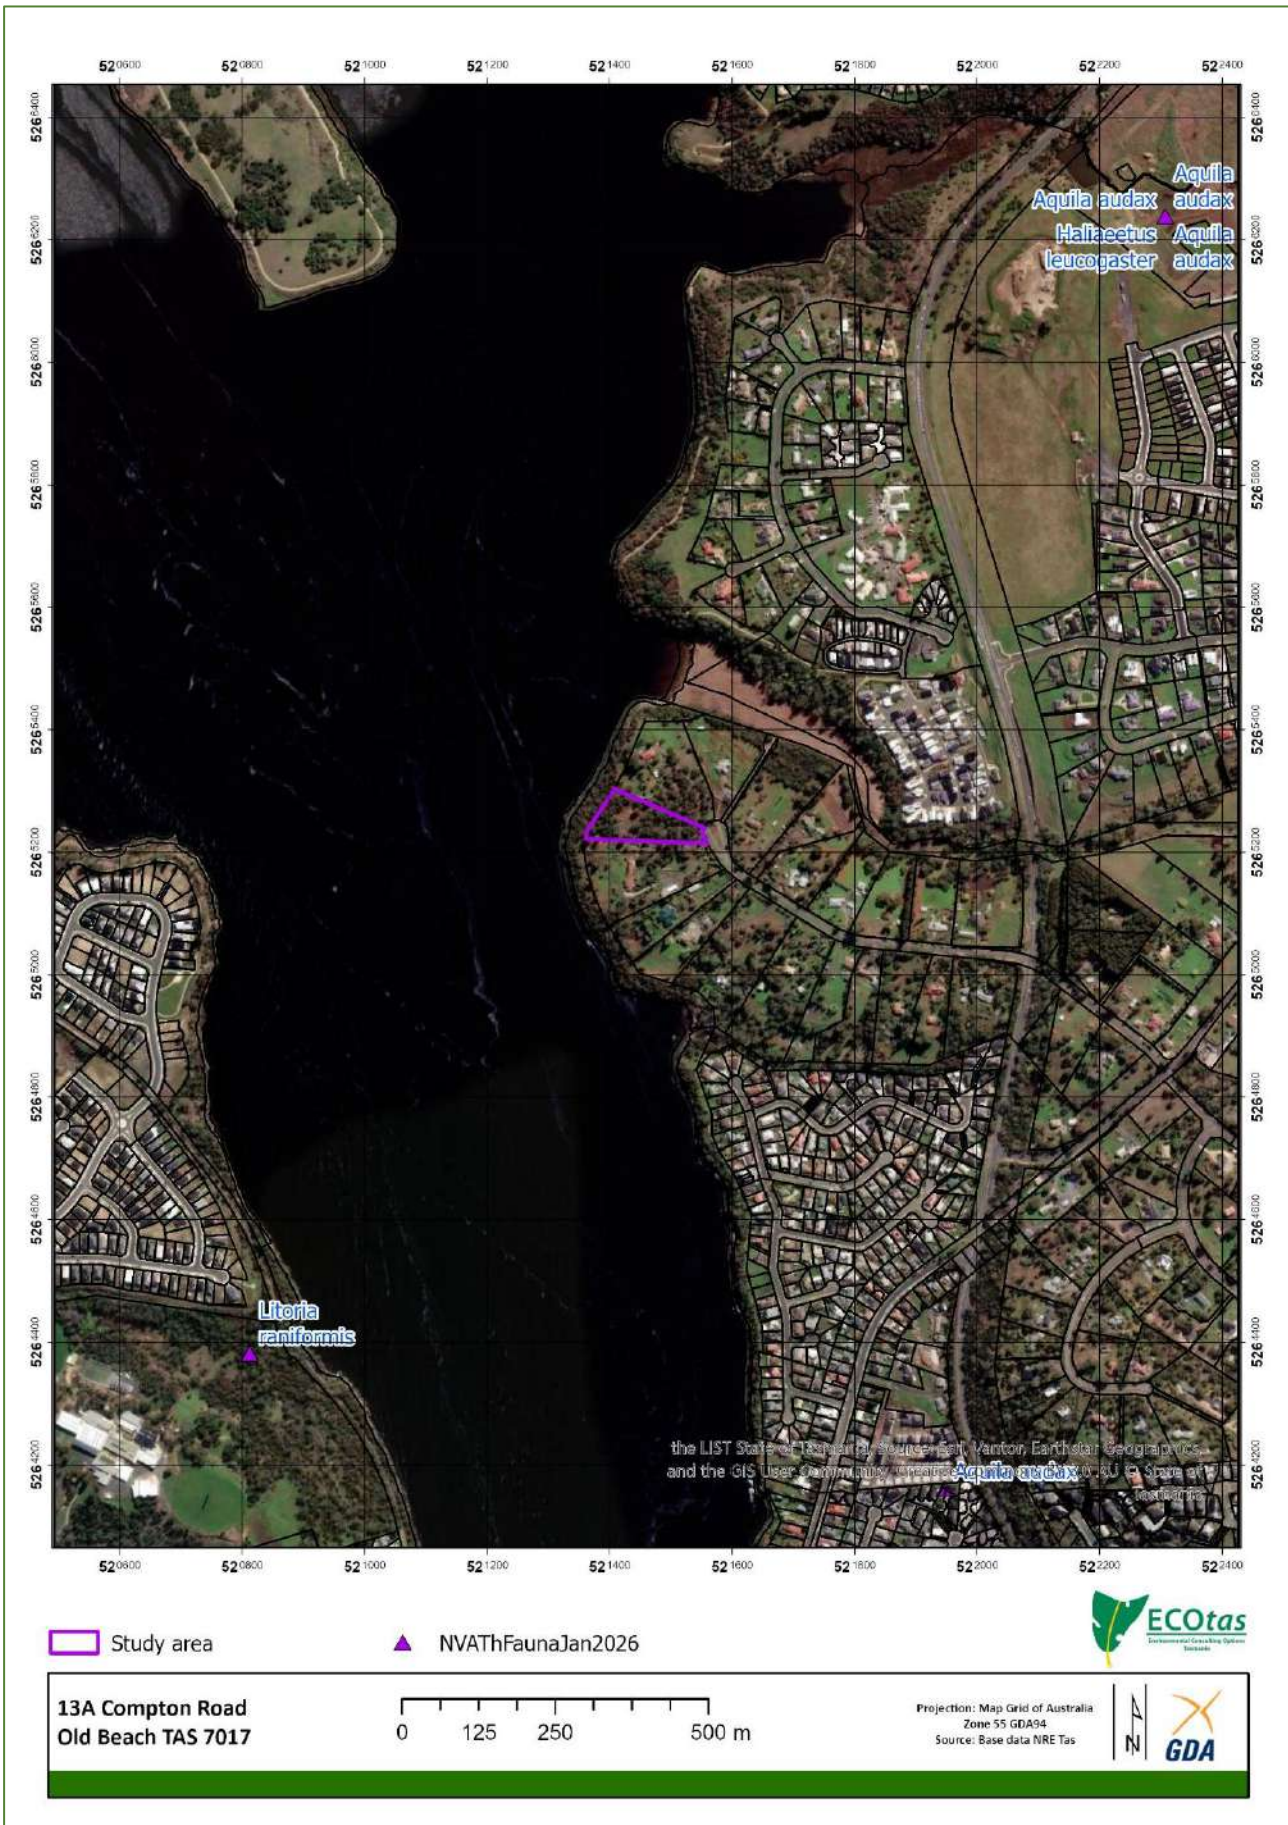
Figure 10. Distribution of threatened fauna in vicinity of study area (overview)

No fauna species listed as threatened on the Tasmanian *Threatened Species Protection Act 1995* and/or the Commonwealth *Environment Protection and Biodiversity Conservation Act 1999* are known from database information, or were detected as a consequence of field survey, from the title area or surrounds (Figure 10).

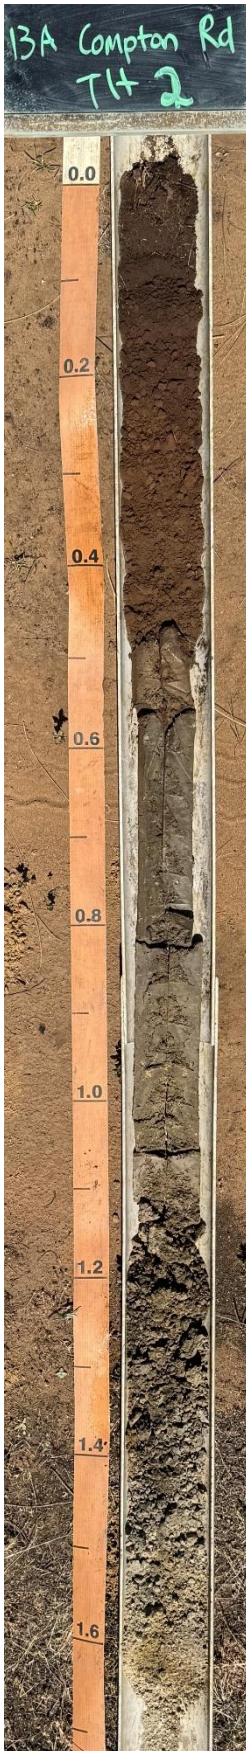
SOIL PROFILES – Test Hole 2

Depth (m)	Horizon	Description and field texture grade	Soil Cat.
0 – 0.5	A1	Dark brown (10YR 3/3) grading to brown (7.5YR 4/3), Sand , poorly graded, dry loose consistency	1
0.5 – 1.2	B2	Dark greyish brown (2.5YR 4/2), Sandy Medium Clay , massive, slightly moist stiff consistency	6
1.2 – 1.5	BC	Very dark greyish brown (2.5YR 3/2) Gravelly Sandy Light Clay , strong fine/medium polyhedral structure, slightly moist firm consistency, common basalt gravels	5
1.5 – 1.65	C _w	Highly weathered basalt bedrock: dark greyish brown (2.5YR 4/2), Gritty Clay Loam , single grain, dry dense consistency. <u>REFUSAL ON WEATHERED BASALT BEDROCK</u>	N/A

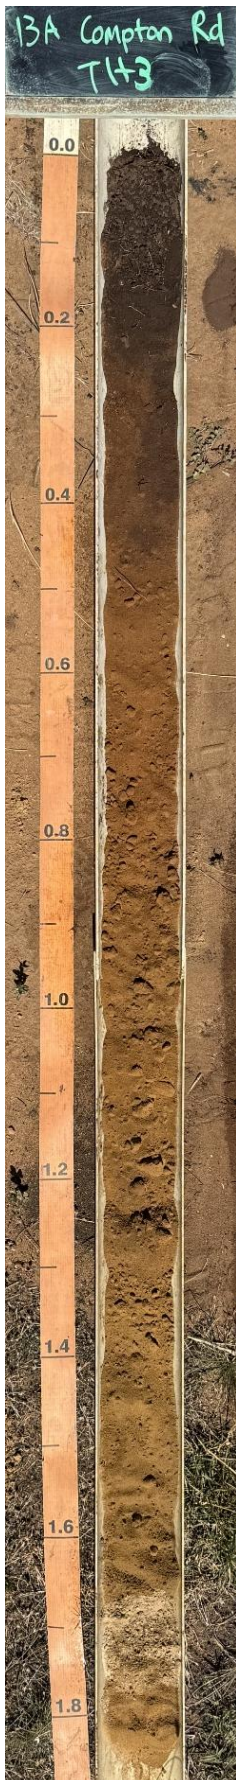
SOIL PROFILES – Test Hole 3

Depth (m)	Horizon	Description and field texture grade	Soil Cat.
0 – 0.4	A1	Dark brown (7.5YR 3/2), Sand , poorly graded, dry loose consistency	1
0.3 – 1.8	C	Strong brown (7.5YR 4/6) grading to yellow brown (10YR 5/4), Sand , poorly graded, dry loose consistency. Highly calcareous lens of sand at 1.65 – 1.75m <u>NO REFUSAL</u>	1

In answer to 11.4.1 P1(b) Test hole 3 was conducted in the area of the proposed stormwater swale drain. The soils are deep sands with no refusal at 1.8 m. Sand is highly permeable.

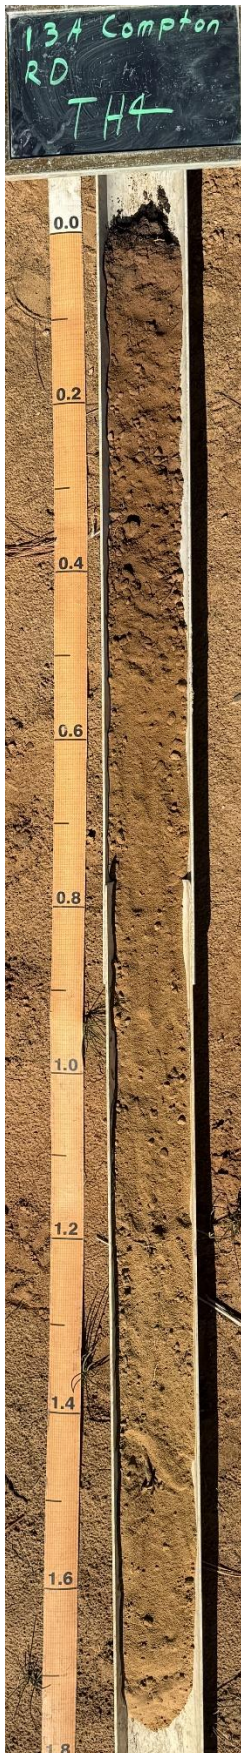
SOIL PROFILES – Test Hole 4

Depth (m)	Horizon	Description and field texture grade	USCS Class
0 – 0.4	A1	Reddish brown (5YR 4/4), Sand , poorly graded, dry loose consistency	1
0.4 – 1.8	C	Strong brown (7.5YR 4/6), Sand , poorly graded, dry loose consistency. <u>NO REFUSAL</u>	1

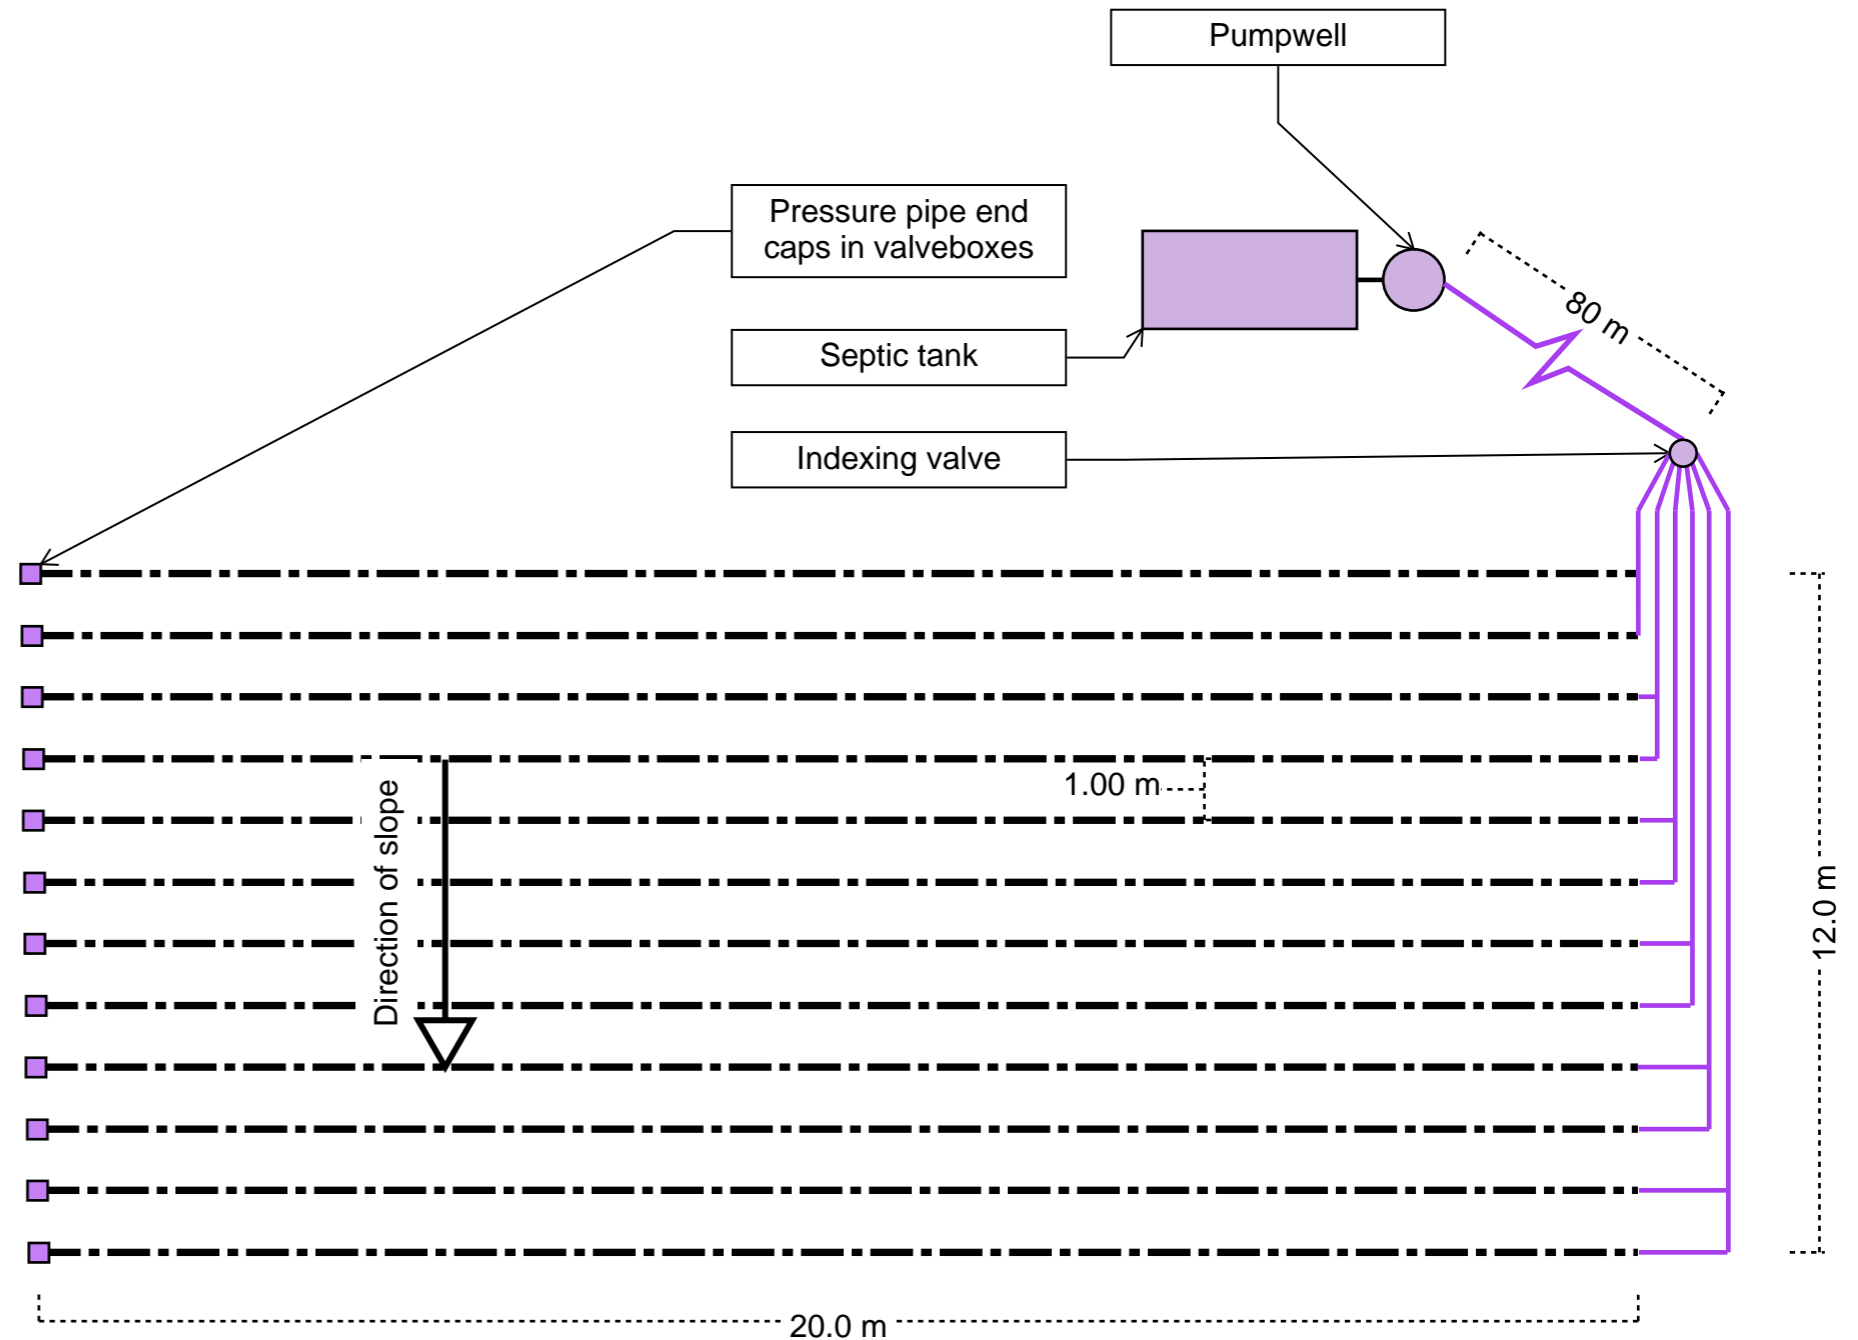
Plan view - Schematic

Designs of onsite wastewater management systems are site-specific. Installer to refer closely to DSC report and design spec sheets. Contact the system designer with any questions or proposed changes to the system prior to proceeding with changes. Failure to do so may prevent designer certification/sign-off

Proposed ONWMS design:
