# Application for Planning Approval

**323 CHURCH ROAD, DROMEDARY**

**SINGLE DWELLING & CARPORT**

# **BUSHFIRE HAZARD ASSESSMENT**

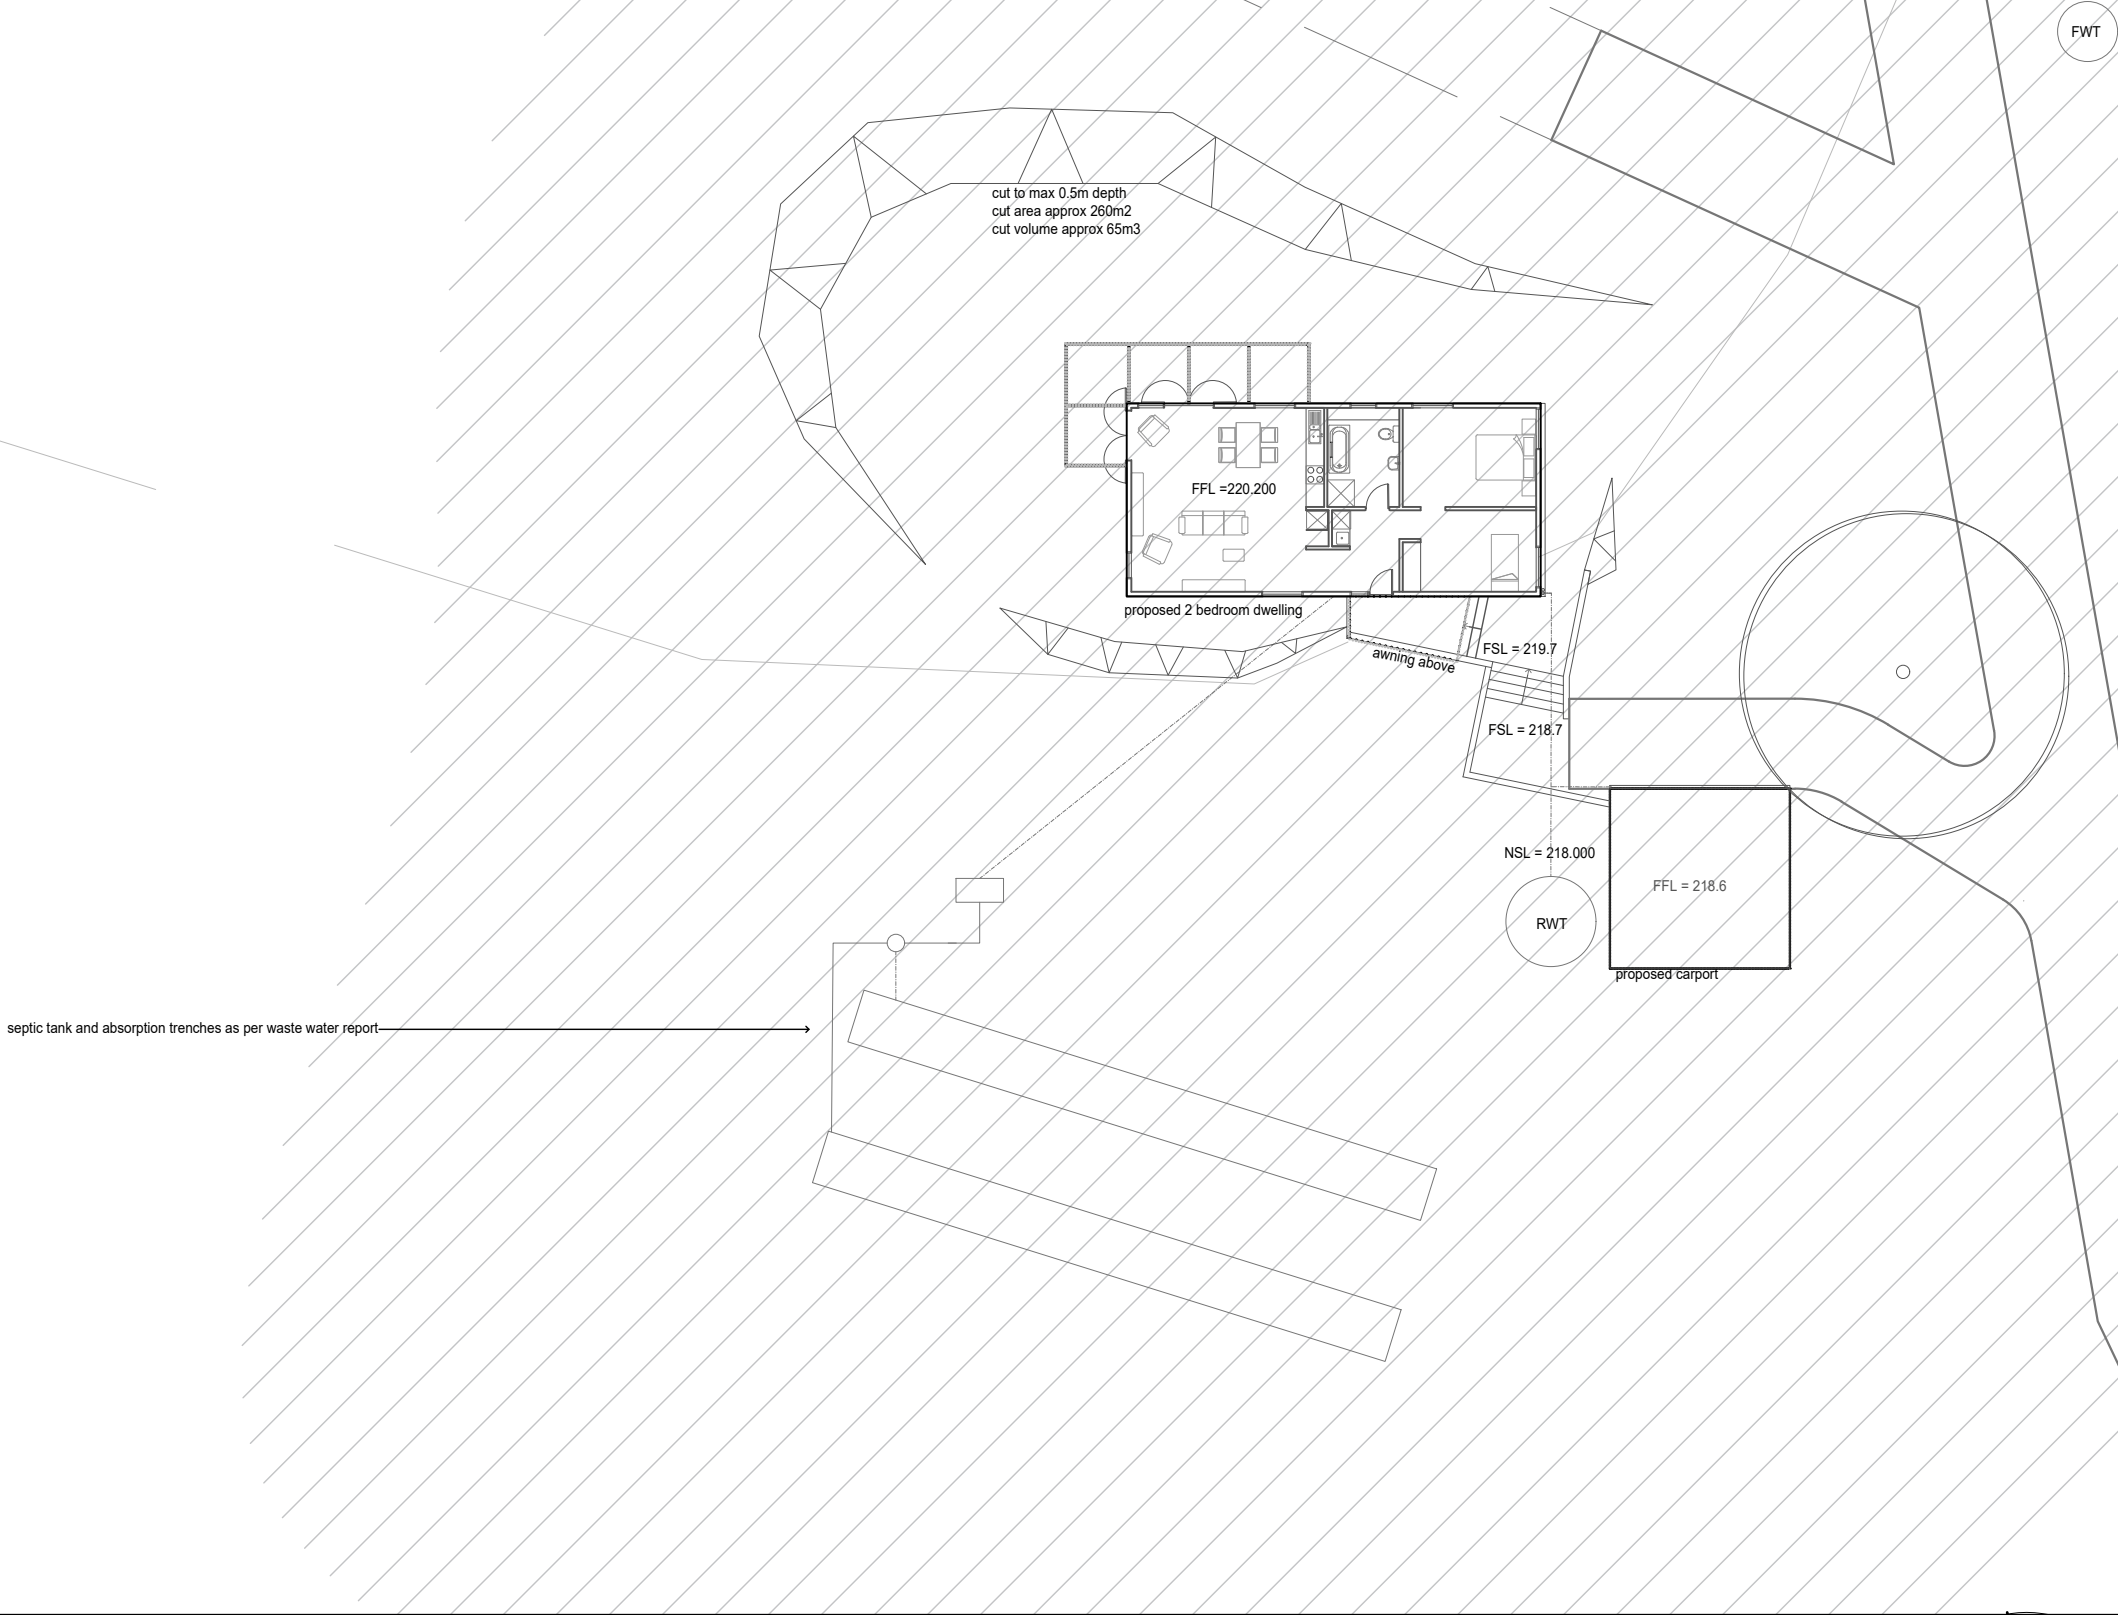
DRAWING: Bushfire Hazard Management Area

Bushfire hazard management area for BAL19  
 as specified in bushfire hazard assessment report  
 =4350m2

- Hazard management area setback distances
- N - 23m
  - NE - 27m
  - E - 34m
  - SE - 34m
  - S - 41m
  - SW - 41m
  - W - 23m
  - NW - 23m

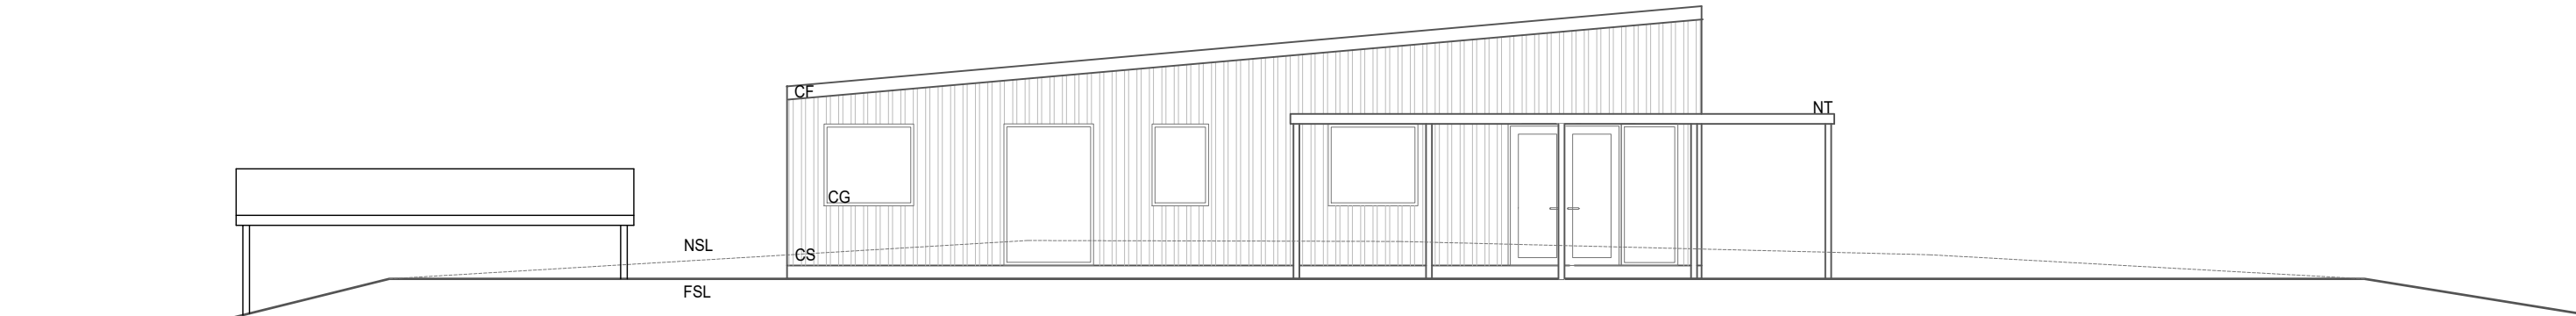
Elevation North

- Materials Legend
- CS Colorbond Sheet, Night Sky, LRV 4
  - CF Colorbond flashing, Night Sky, LRV 4
  - CG Clear Glazing, LRV NA
  - SS Structural Steel, black paint finish, LRV <10
  - CB Concrete blockwork, LRV 30

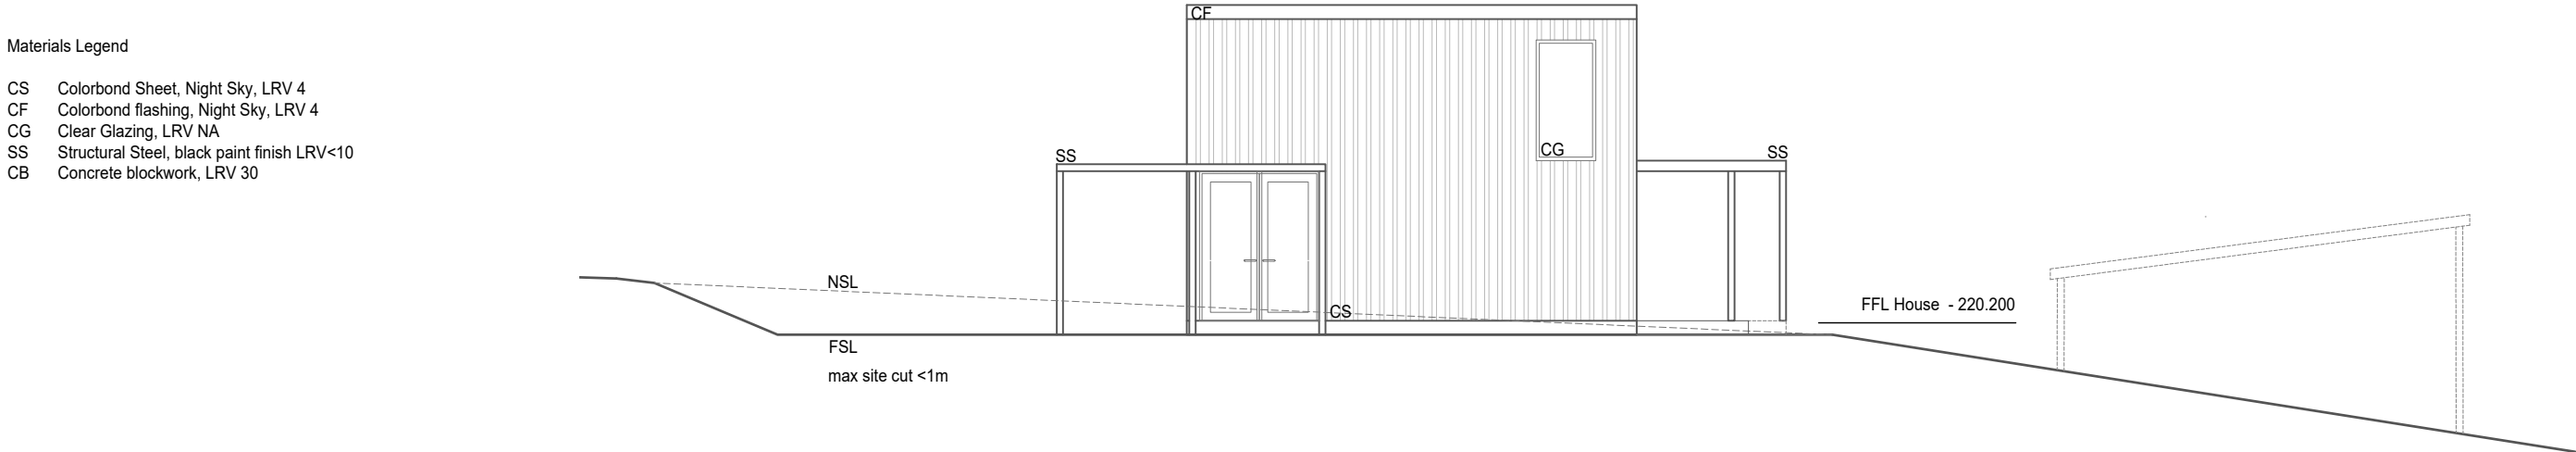
Elevation West

- Materials Legend
- CS Colorbond Sheet, Night Sky, LRV 4
  - CF Colorbond flashing, Night Sky, LRV 4
  - CG Clear Glazing, LRV NA
  - SS Structural Steel, black paint finish LRV<10
  - CB Concrete blockwork, LRV 30

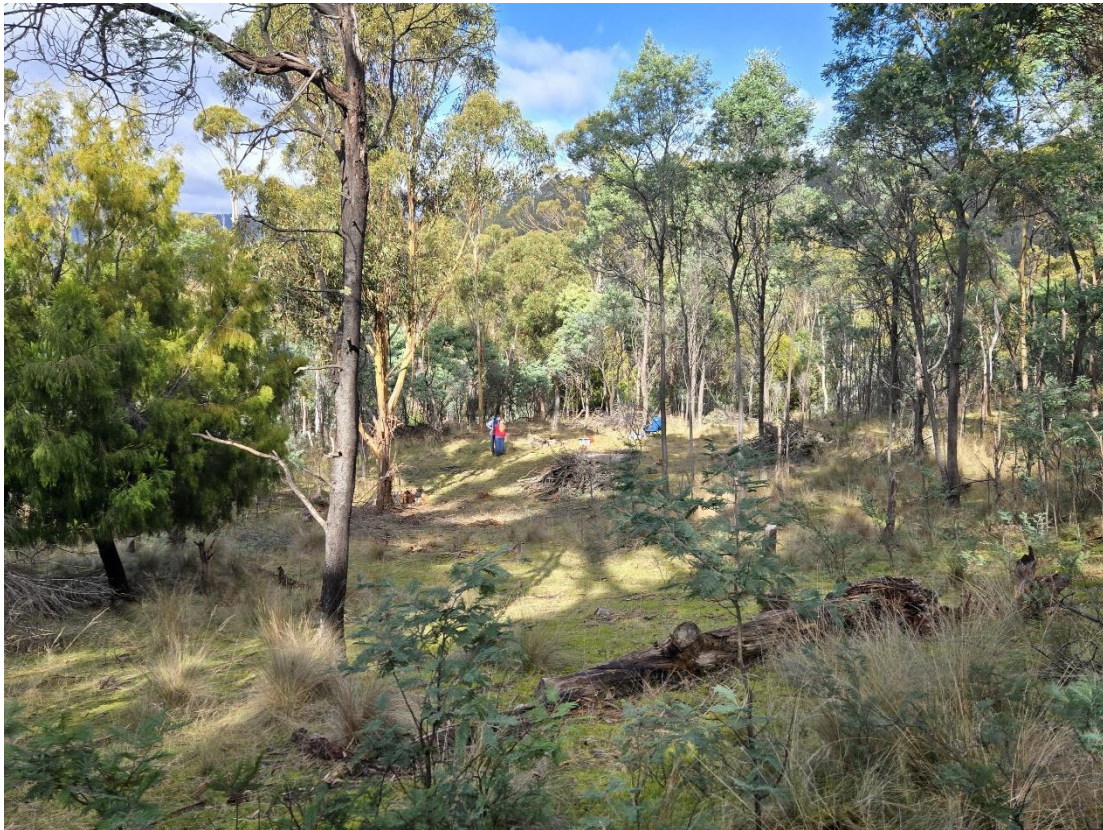
*Figure 1: View of site location 1, facing SE*

The vegetation that can be found within the site is predominantly covered in foliage with 30-70% of cover, with various types of grasses, shrubs that range from 1m-4m, and trees that reach over 30m in height. Therefore, the site can be classed as GROUP A FOREST per Table 2.3 of AS3959:2018.

Photos for site location 1 can be found in figures 1 & 18.

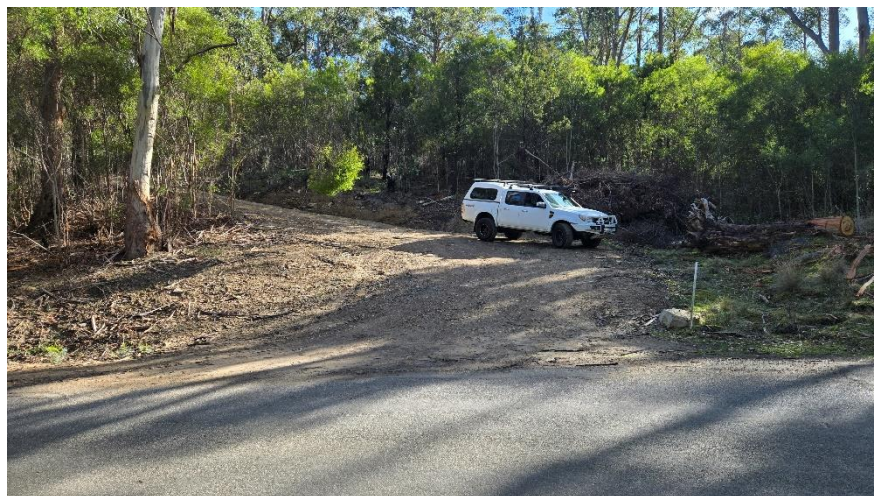
*Figure 7: Existing access to site from Church Road, facing NW*

Both site locations will utilise the same gravel driveway access from Church Road. The access is approximately 8m in width at Church Road, reducing to 3-4m in width for the remainder of the distance to site location 1.

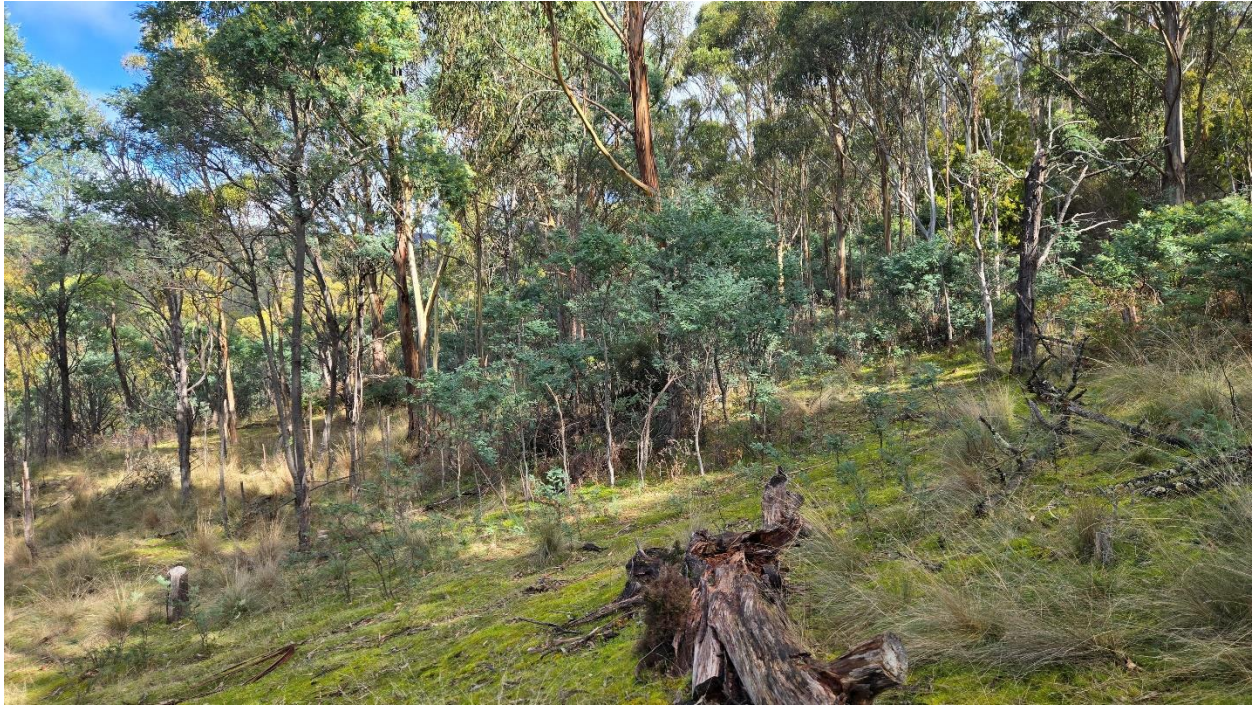
*Figure 14 – Forest fuel NW of Site Location 1, Facing SW*

Photos north of site location 1 can be found in figures 14, 17 & 18.

Photos west of site location 1 can be found in figures 14, 15 & 16.

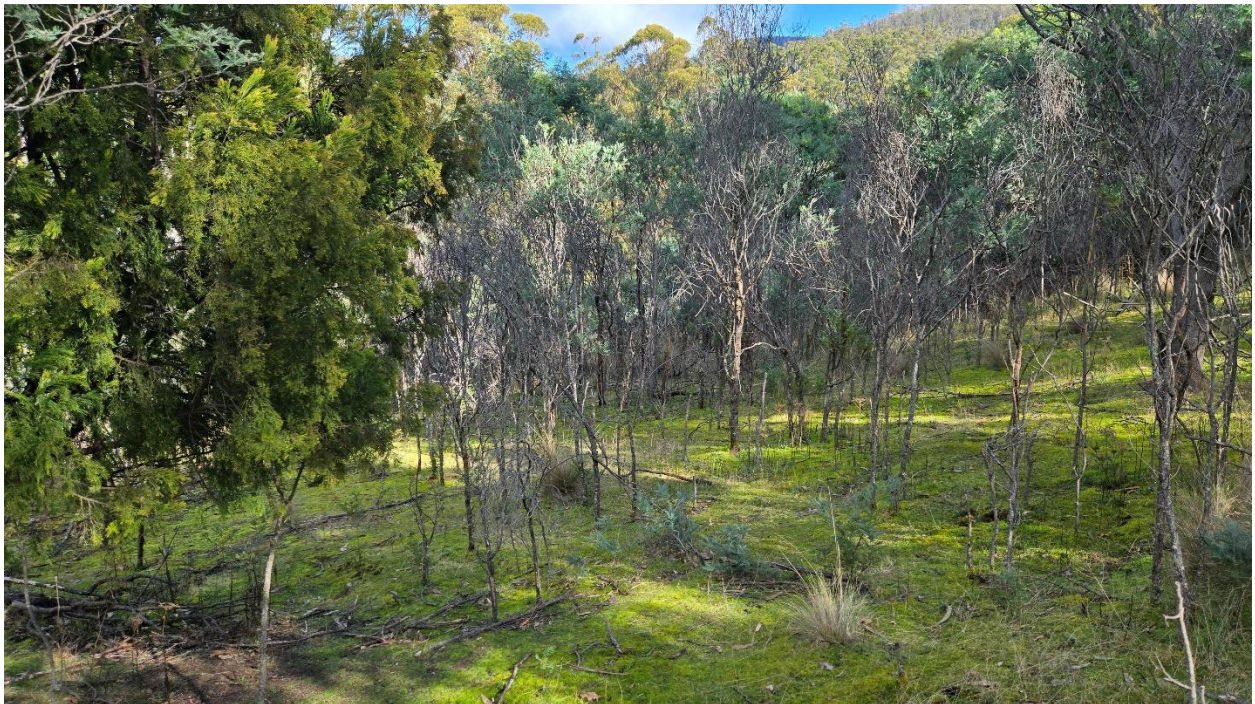
*Figure 15 – Forest fuel SW of Site Location 1, Facing S*

Photos south of site location 1 can be found in figures 15 & 19.

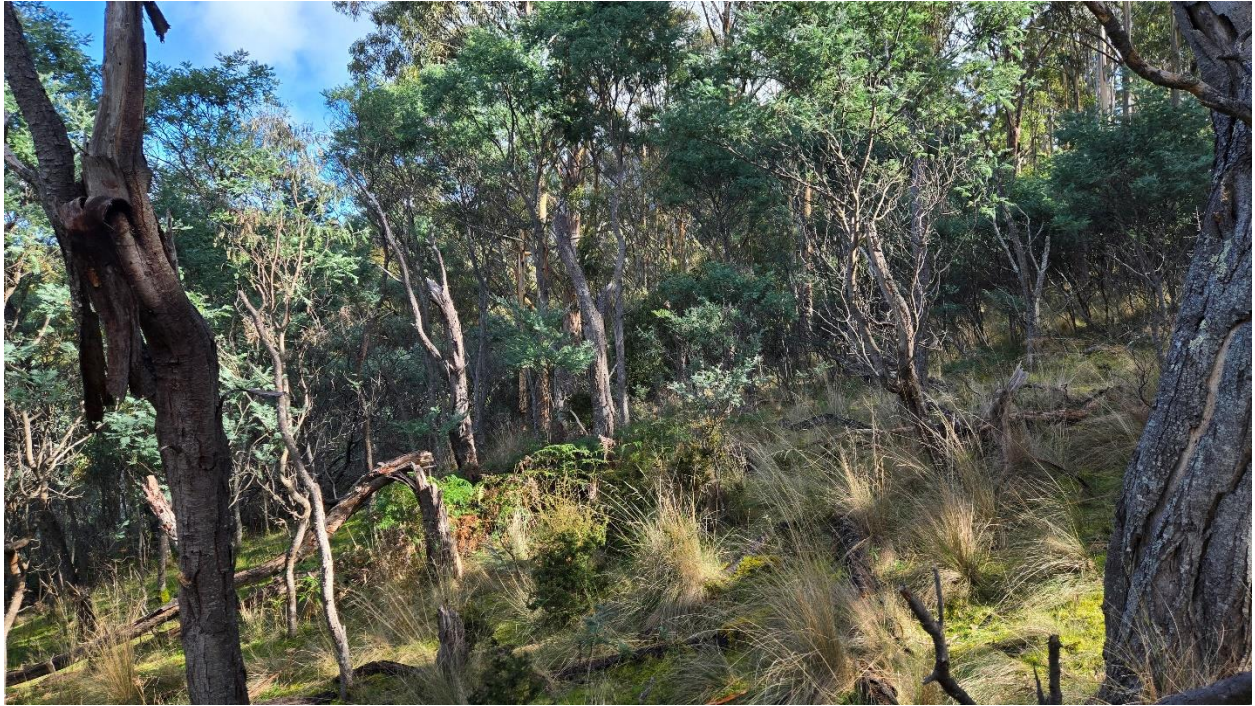
*Figure 16 – Forest fuel W of Site Location 1, Facing W*

To the west of the site, downslope, is land within the same property. There is an existing track approximately 8m from the site used for access throughout the property and is approximately 3m in width. The vegetation is predominantly covered in foliage with 30-70% of cover, with various types of grasses, shrubs that range from 1m-4m, and trees that reach over 30m in height. Therefore, it can be classed as GROUP A FOREST per Table 2.3 of AS3959:2018.

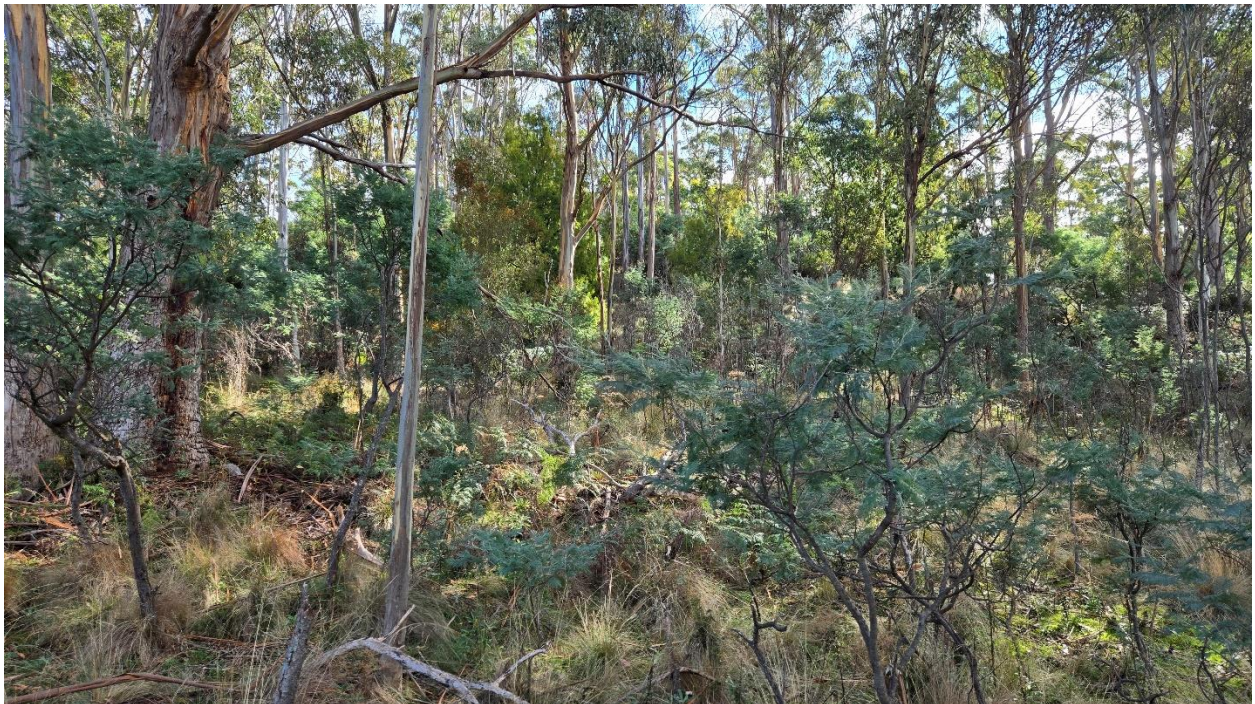
*Figure 17 – Forest fuel N of Site Location 1, Facing N*

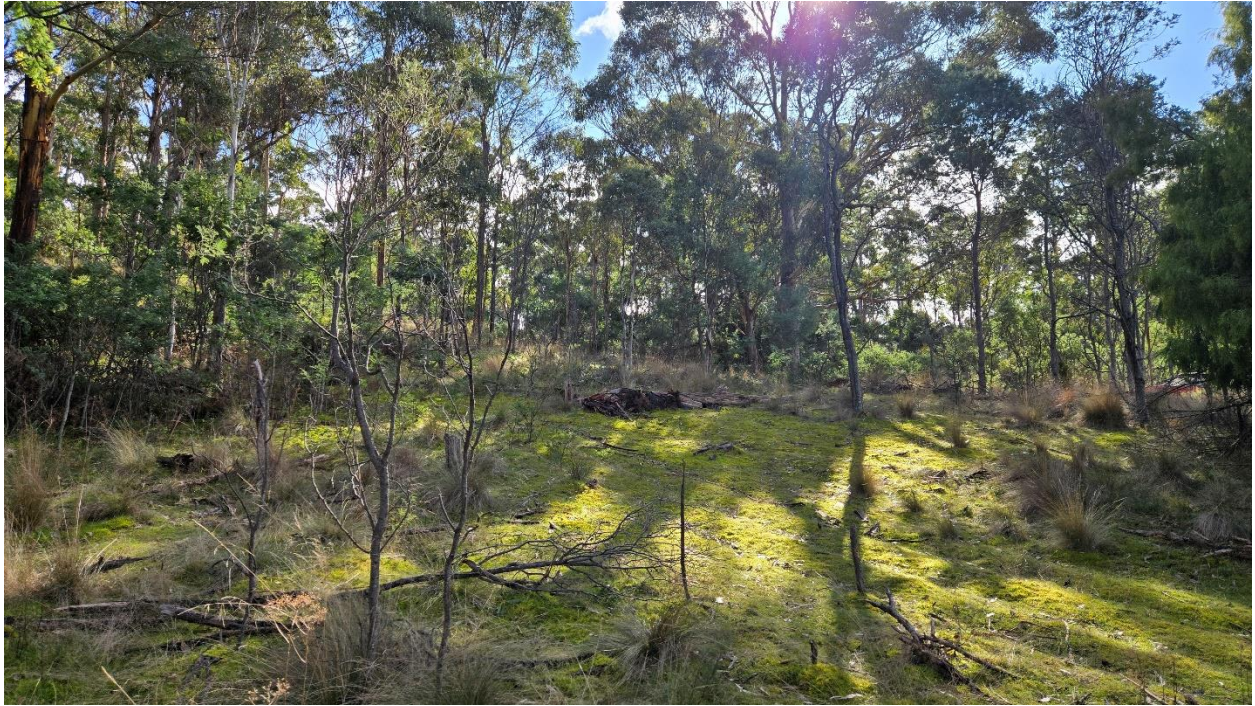
*Figure 18 – Various vegetation N of Site Location 1, Facing N*

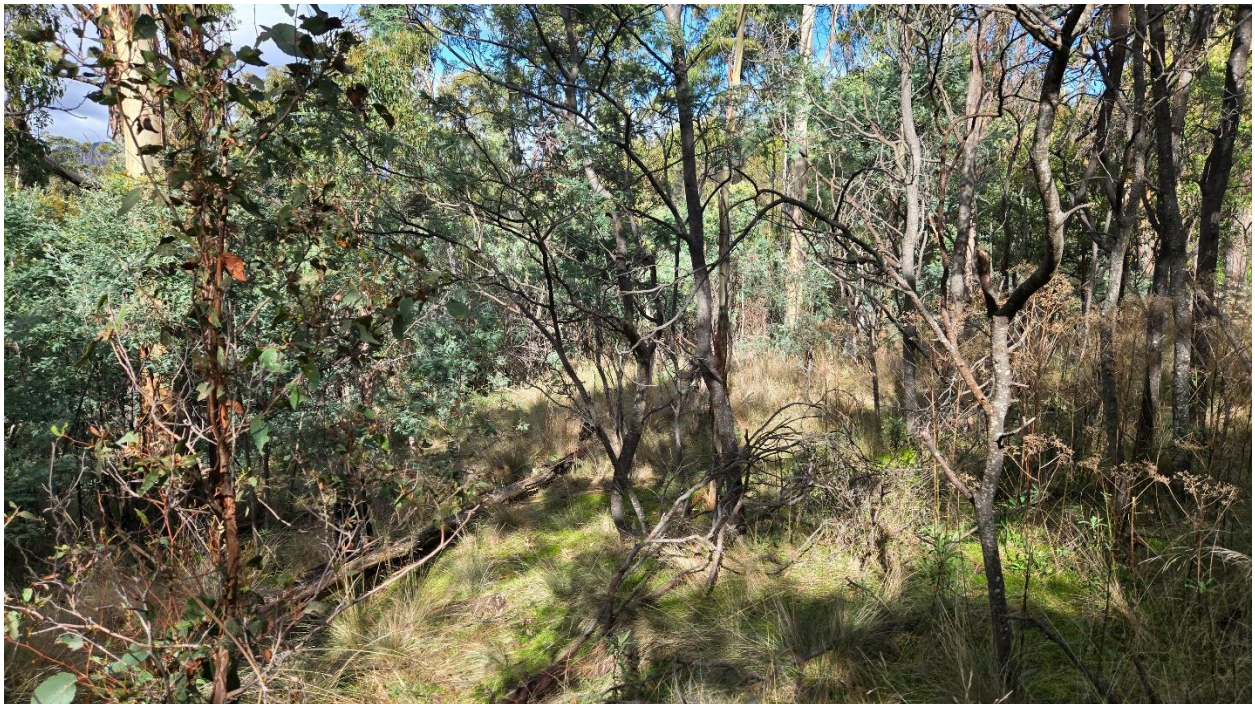
*Figure 19 – Forest Vegetation SE of Site Location 1, Facing S*

Photos east of site location 1 can be found in figure 19.

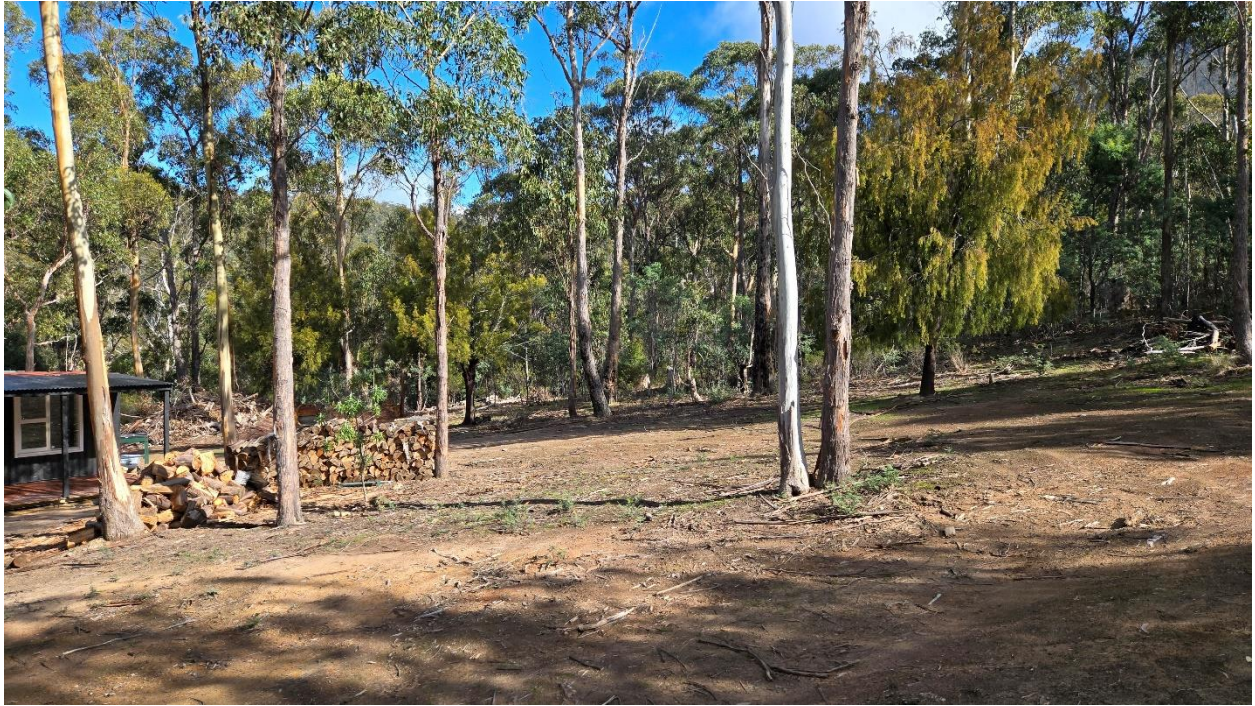
*Figure 20 – Existing storage container and Woodland fuel N of site Location 2, Facing W*

The vegetation that can be found within the site is reasonably sparse with vegetation with foliage cover less than 30%, various bushes and shrubs that are 1m-4m in height, and trees that are 10m-30m in height. Therefore, the site can be classed as GROUP B WOODLAND per Table 2.3 of AS3959:2018.

Photos for site location 2 can be found in figures 20 & 23.

Photos south of site location 2 can be found in figures 20, 22, 23 & 24.

Photos west of site location 2 can be found in figures 20 & 21.

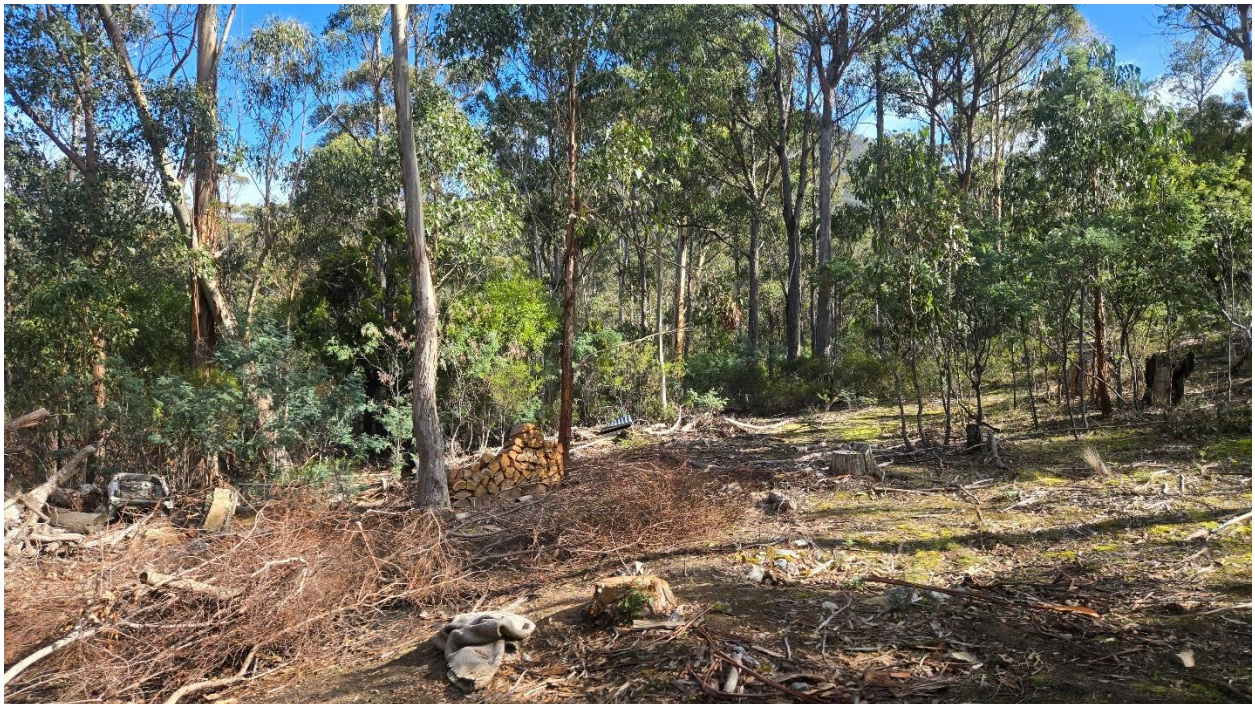
*Figure 21 – Woodland and forest fuel NW of site Location 2, Facing NW*

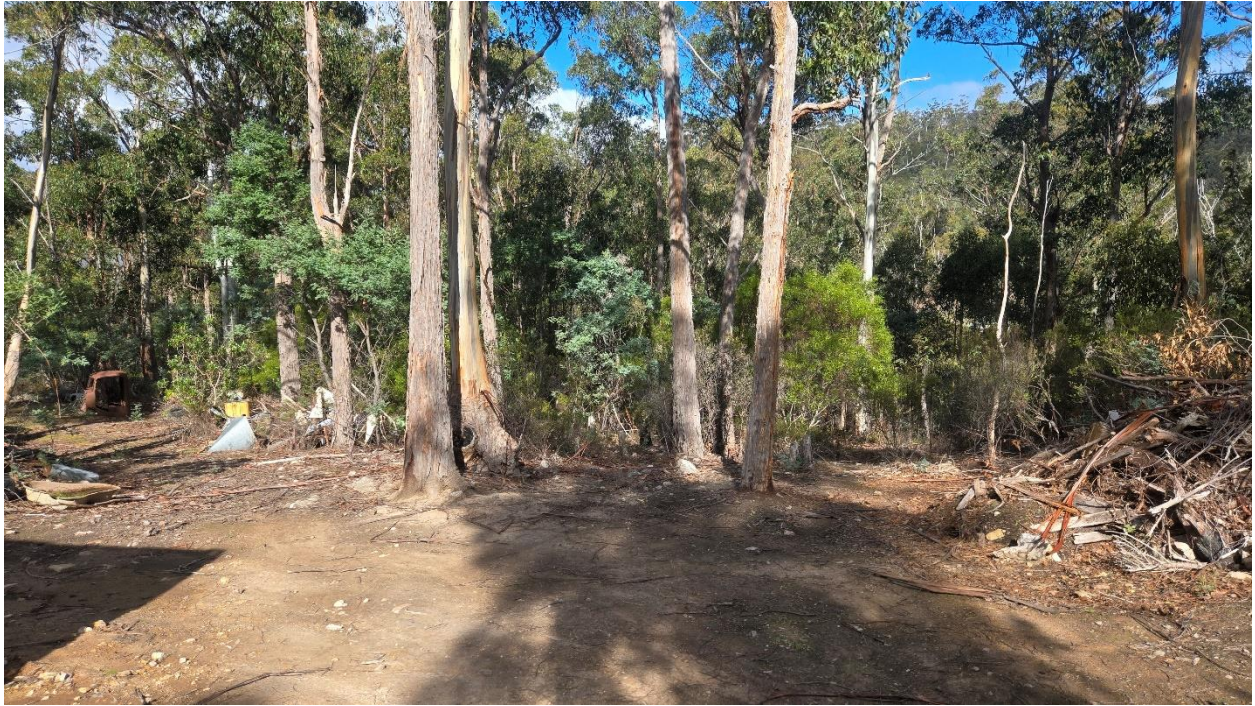
*Figure 22 – Forest fuel SW of site Location 2, Facing S*

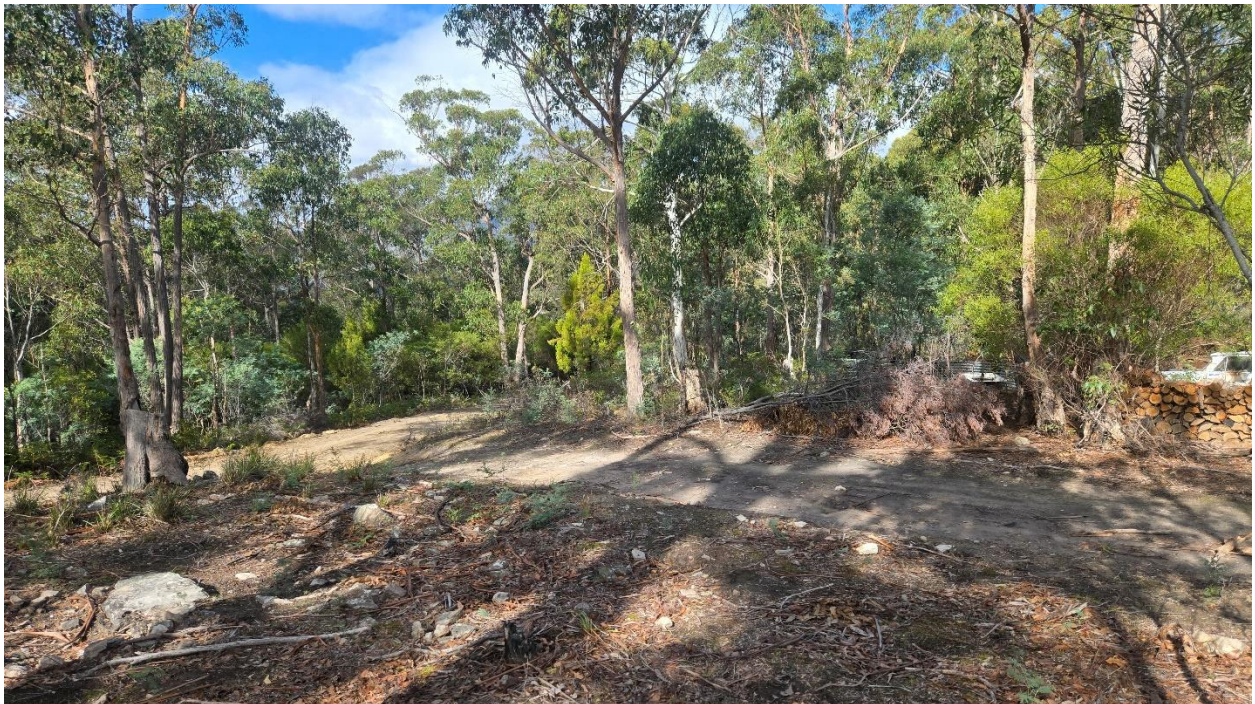
*Figure 23 – Existing tracks, woodland and forest fuel SE of site Location 2, Facing S*

Photos east of site location 2 can be found in figures 23 & 24.

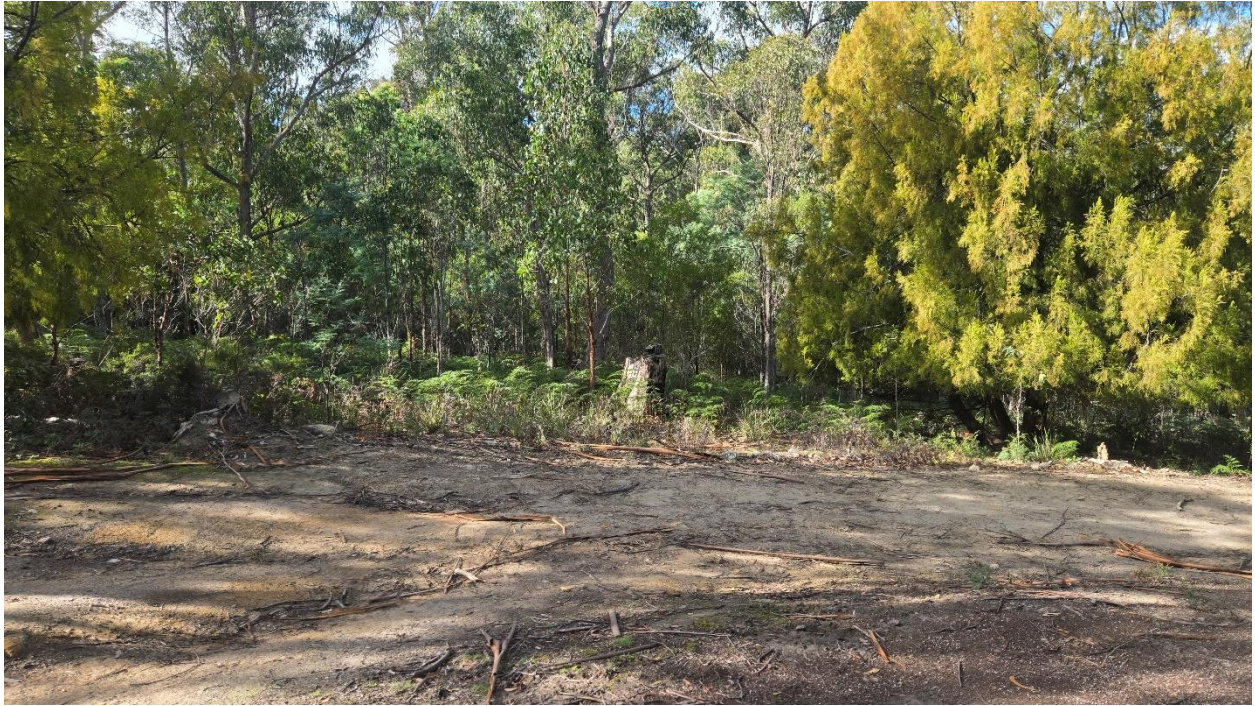
*Figure 24 – Existing track and Forest fuel NE of site location 2, facing E*

Photos north of site location 2 can be found in figures 24, 25 & 26.

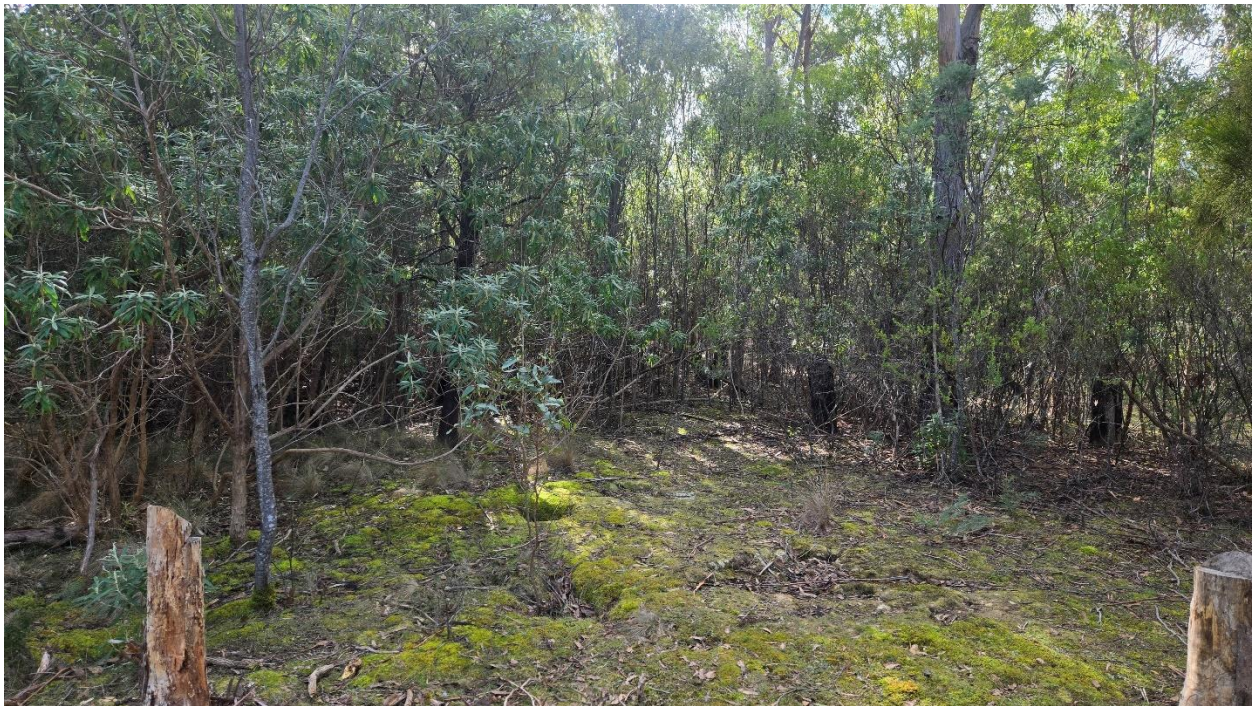
*Figure 25 – Forest vegetation N of site location 2, facing N*

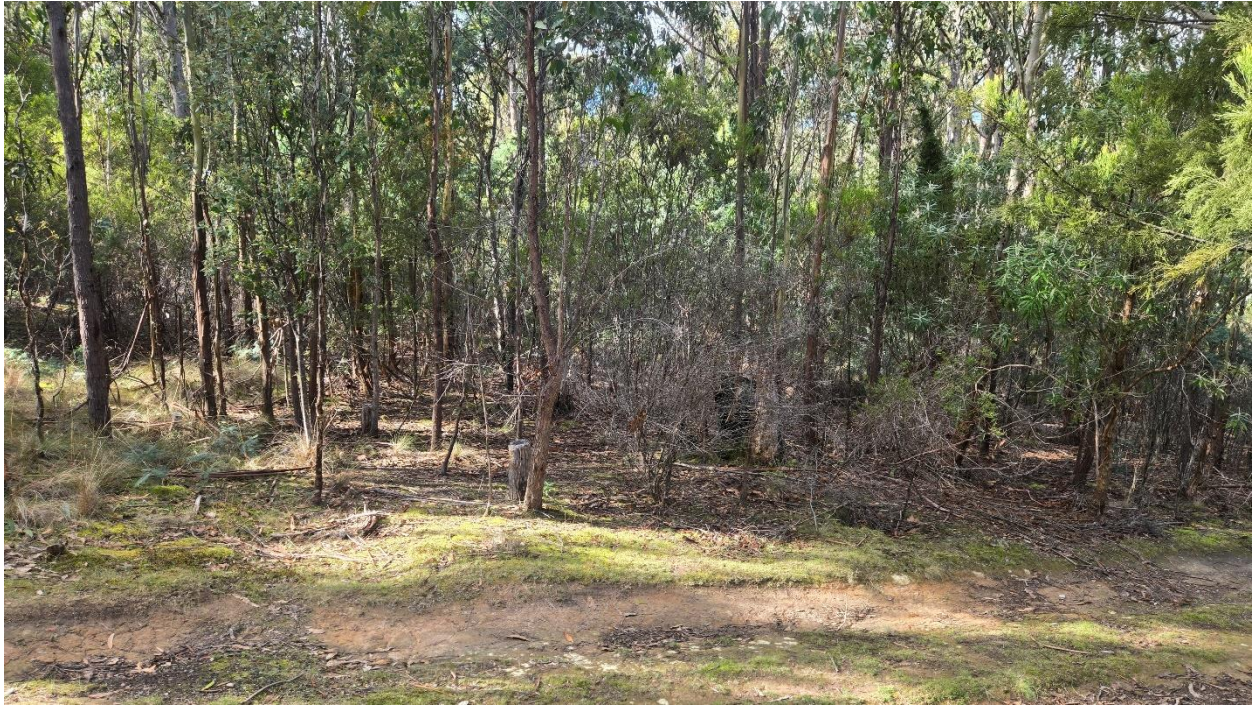
*Figure 26 – Existing track and forest vegetation NE of site location 2, facing E*
