# Application for Planning Approval

**323 CHURCH ROAD, DROMEDARY**

**SINGLE DWELLING & CARPORT**

# **BUSHFIRE HAZARD ASSESSMENT**

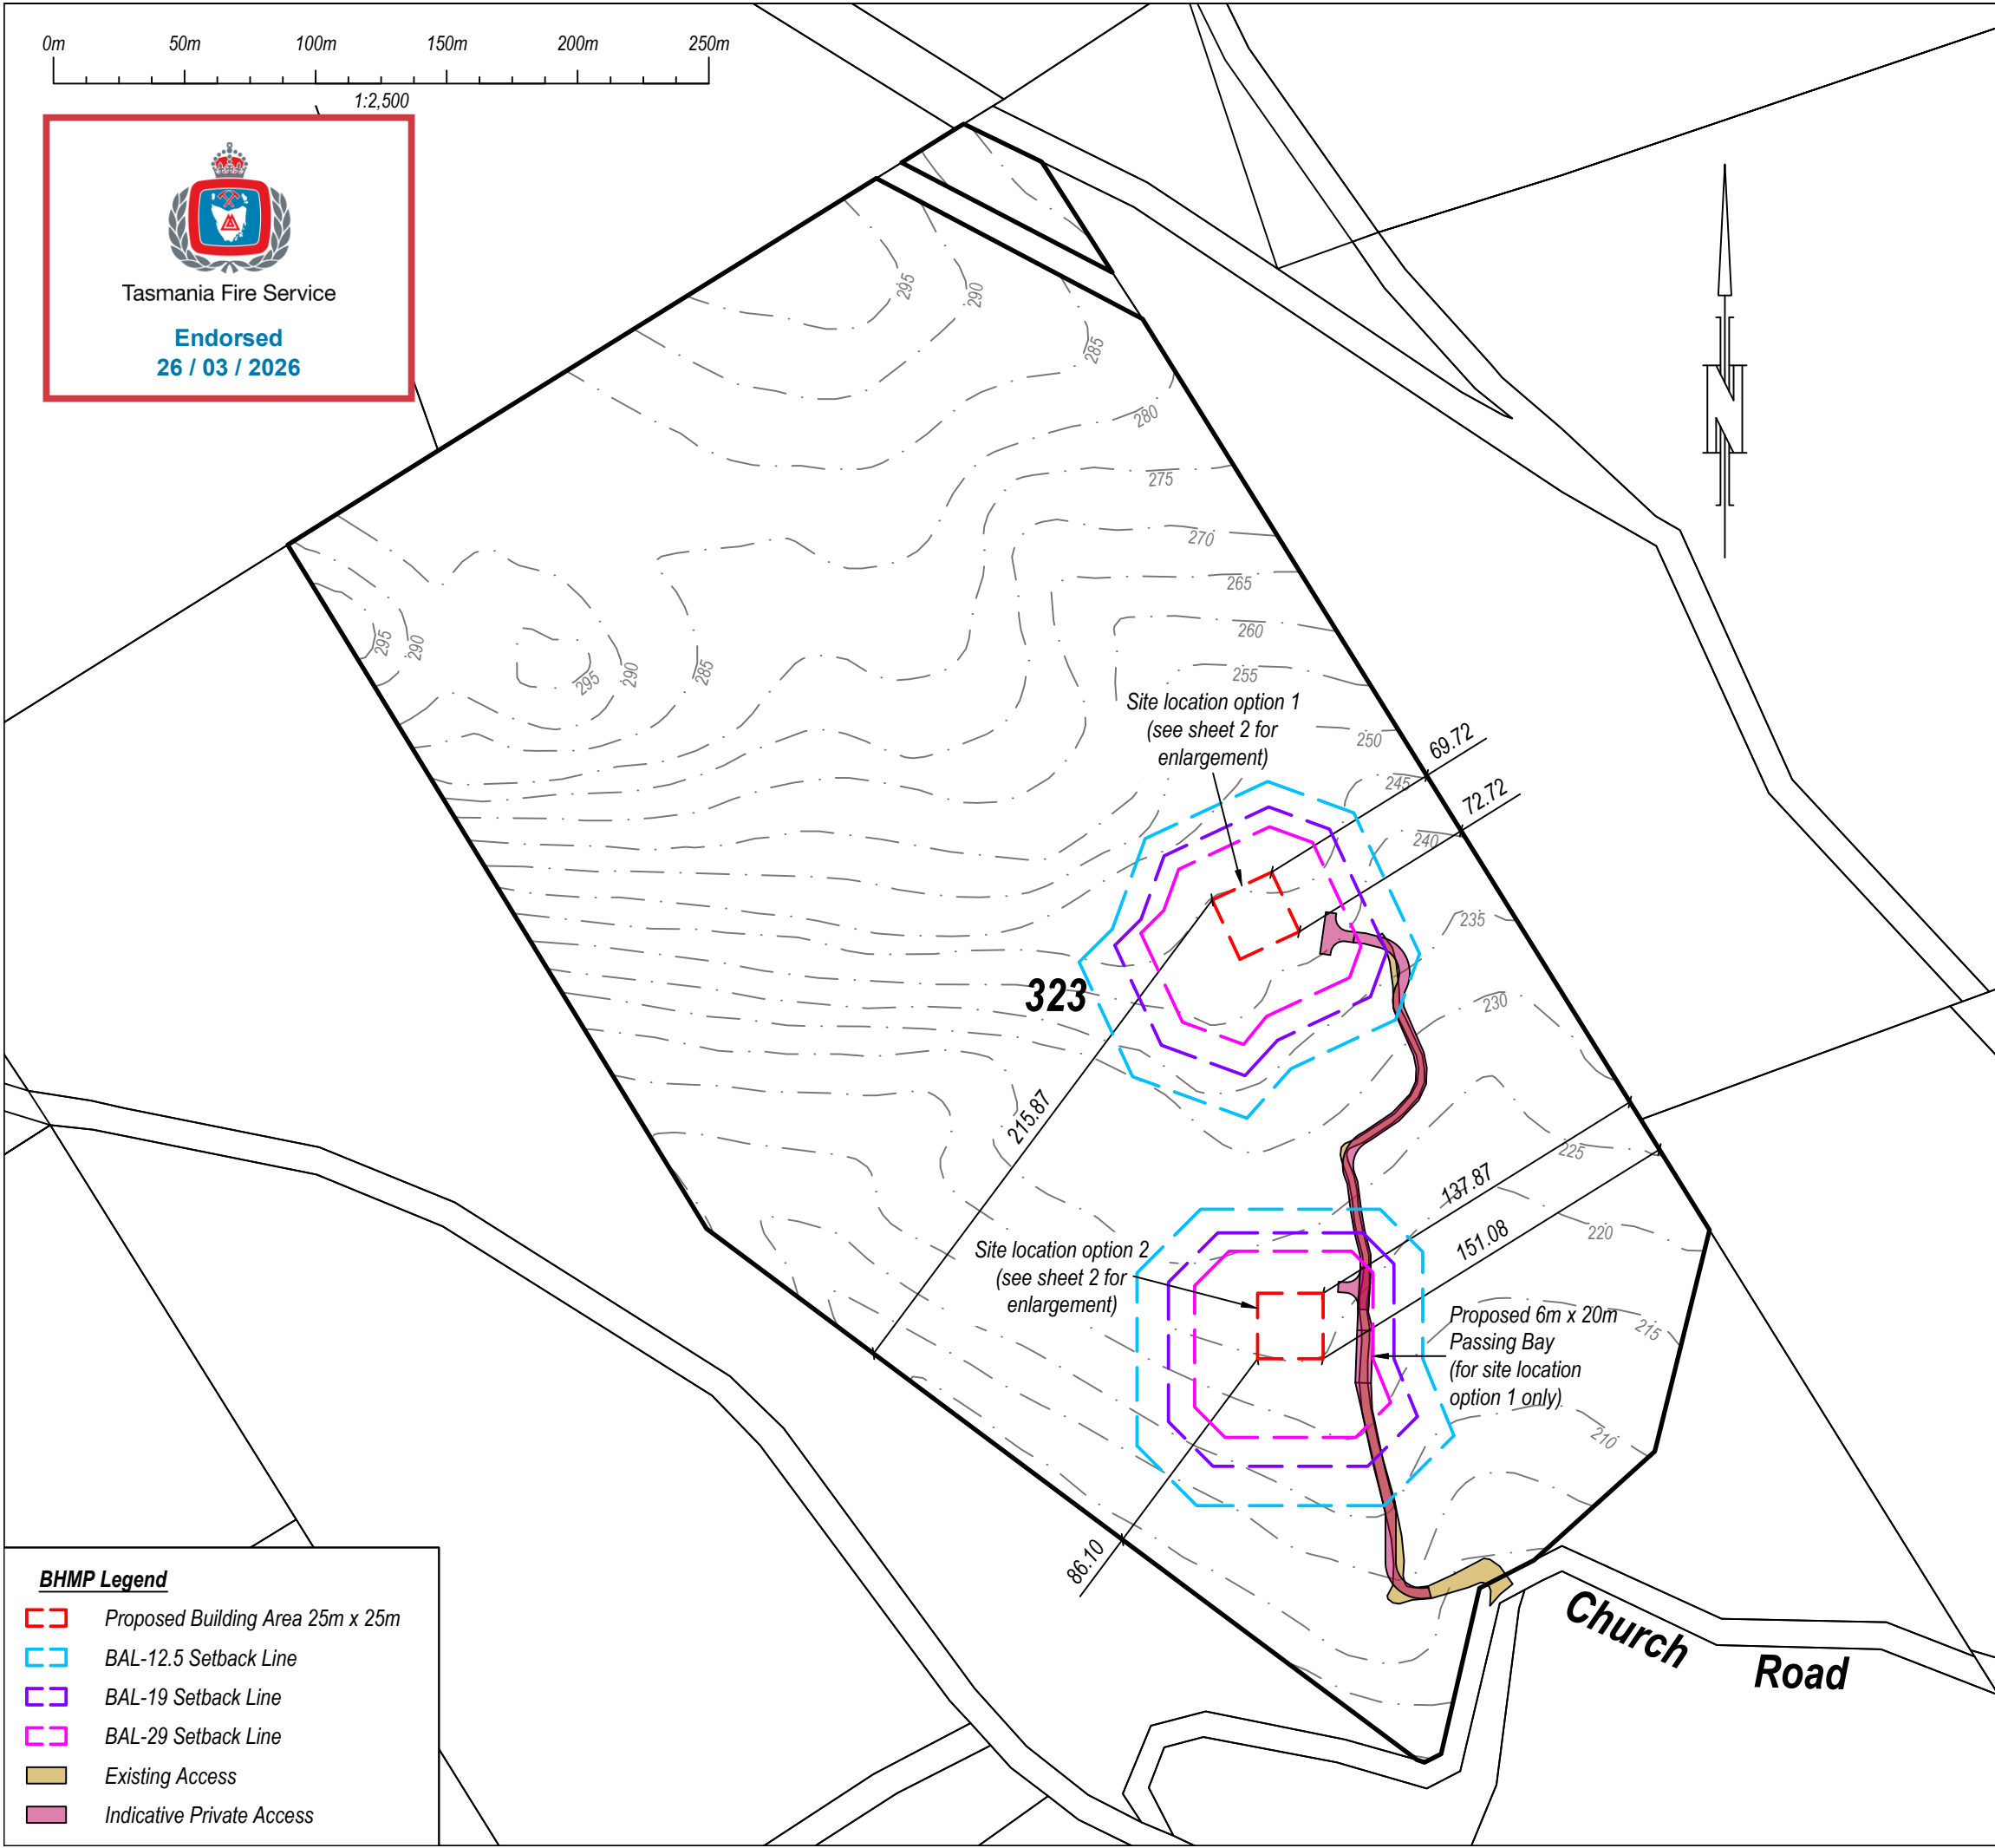
| LH Bushfire | |
|---|---|
| 1.1. | HMA to be established to distances indicated on this plan and as set out in Section 4.1 of the Bushfire Hazard Report. |
| 1.5. | Non-combustible elements including driveways, paths and short cropped lawns are recommended within the HMA. |

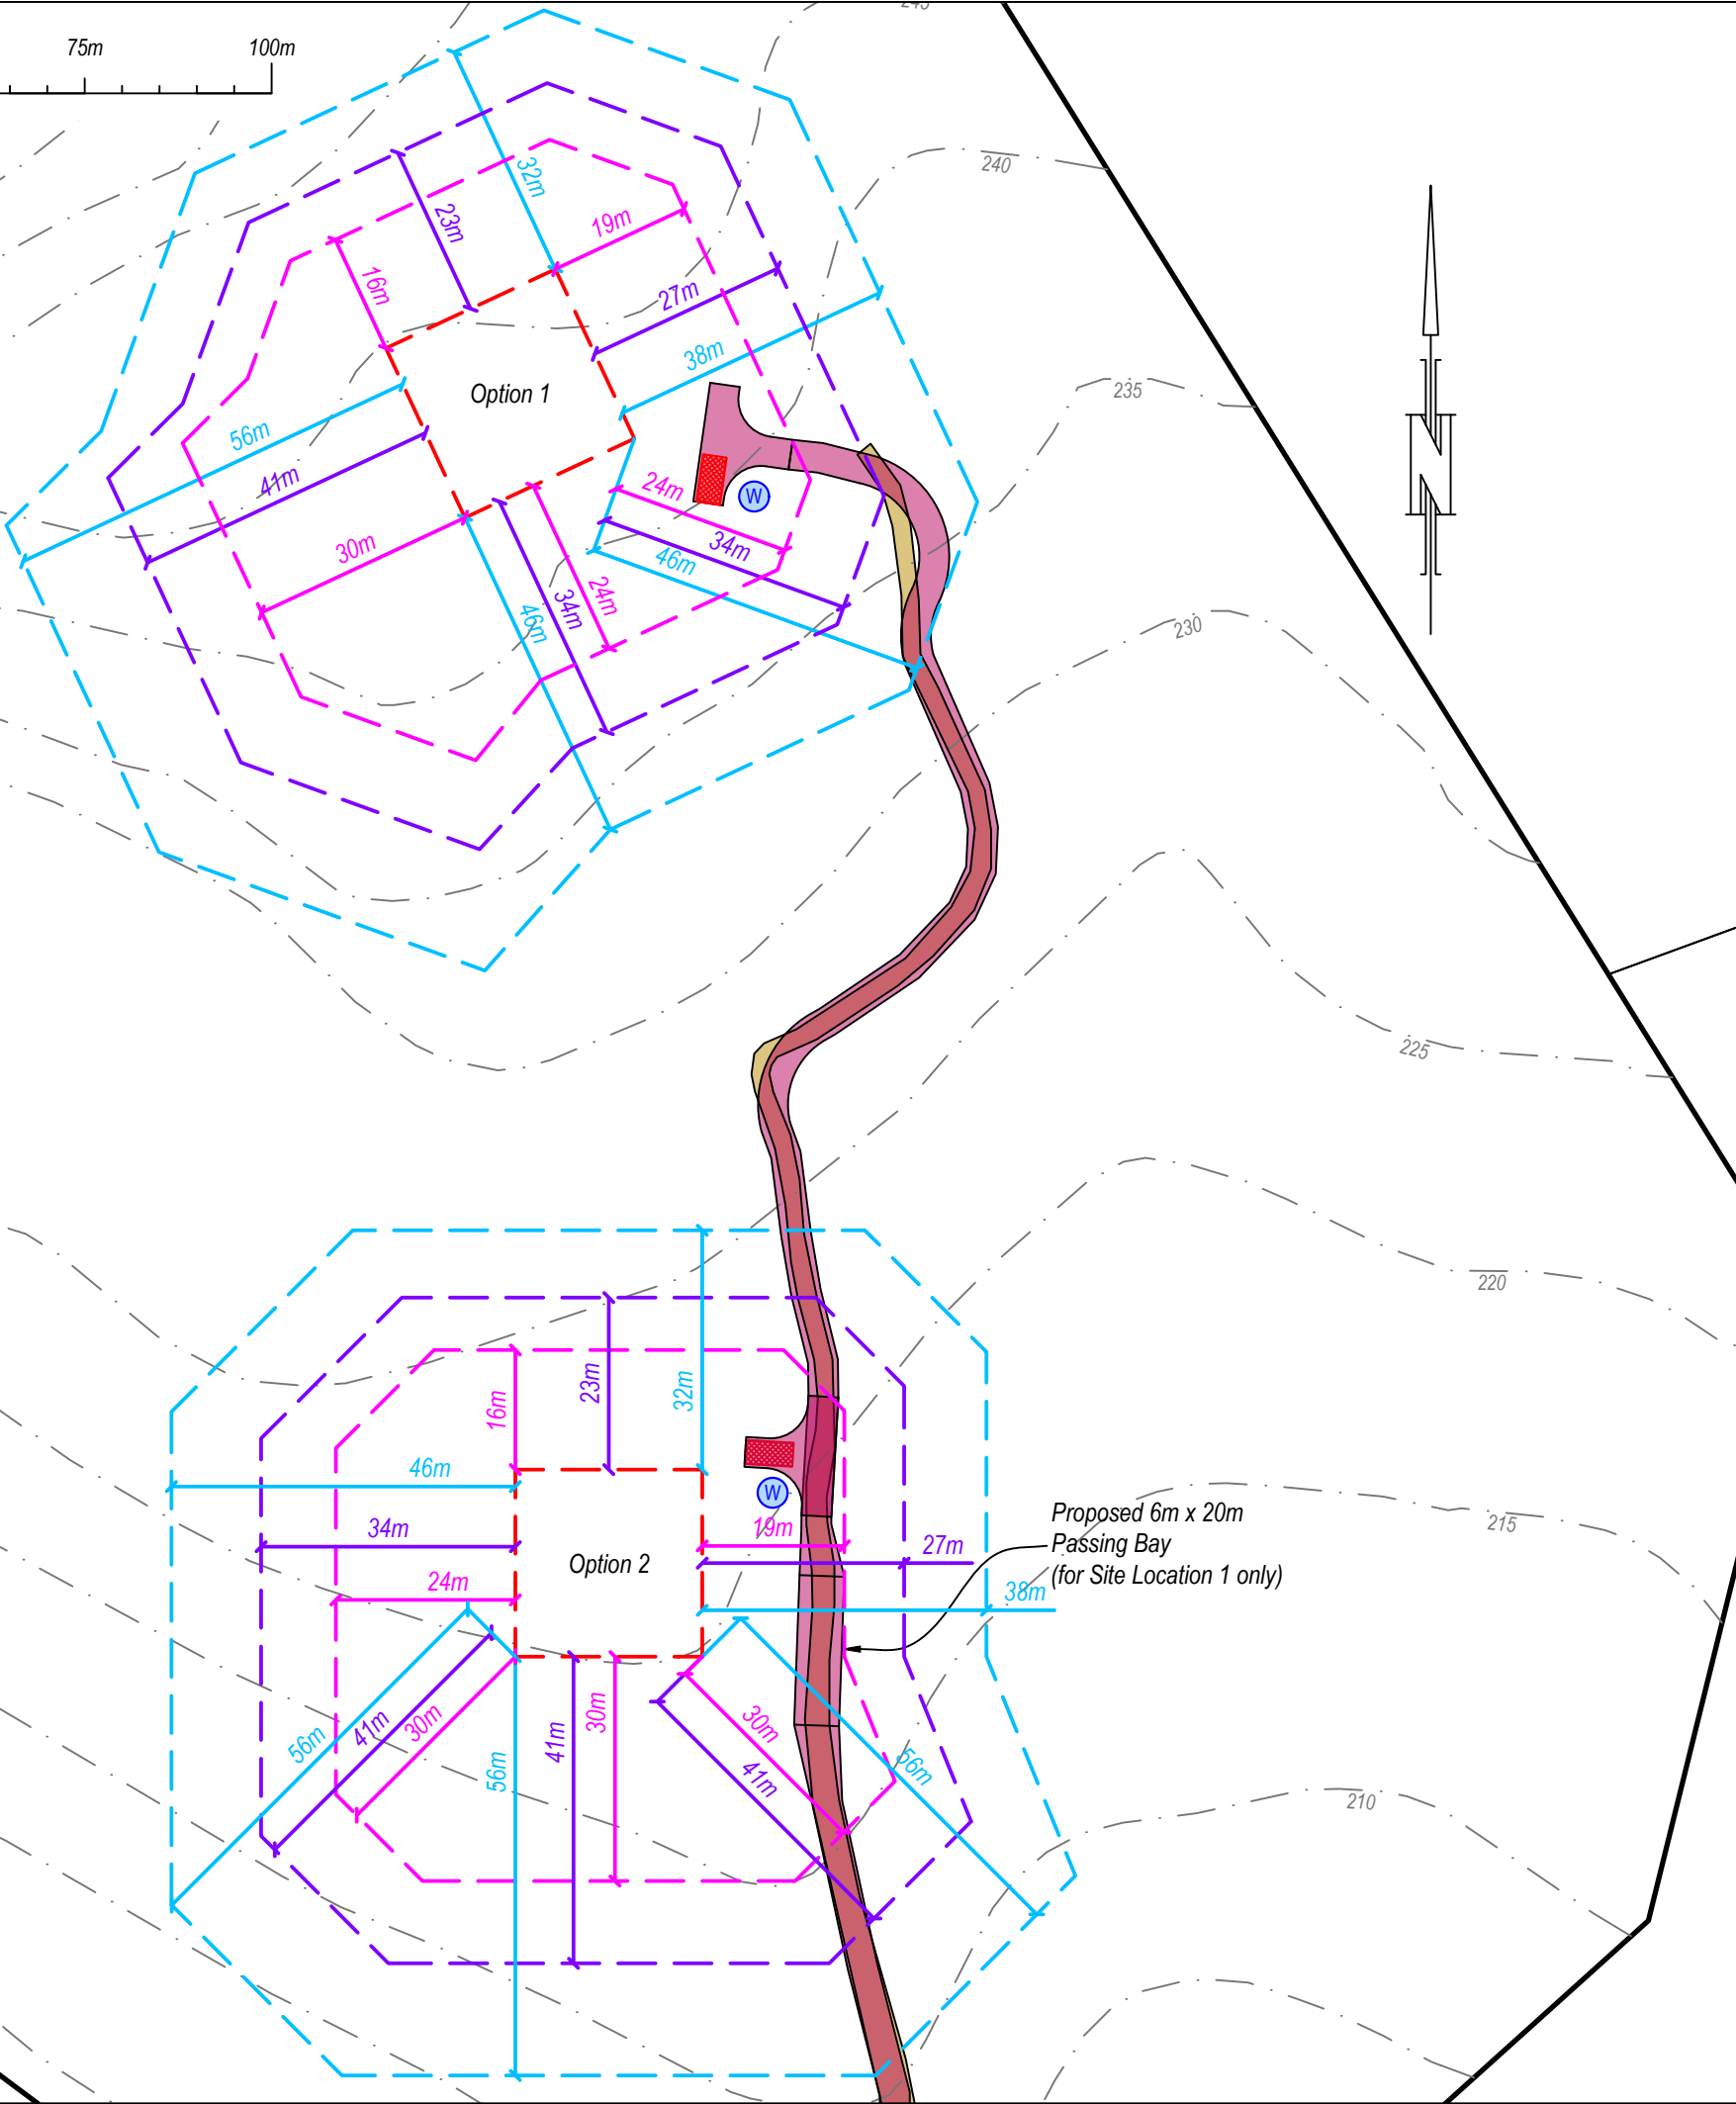
## BUSHFIRE HAZARD MANAGEMENT PLAN VER. 4 ENLARGEMENT (Sheet 2 of 2)

- HAZARD MANAGEMENT AREAS (HMA)**
  - HMA to be established to distances indicated on this plan and as set out in Section 4.1 of the Bushfire Hazard Report.

- No trees to overhang houses to prevent branches or leaves from falling on the building.
  - Non-combustible elements including driveways, paths and short cropped lawns are recommended within the HMA.

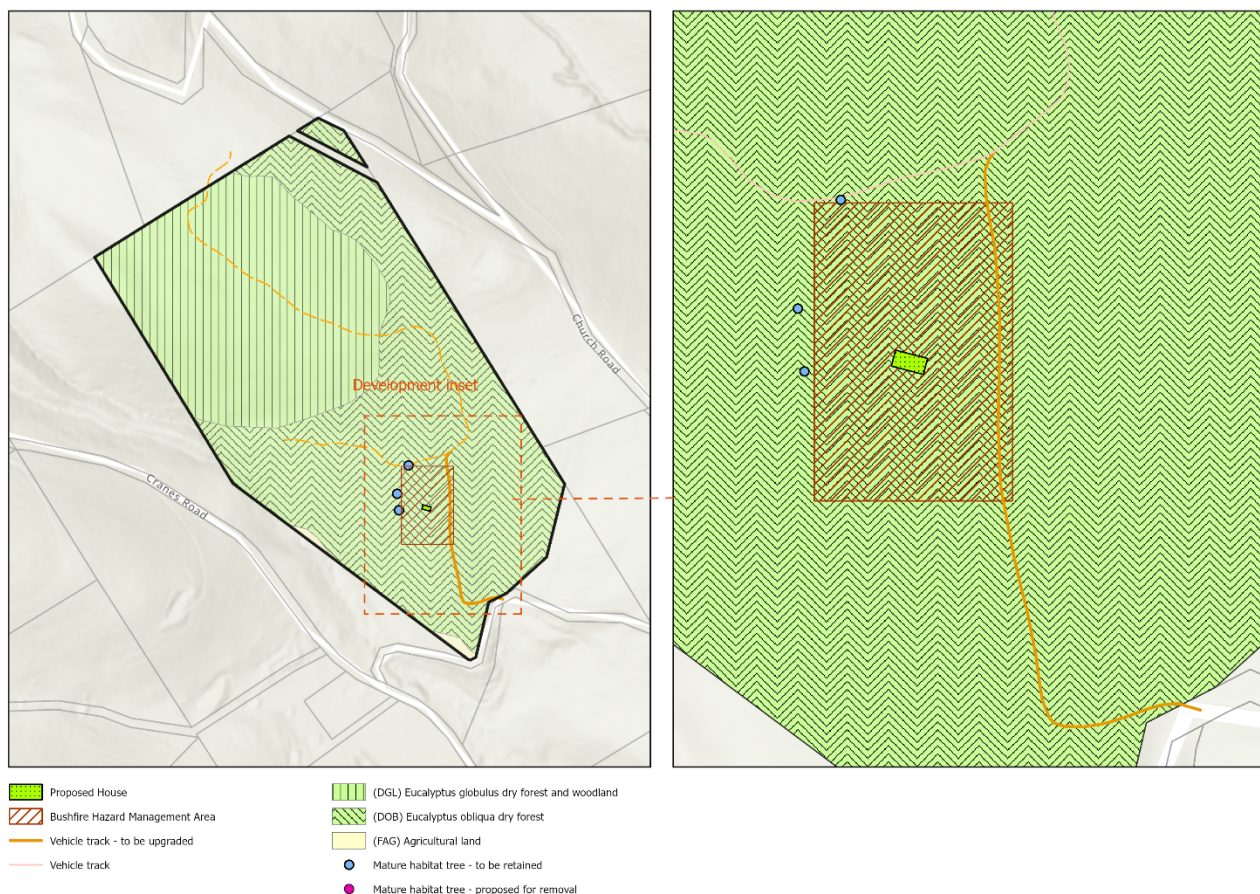
Figure 2. Natural values assessment

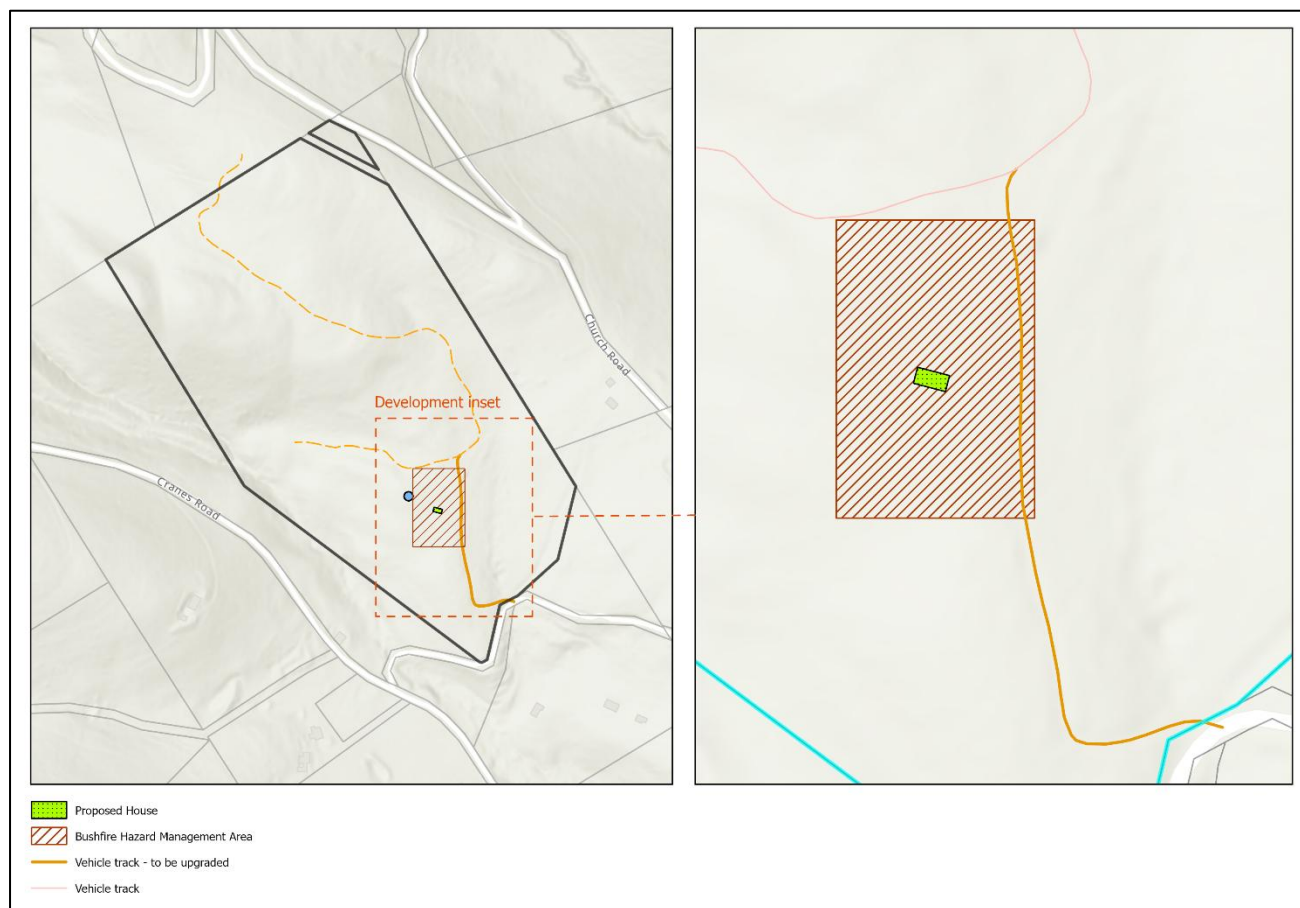
Figure 3. Development location and proposed infrastructure

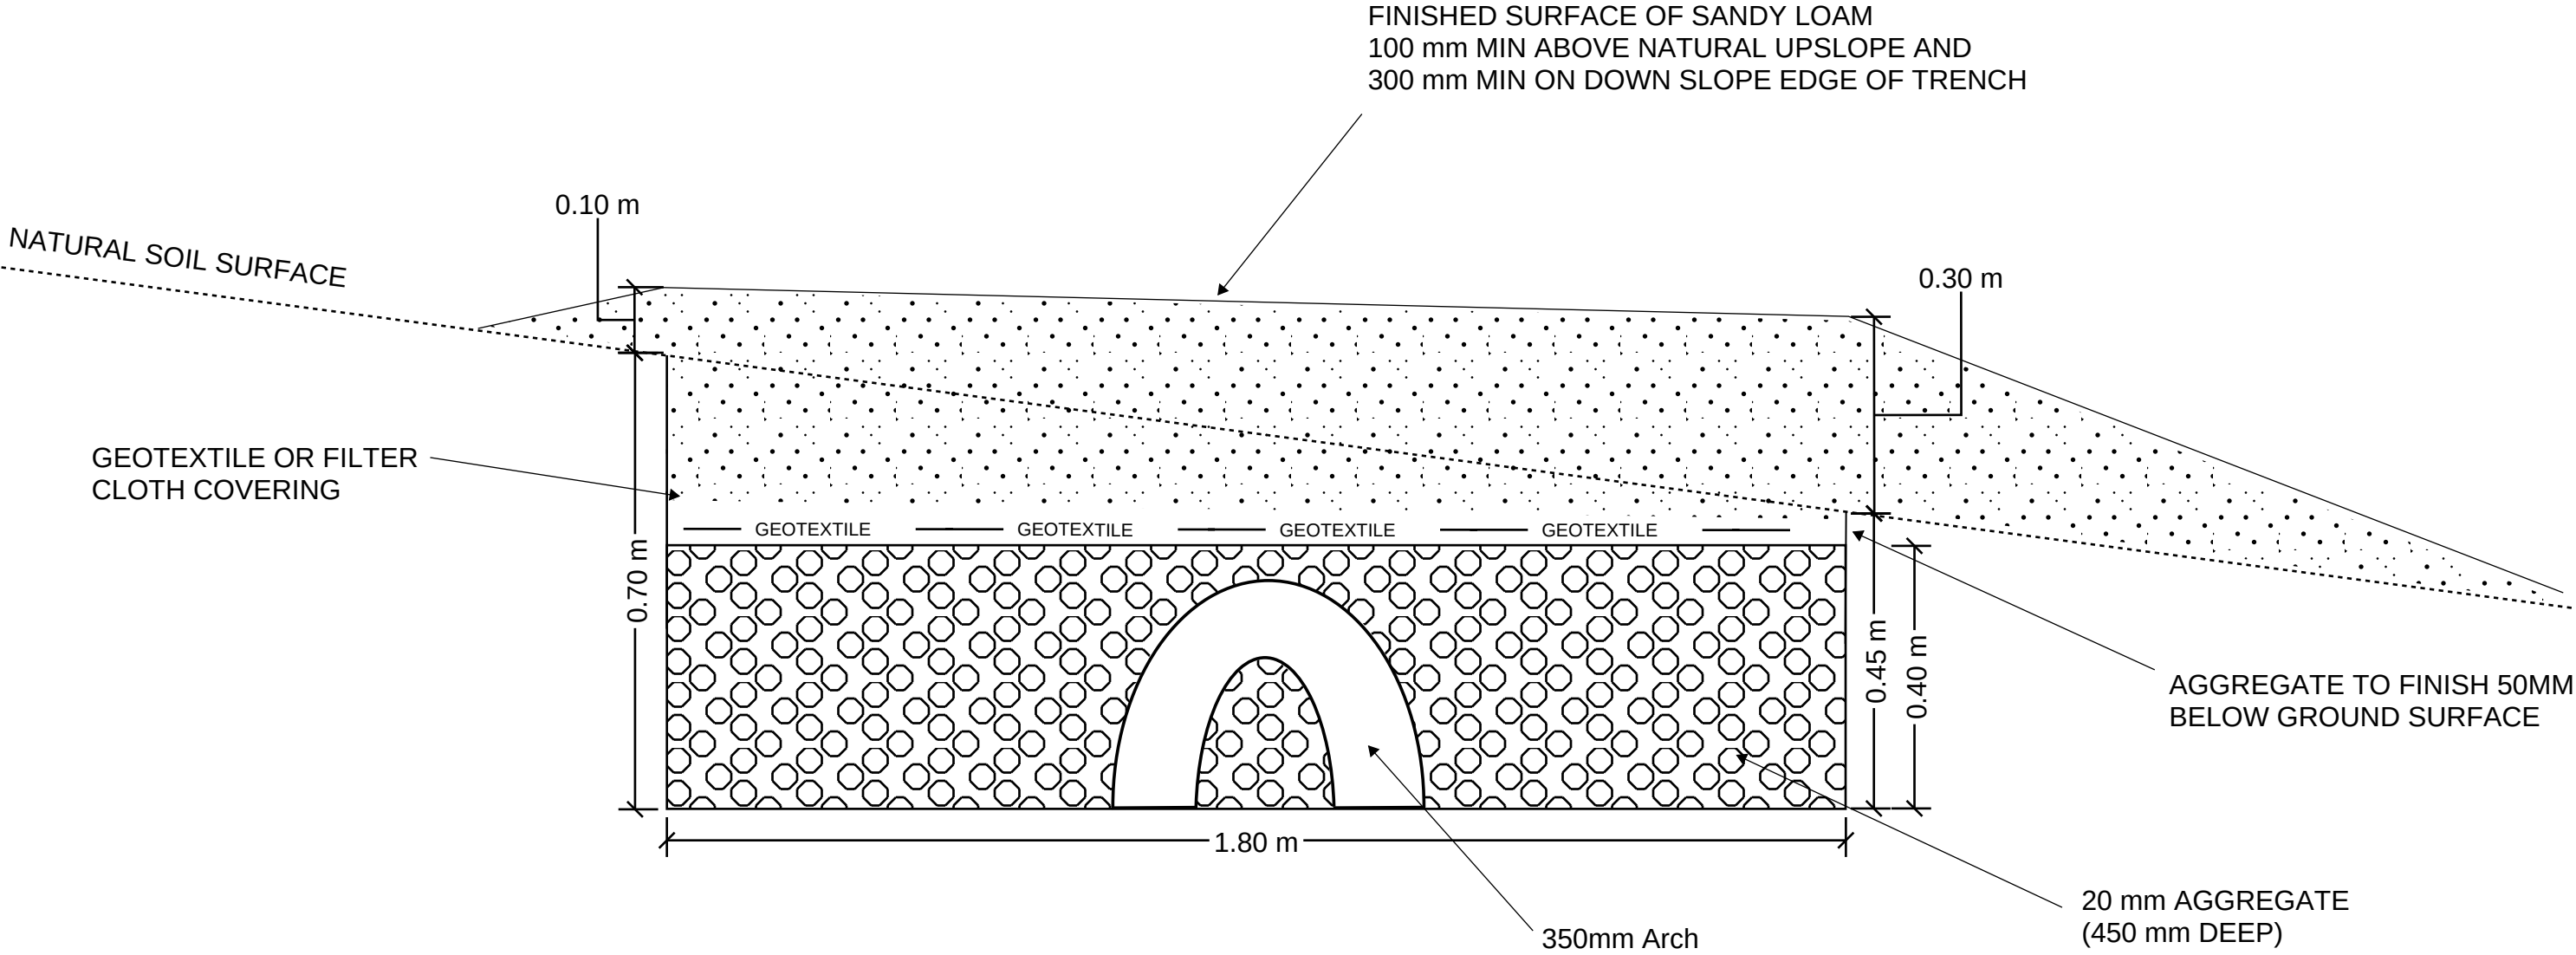
- 1.Absorption trench dimensions of up to 20m long by 0.45m deep by 1.8m wide  
– total storage volume calculated at average 35% porosity.
- 2.Base of trenches to be excavated level and smearing and compaction avoided.
- 3.350mm Arch should be placed in the centre of trench
- 4.Geotextile or filter cloth to be placed over the distribution arch to prevent clogging
- 5.Construction on slopes up to 20% to allow trench depth range 700mm upslope edge to 450mm on down slope edge
- 6.Dispersive soils gypsum to be incorporated into the base of the trench at a rate of 1kg/m<sup>2</sup>
- 7.All works on site to comply with AS3500 and Tasmanian Plumbing code.

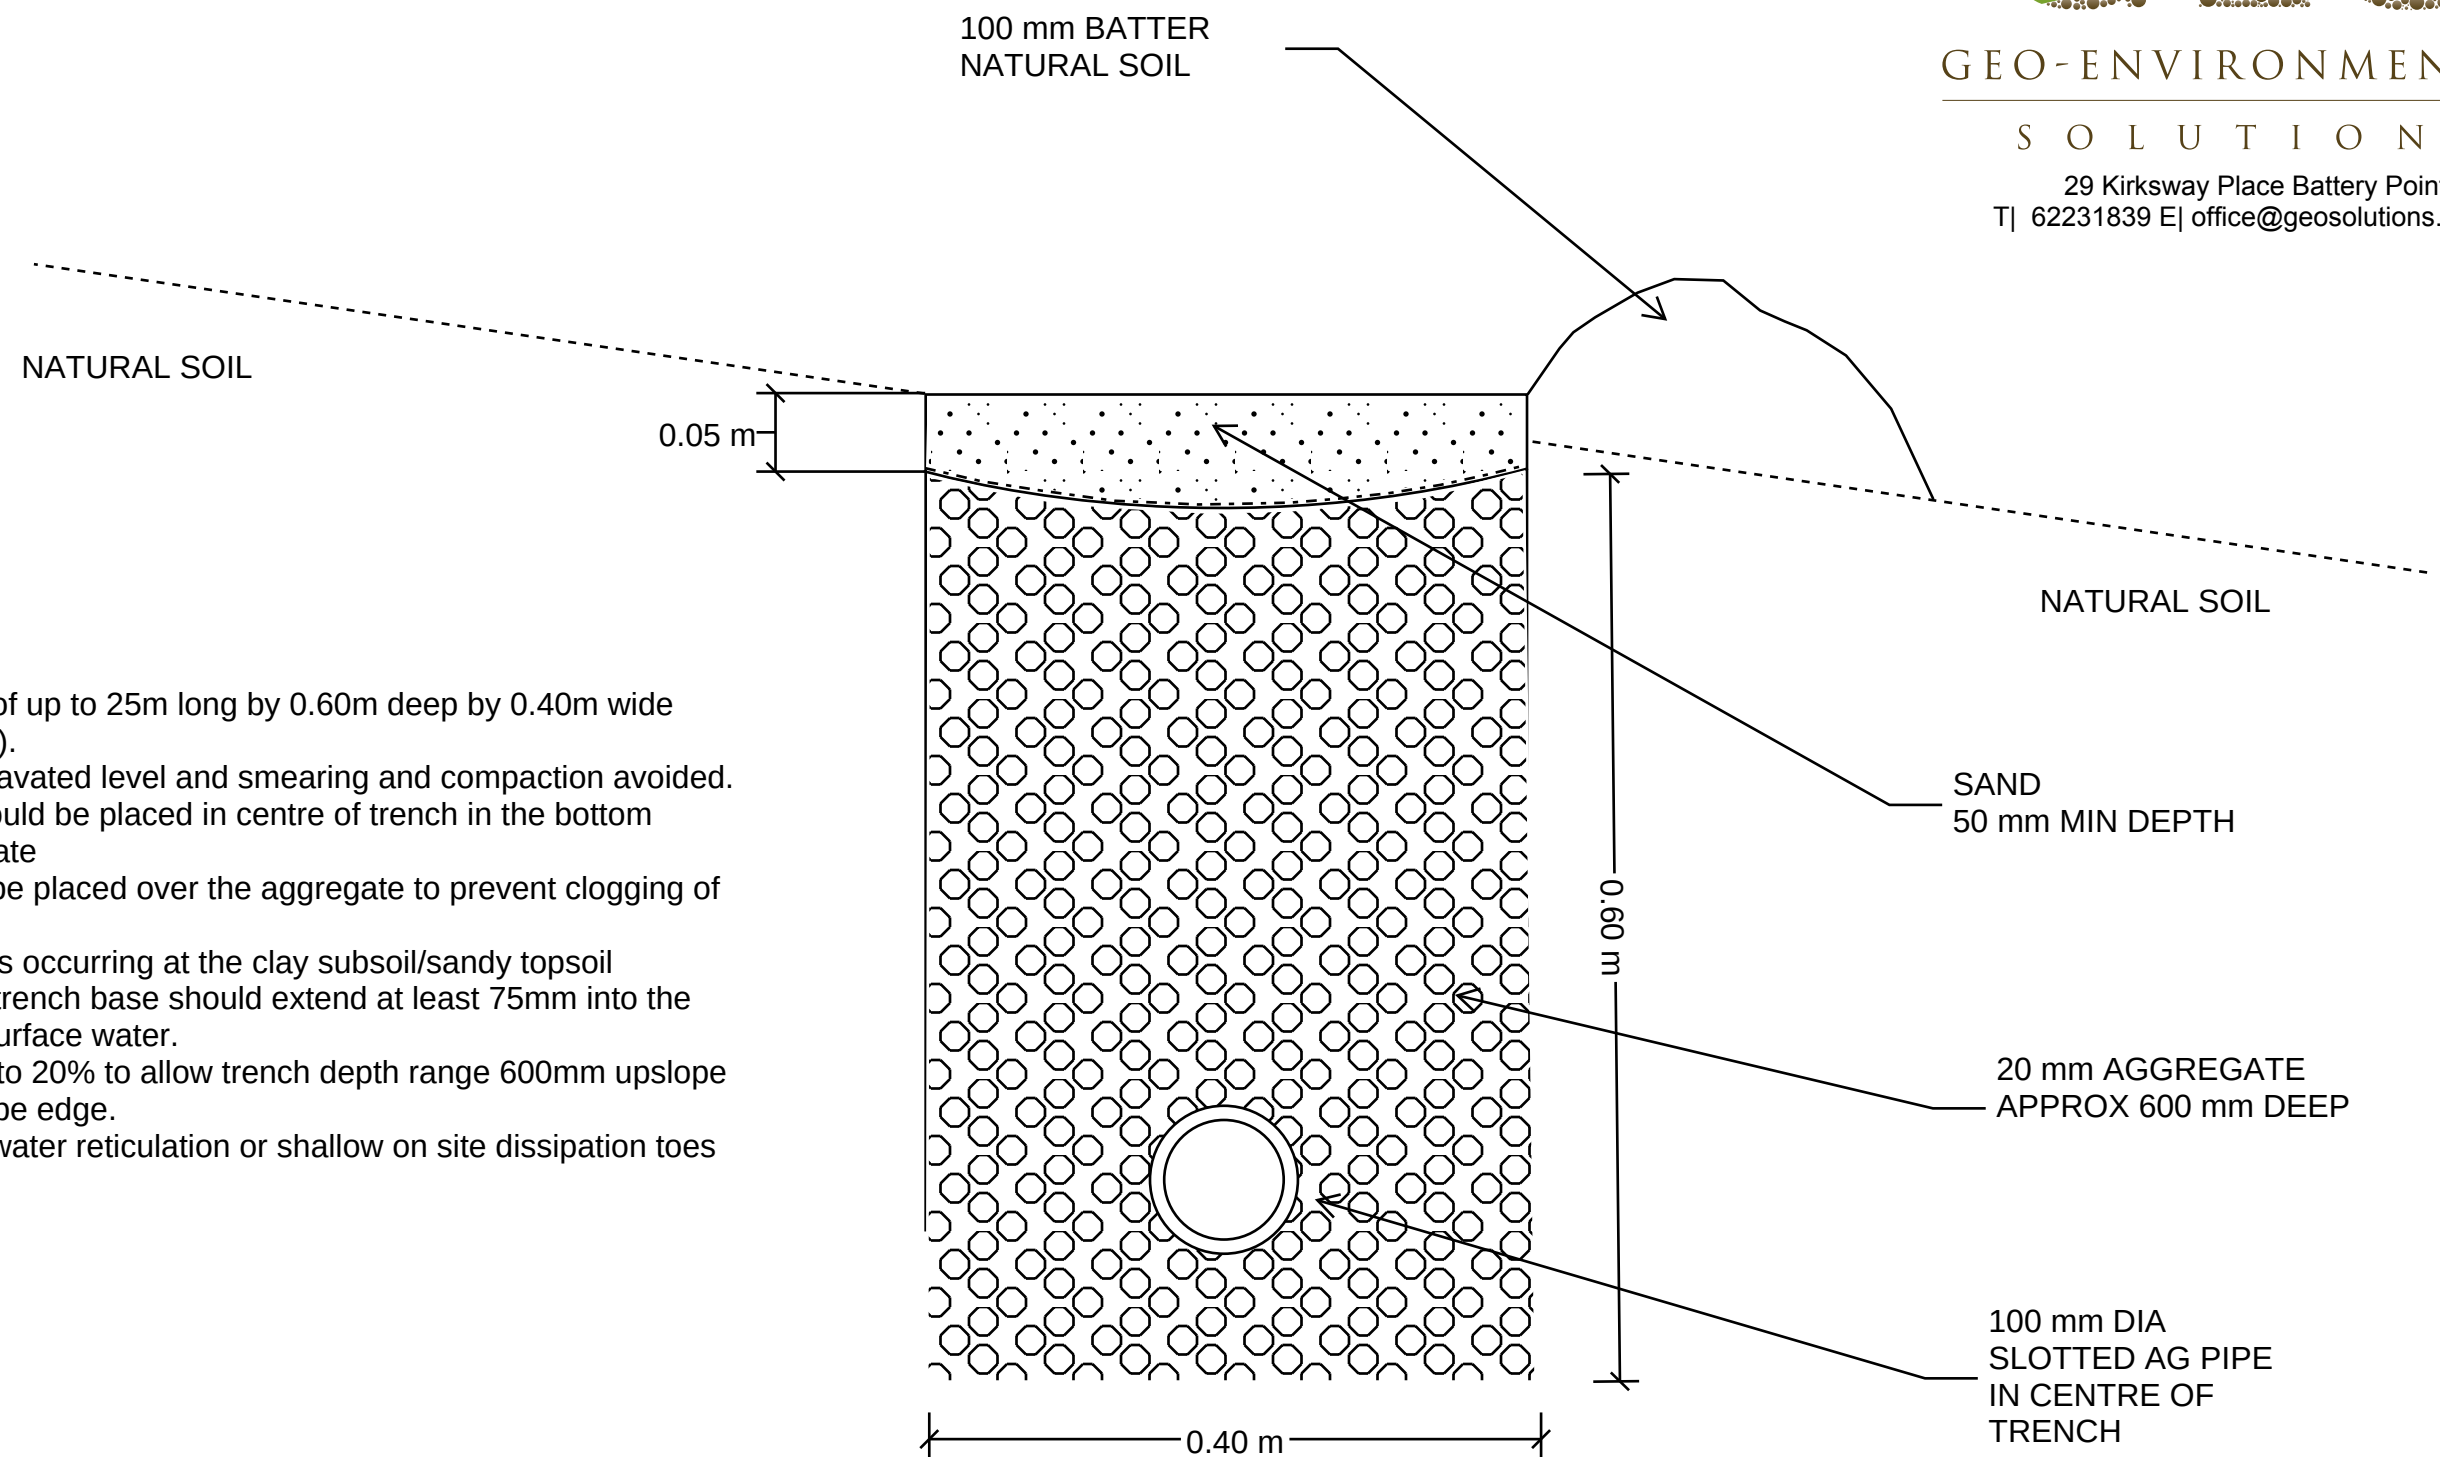
1. Cut-off trench dimensions of up to 25m long by 0.60m deep by 0.40m wide (depths and widths minimum).
2. Base of trenches to be excavated level and smearing and compaction avoided.
3. 100mm slotted ag-pipe should be placed in centre of trench in the bottom 100mm of the 20mm aggregate
4. Geotextile or filter cloth to be placed over the aggregate to prevent clogging of the pipes and aggregate
5. If shallow subsurface flow is occurring at the clay subsoil/sandy topsoil boundary (duplex soils), the trench base should extend at least 75mm into the subsoil clay to capture sub-surface water.
6. Construction on slopes up to 20% to allow trench depth range 600mm upslope edge to 400mm on down slope edge.
7. Trench discharge to stormwater reticulation or shallow on site dissipation toes across the contour.

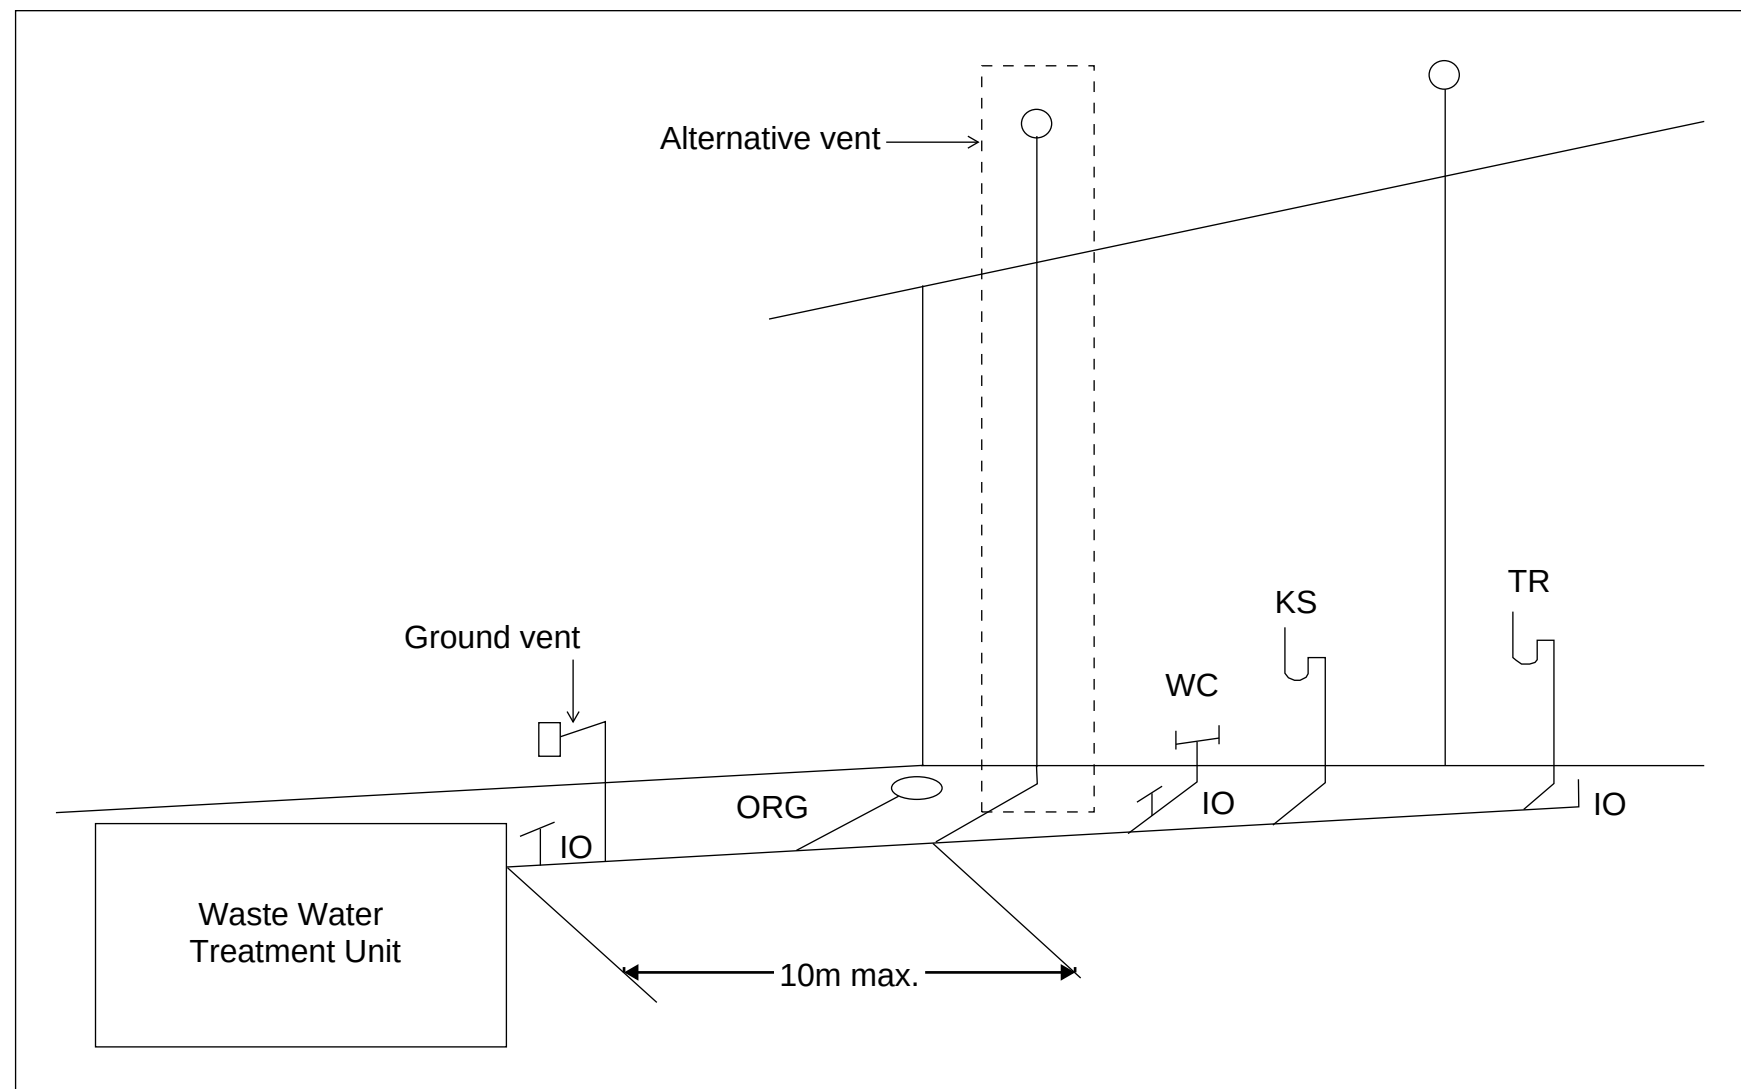
### Tas Figure C2D6 Alternative Venting Arrangements

Vents must terminate in accordance with AS/NZS 3500.2
