Planning Report

Clean Fill & Farm Track Upgrades August 2023

Natural Values Assessment – Waterway and Coastal Protection Area

Proposed Works- 97 Nelsons Buildings Road, Brighton, TAS 7030

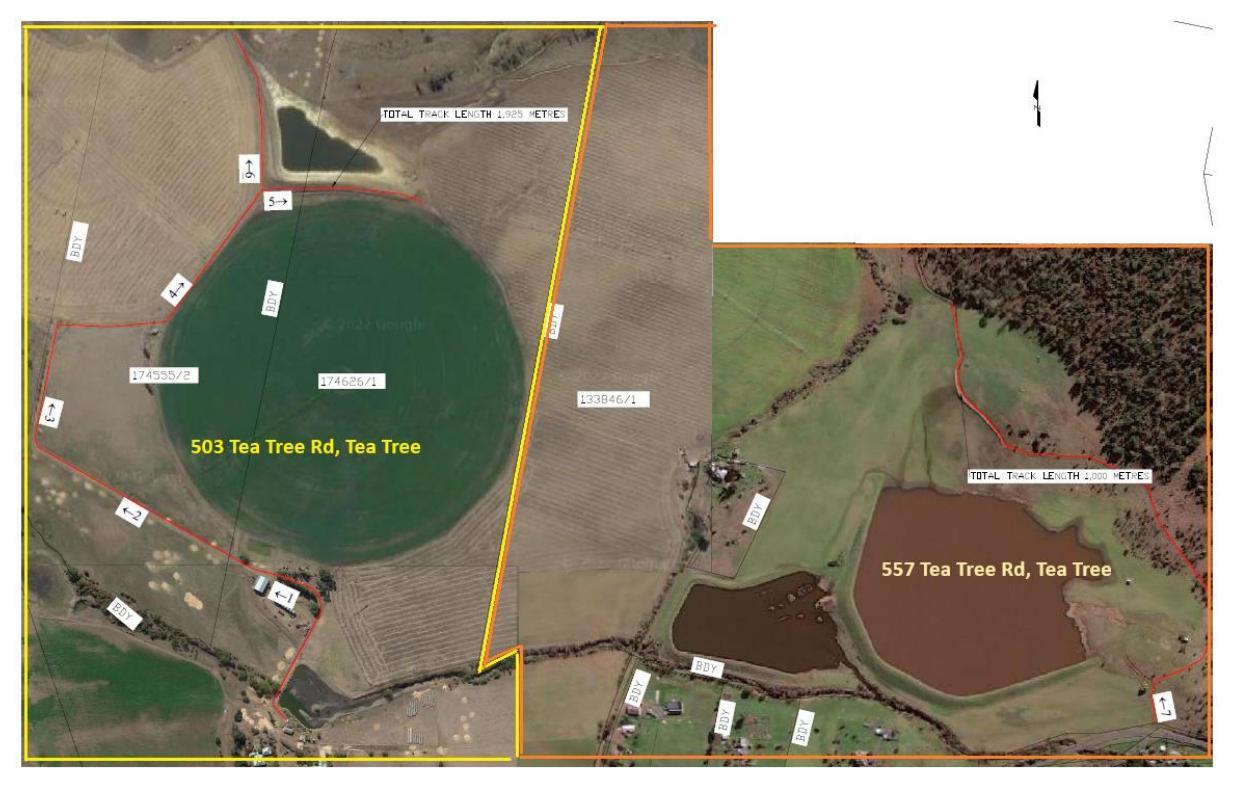
TRACKS TO HAVE MAINTENANCE LAYER APPLIED

Figure 1. Aerial image of the farm track upgrade sites – 503 & 557 Tea Tree Rd, Tea Tree (Courtesy: theList Mapping Services)

The proposed farm track upgrades will utilise road castings, which are pulverised asphalt and crushed rock. The total track length for the upgrade is approximately 6,465 lineal metres, and it is expected that other tracks on the properties can also benefit from the proposed works.

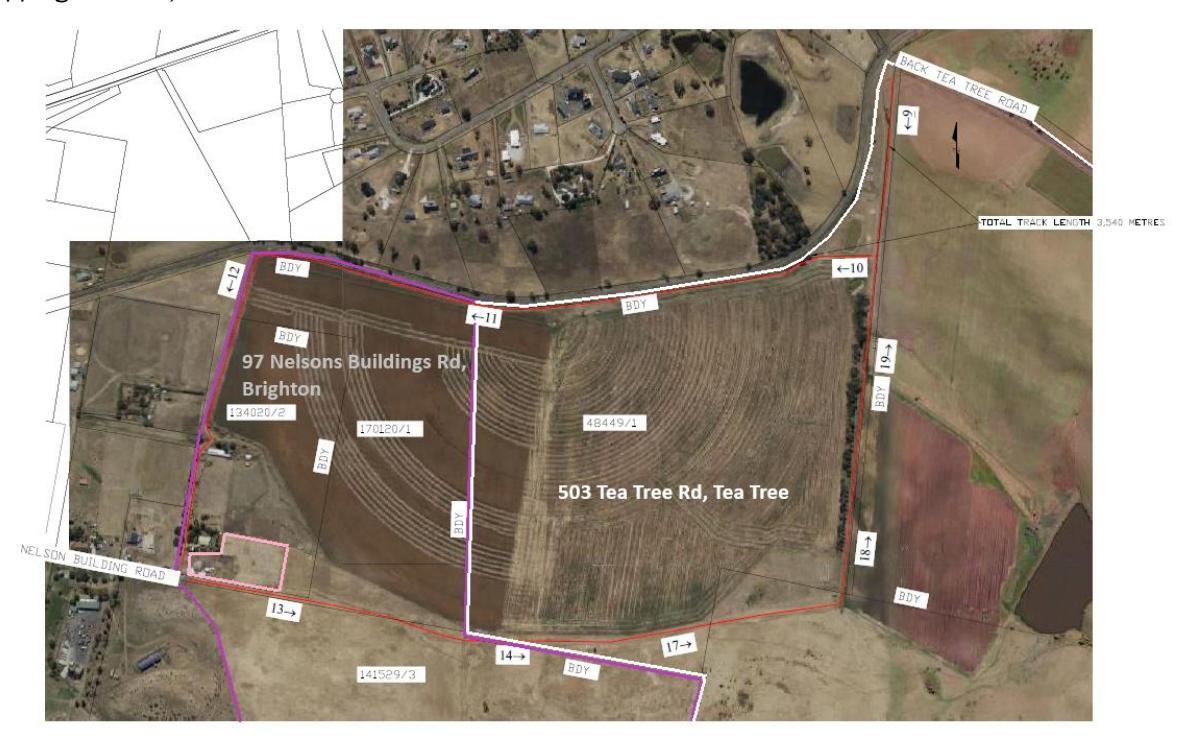
TRACKS TO HAVE MAINTENANCE LAYER APPLIED

Figure 2. Aerial image of the farm track upgrade sites –97 Nelsons Buildings Rd, Brighton & 503 Tea Tree Rd, Tea Tree (Courtesy: theList Mapping Services)

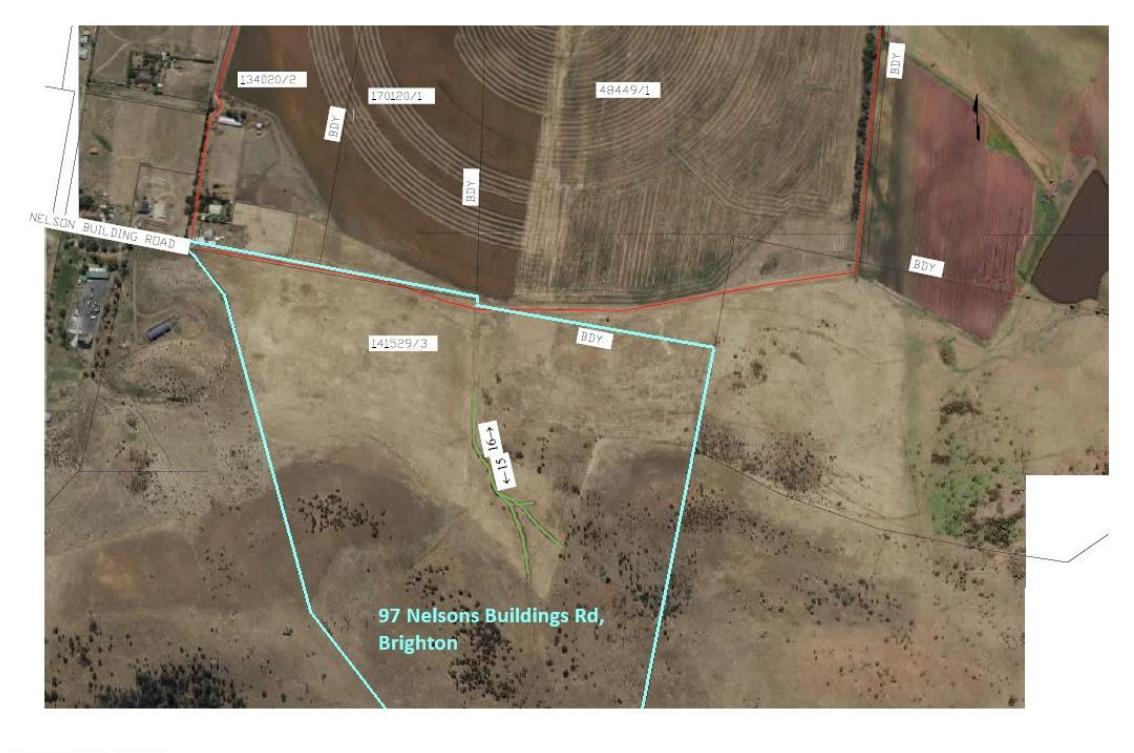
CLEAN FILL AREAS

Figure 3. Aerial image of the clean fill areas - 97 Nelsons Buildings Rd, Brighton (Courtesy: theList Mapping Services)

The clean fill site has a capacity for at least 10,000m3 of fill, and Council will prioritise the access upgrades to take place from Nelson's Buildings Road to ensure the site is accessible under all types of weather conditions.

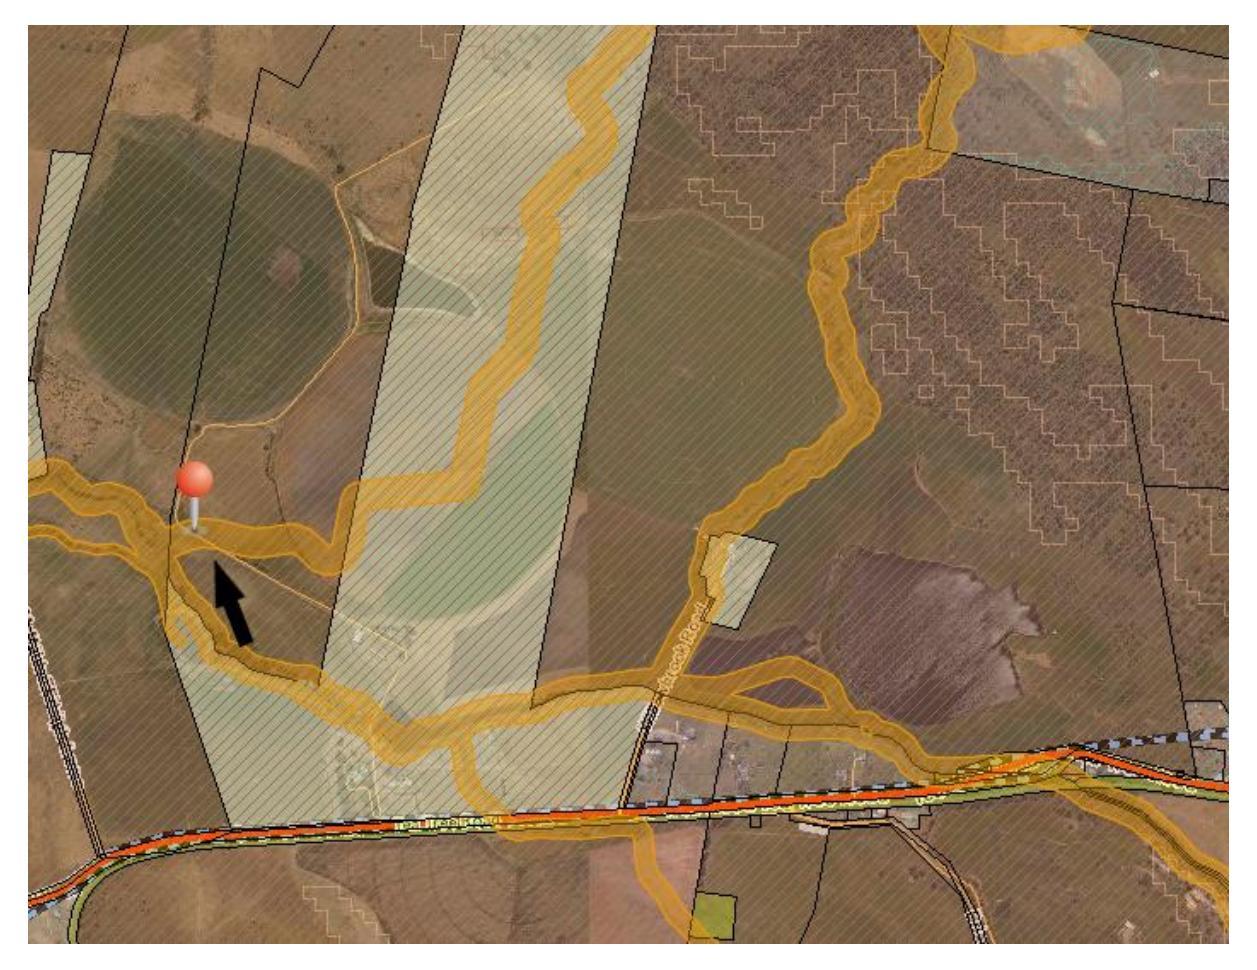
Figure 4. Aerial image of the farm track within the waterway and coastal protection area overlay

The site - 174555/2 – contains a portion of the farm track (see area pointed by an arrow in Figure 4) within the waterway and coastal protection area. Therefore, the subject land has been assessed against relevant standards under this Code.

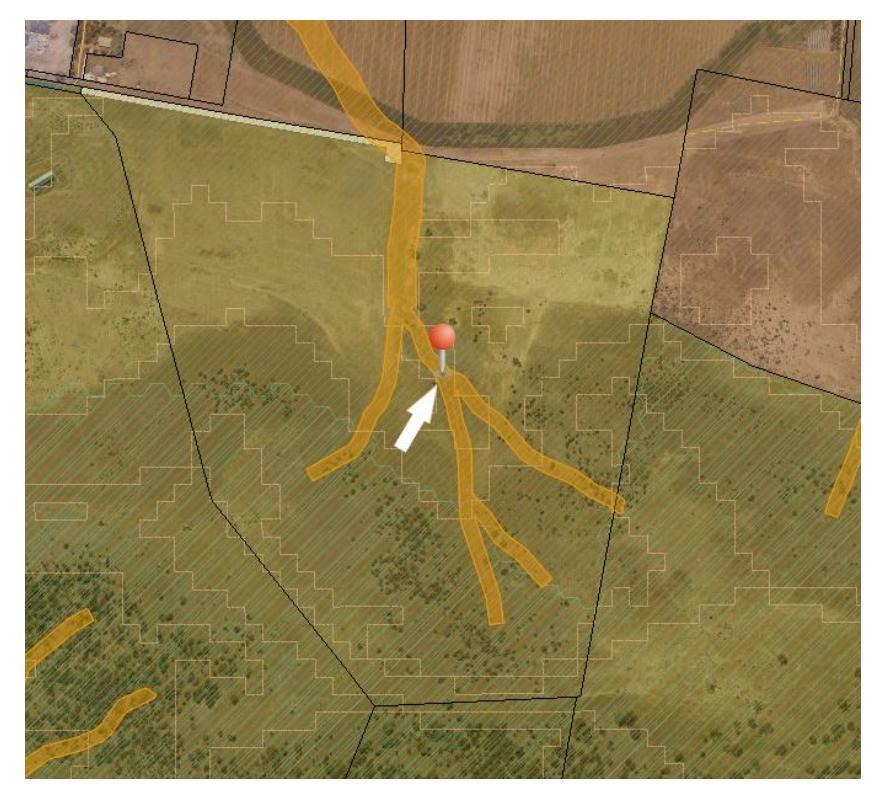
Figure 5. Aerial image of the clean fill area within the waterway and coastal protection area overlay

The proposed clean fill area is within the waterway and coastal protection area, as indicated by an arrow in Figure 5. Therefore, it has been assessed against relevant standards under this Code.
