Application for Planning Approval

6 WOODRIEVE ROAD, BRIDGEWATER

FILL & ASSOCIATED SITE WORKS (RETROSPECTIVE)

PROPOSED SITE WORKS 6 WOODRIEVE ROAD, BRIDGEWATER

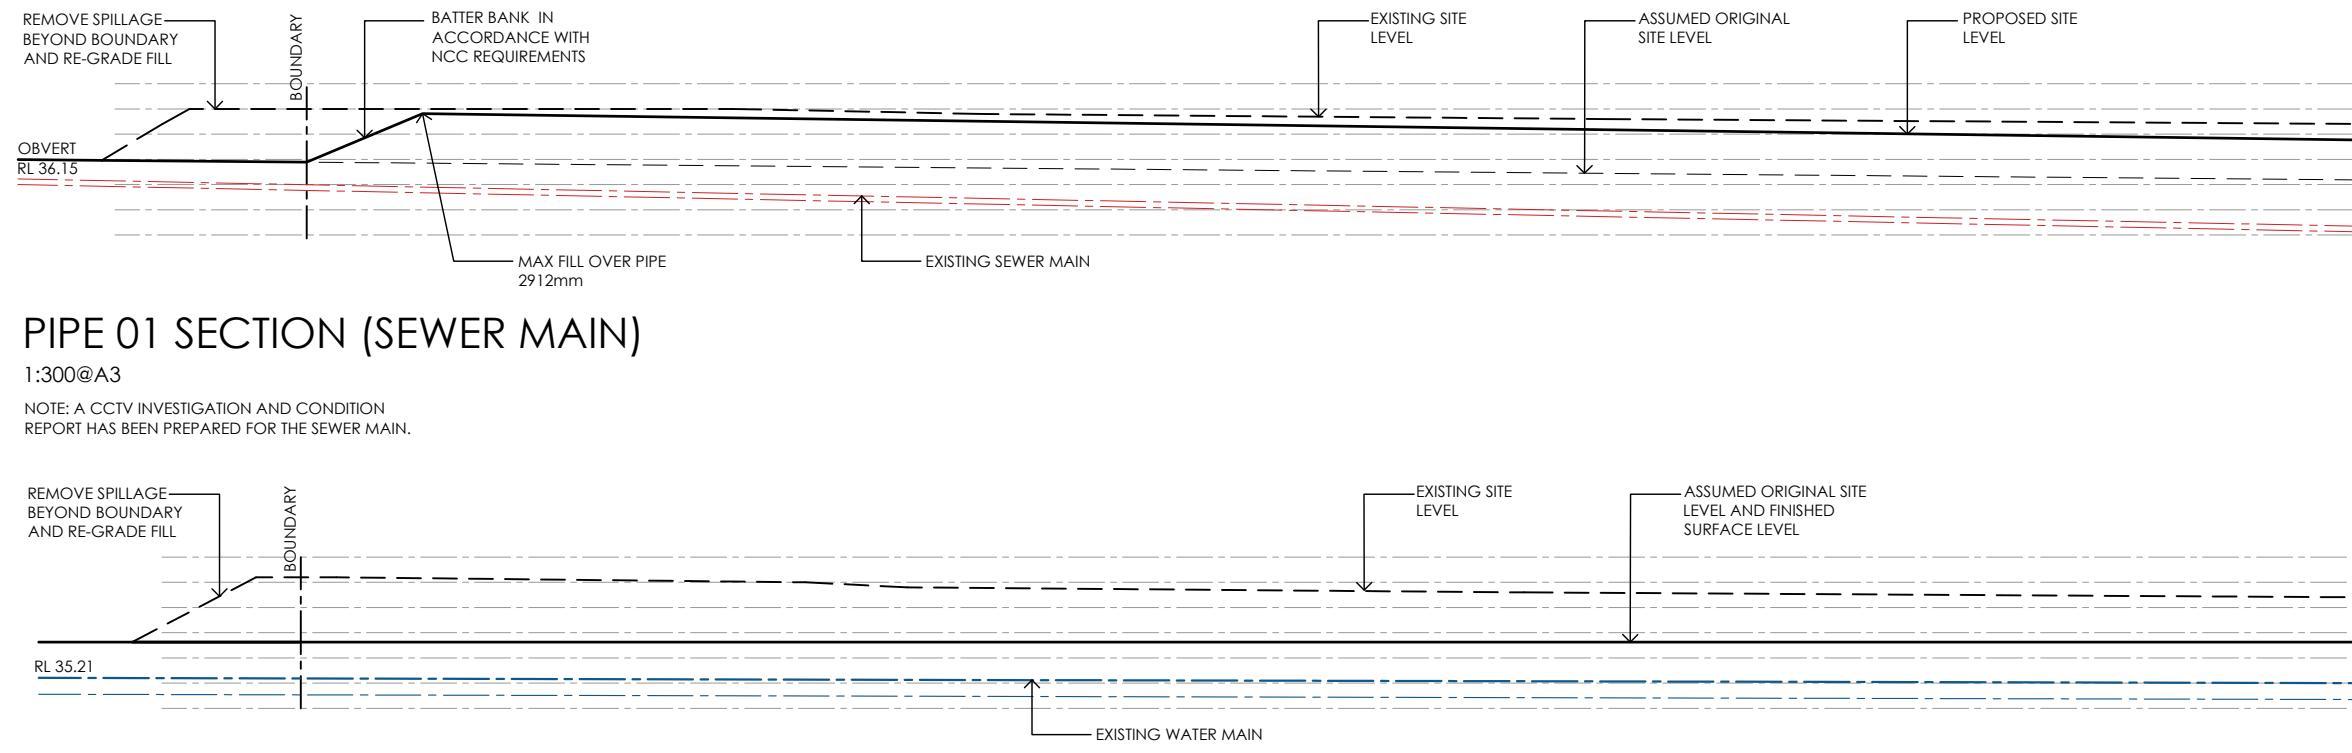
PIPE 02 SECTION (WATER MAIN)

EXISTING WATER MAIN

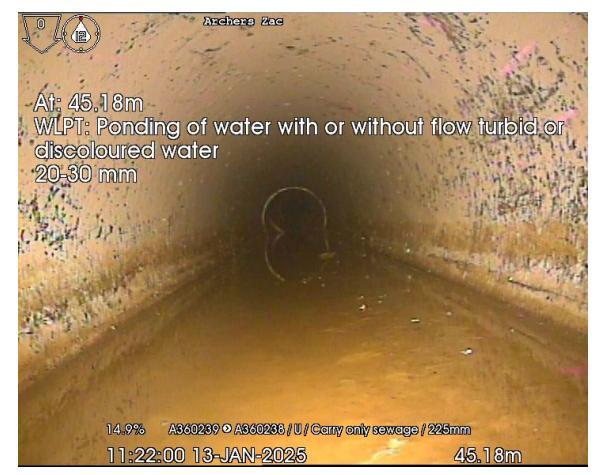
A360444_45-18m_112200.jpg, 00:07:24, 45.18 Ponding of water with or without flow turbid or discoloured water, 20-30 mm

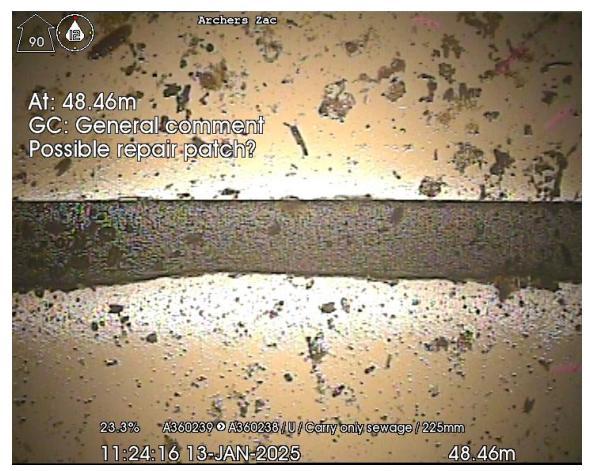
A360444_48-46m_112416.jpg, 00:09:18, 48.46 General comment / Possible repair patch?

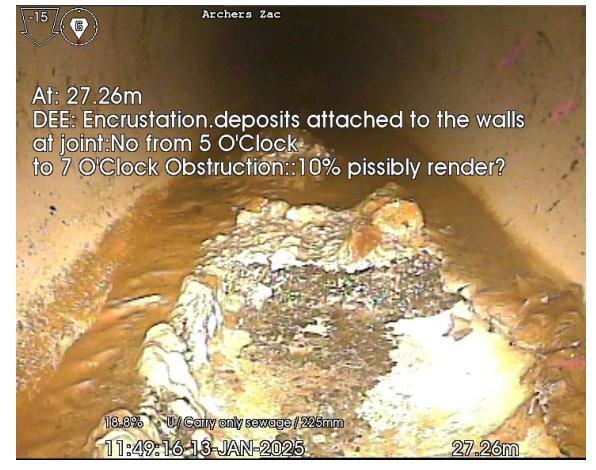
A360443_27-26m_114916.jpg, 00:03:53, 27.26 Encrustation-deposits attached to the walls from 5 o'clock to 7 o'clock, Obstruction: 10% / pissibly render?

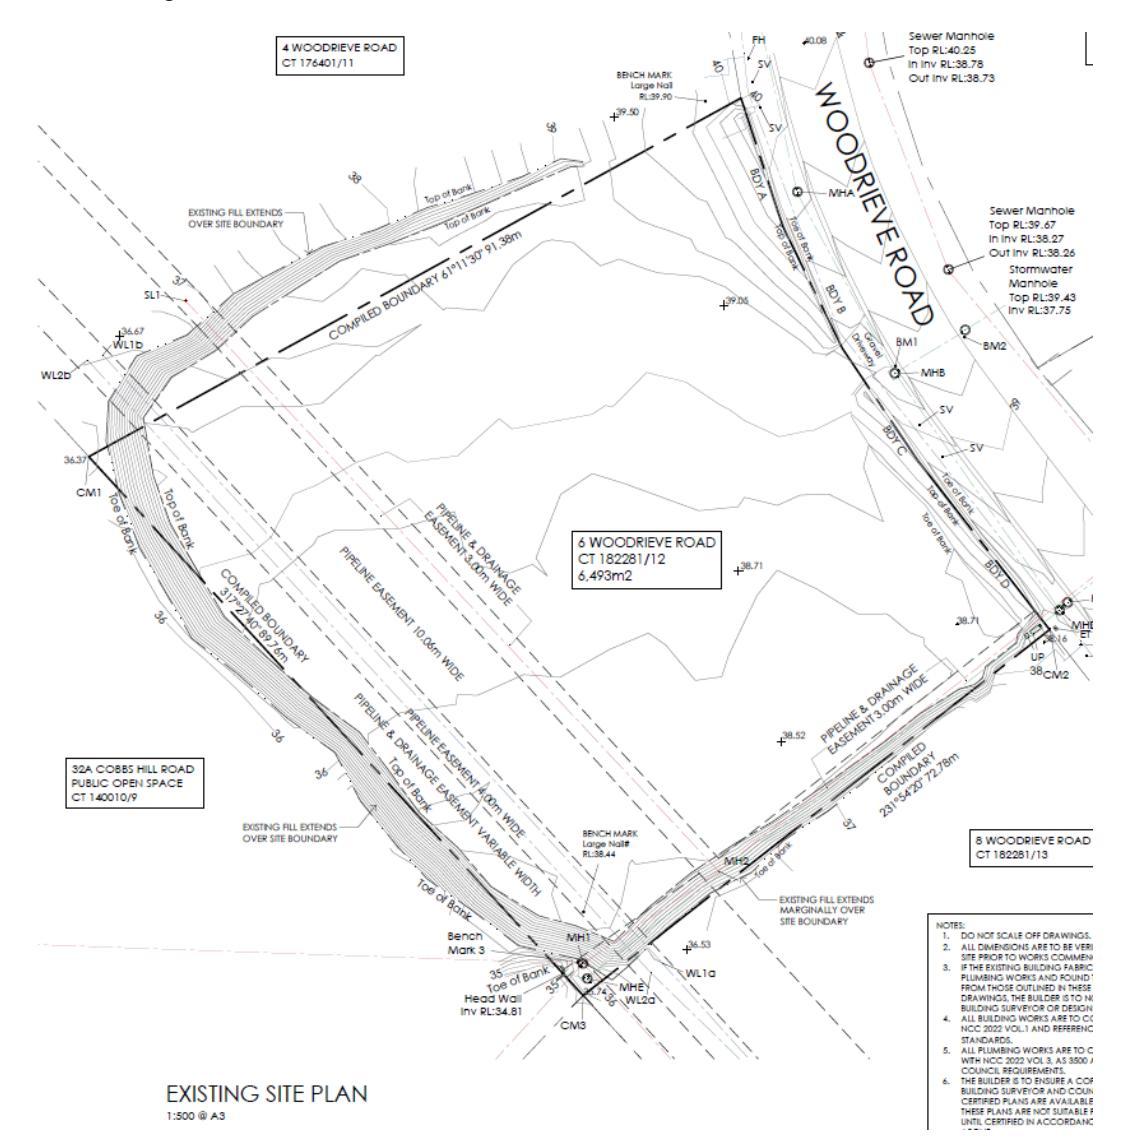
Figure 5 – Site plan showing current extent of fill

There are existing Taswater sewer and bulk water assets that have been filled over and a Council stormwater main on the southern boundary that is on the edge of the fill batter. All assets have been surveyed and are presented on the design drawings prepared by Little Island Building Design.

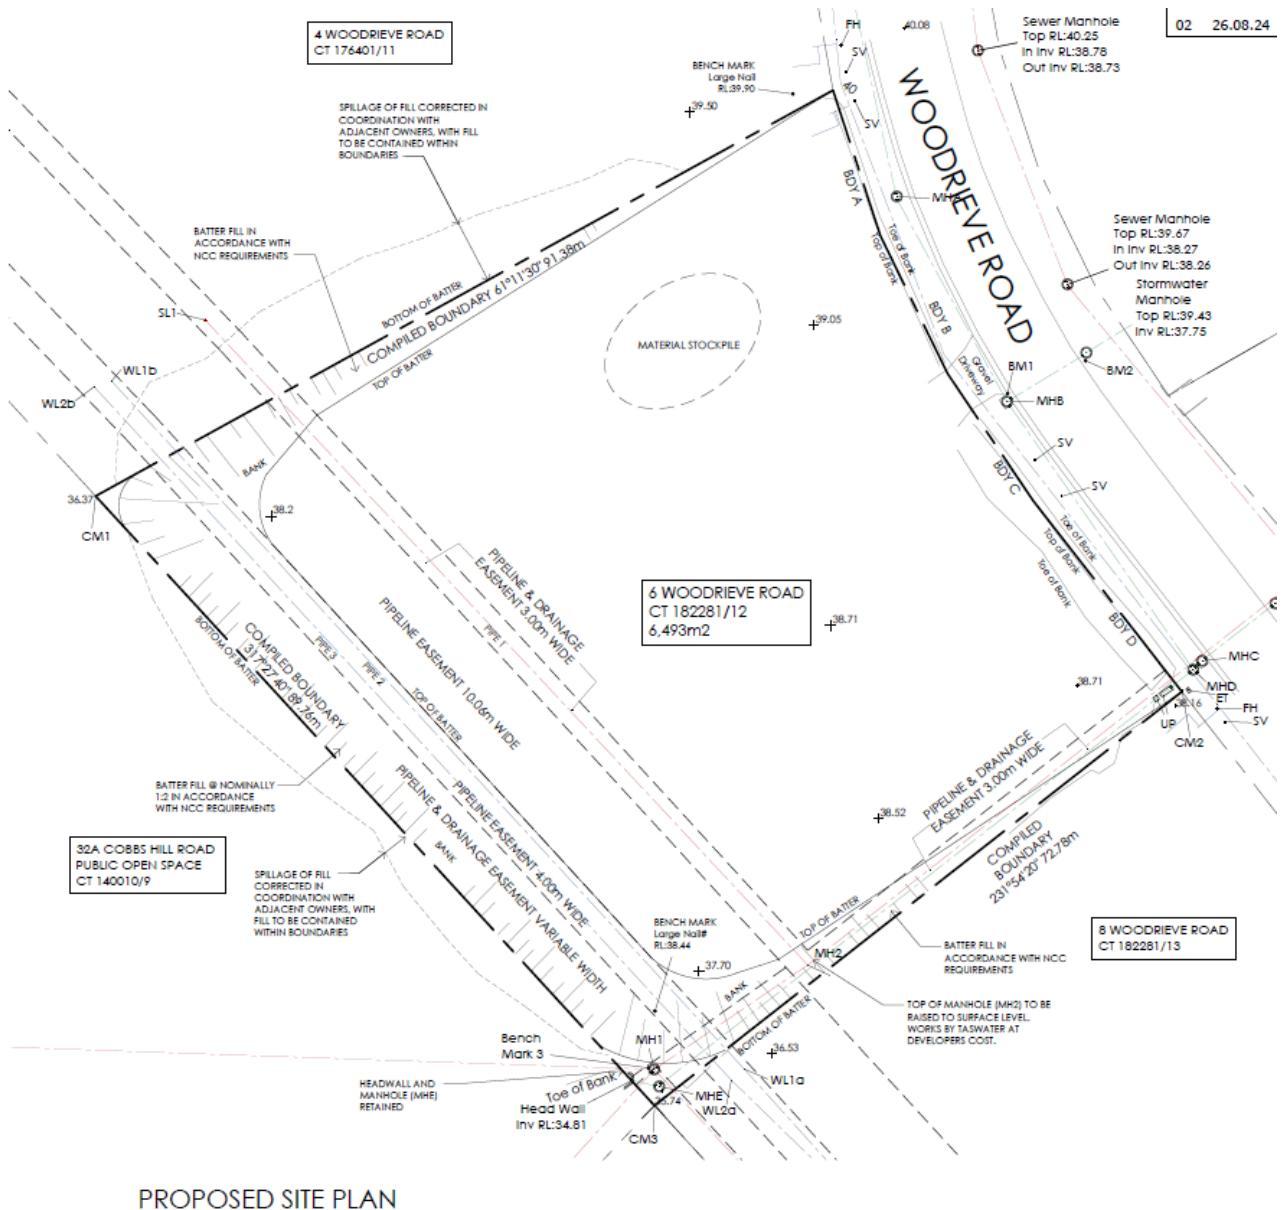
Figure 6 - Proposed extent of fill

The proposed extent of the fill is shown in Figure 6.

The batter slopes have also been decreased to reduce the amount of fill over the existing Taswater and Council assets. The drawings prepared by Little Island Building Design provide elevations showing the batter slopes and clearances to the services.

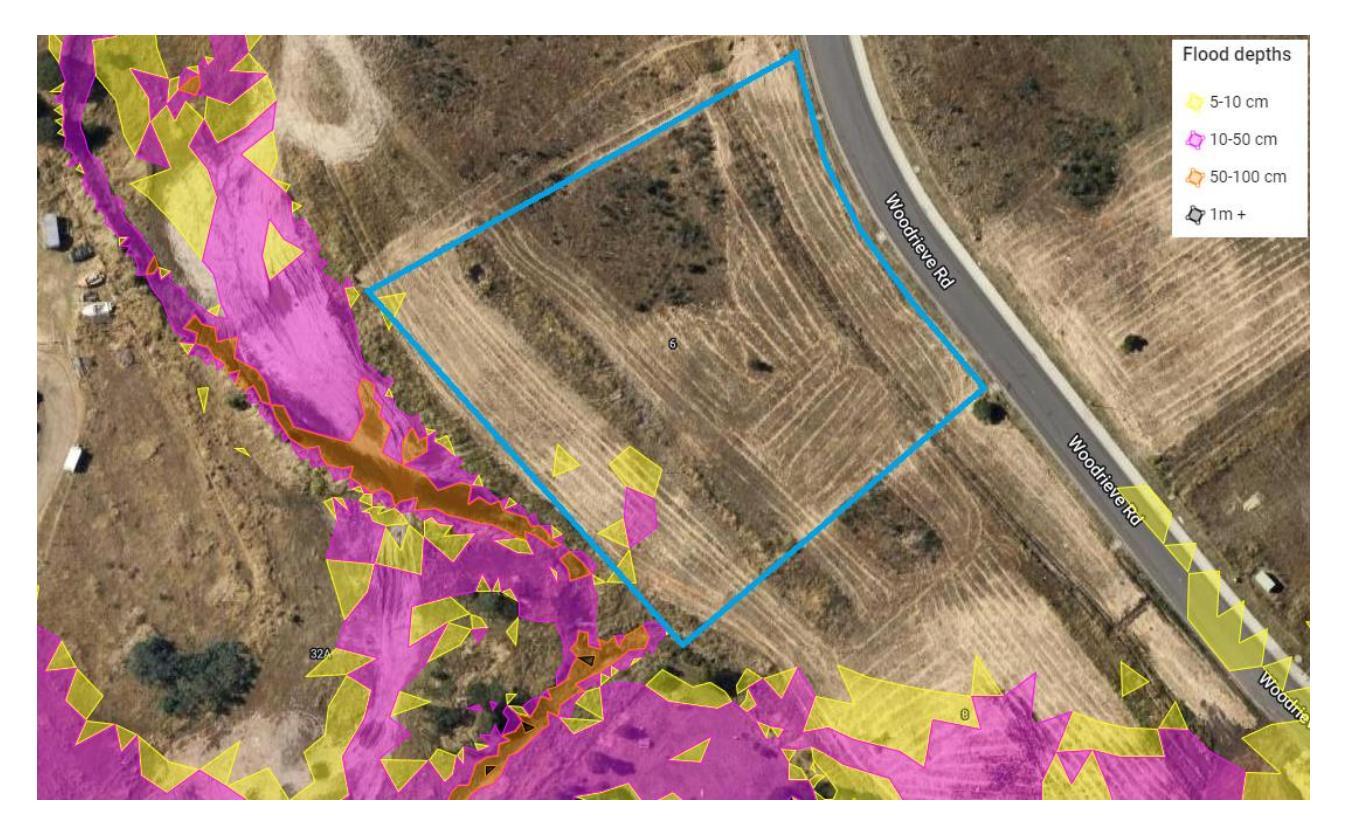
Figure 7 – Council inundation mapping

The local overland flow mapping shows that in a 1% AEP rainfall event for the local catchment, there are small areas of inundation in the NW corner and SW corner with estimated flow depths in the 5-10cm and 10-50cm ranges.

These areas do not align with the main flow path which is governed by the existing watercourse and topography and appear to be spurious data points that the model has picked up as localised low areas in the surface and routed flow to these.

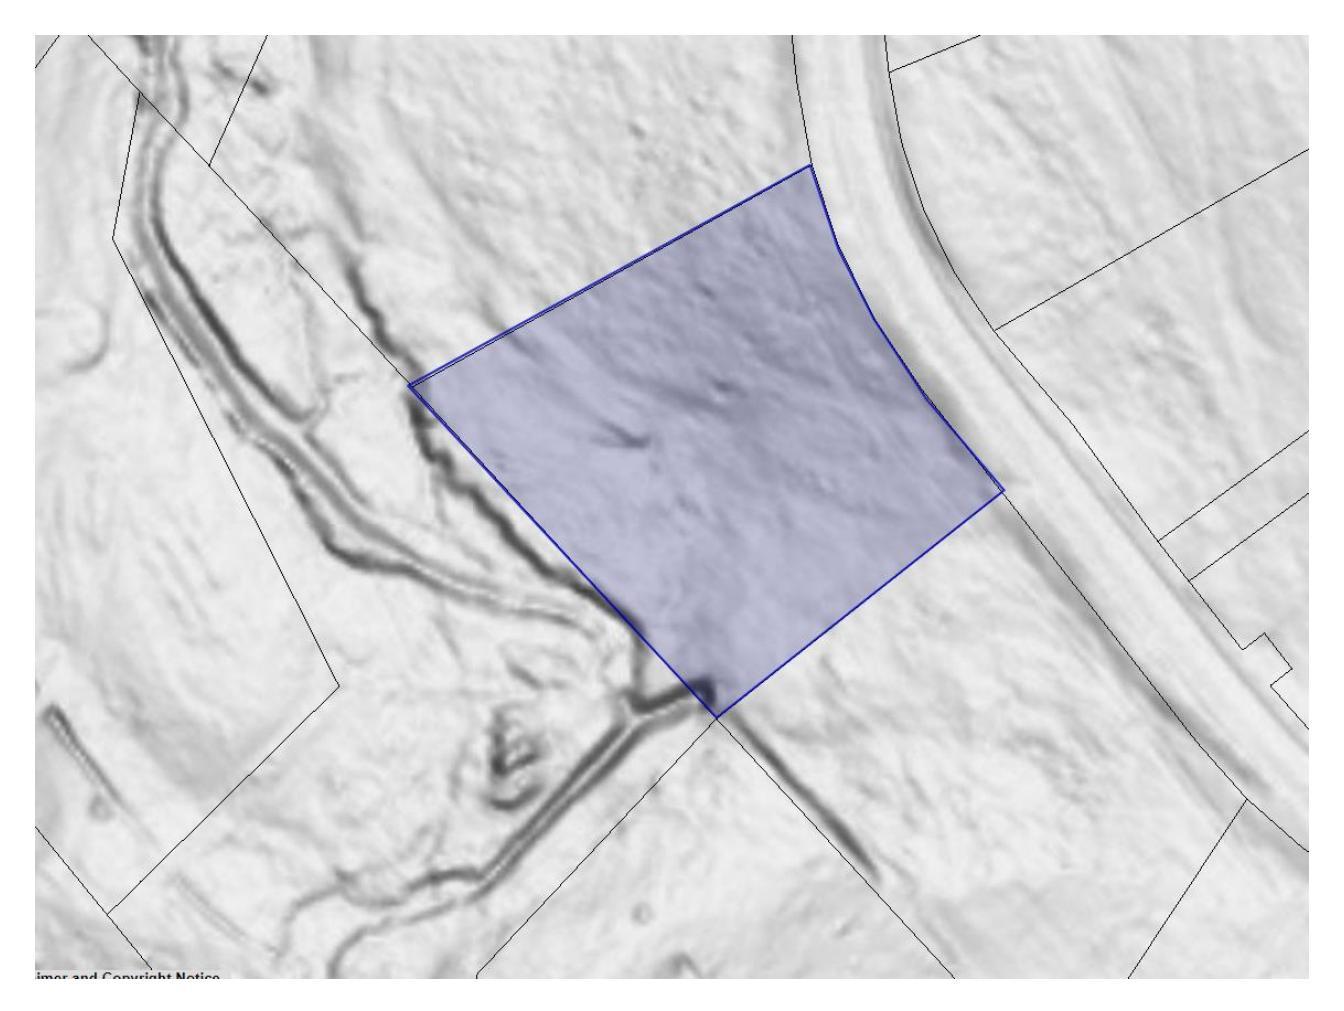
Figure 8 – LiDAR surface showing depressions that correlate with the inundation polygons

Comparing the inundation polygons against pre-fill aerial imagery and LiDAR surfaces, the polygons correlate with localised low points which supports this view.

The estimated volume of these areas is in the vicinity of 3.5m3 based on the polygon size and reported flow depths.

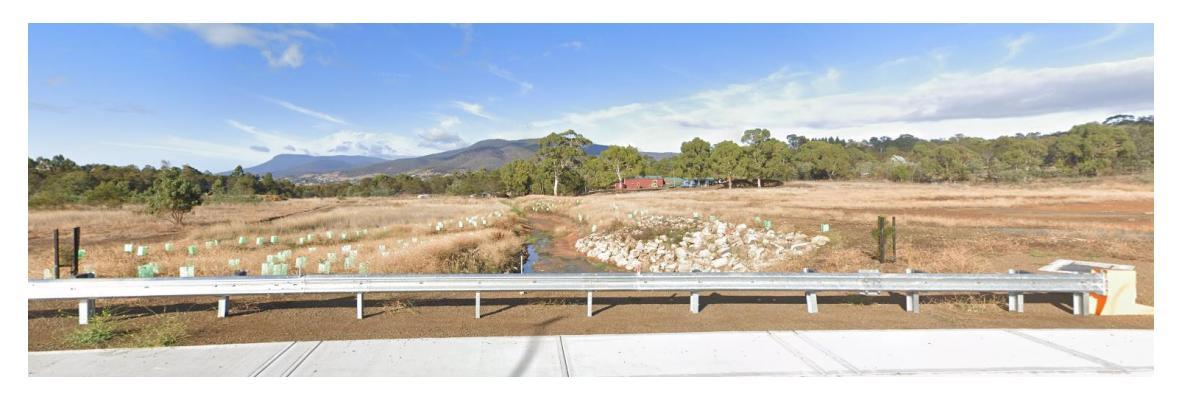
Figure 8 – Watercourse improvements immediately upstream of the subject site

It is noted that there have been improvement works undertaken on the watercourse to improve channelisation and revegetation for erosion protection. The re-shaping of the batters and re-vegetation will be consistent with this work.

The net impact is expected to be an improvement in management of flow paths and the increase in channel capacity is likely to provide a small reduction in water heights immediately downstream of the subject property.

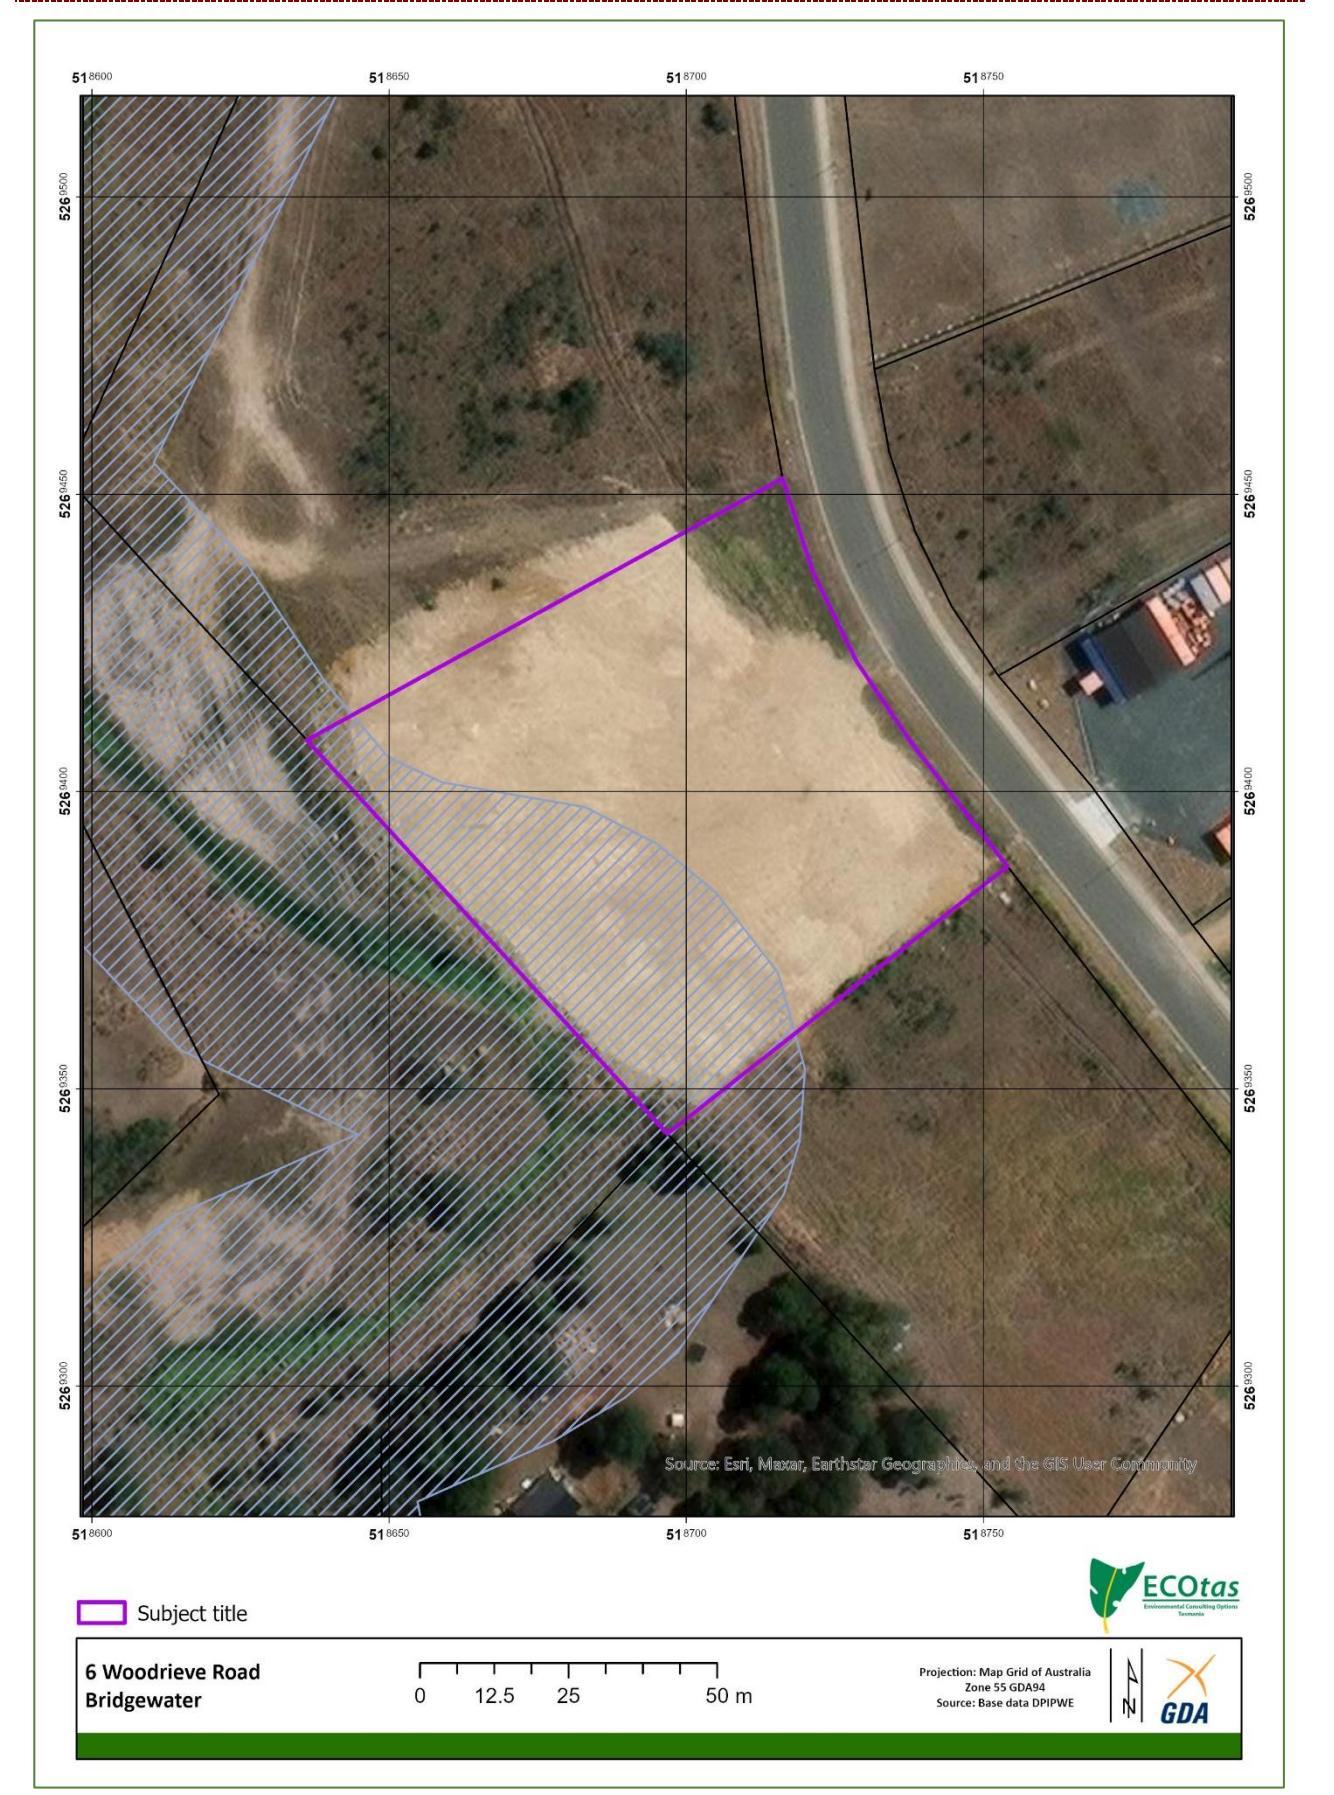
Figure 5. Detailed location of study area, showing extent of Waterway and Coastal Protection Area overlay (blue hatching) pursuant to the *Tasmanian Planning Scheme – Brighton Local Provisions* Schedule

This watercourse (Plates 5-8) is subject to the Waterway and Coastal Protection Area overlay (Figure 5), indicated as 30 m each side of the watercourse, which extends on to the subject title.

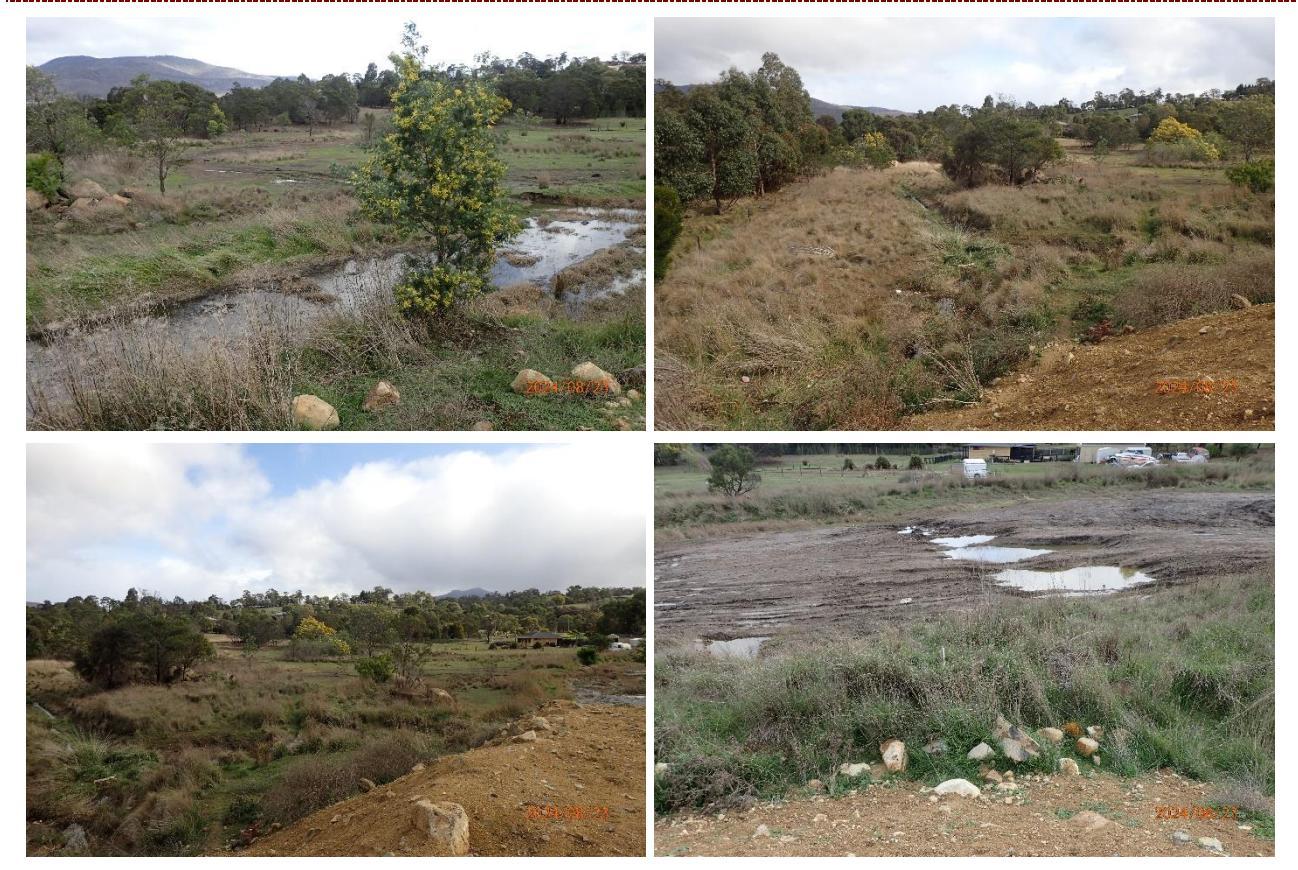
Plates 5-8. Views of the status of Ashburton Creek viewed from 6 Woodrieve Road – note in particular the extensive disturbance of the watercourse and associated flats immediately west of the western point of the title, with this disturbance continuing extensively "upstream" to the northwest (on the council title) and north (on the private title north of 6 Woodrieve Road, which is shown in Plates 9-12

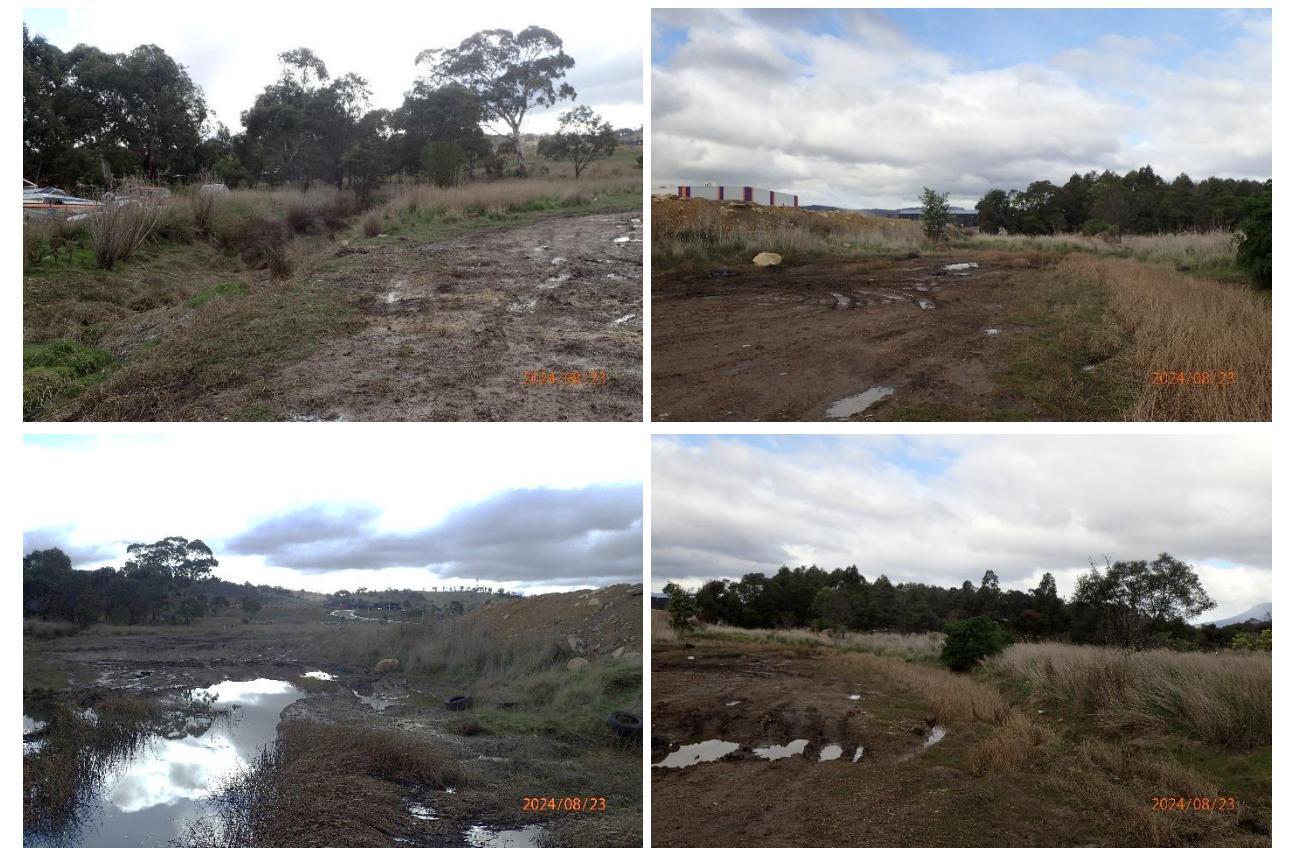
Plates 9-12. Examples of extensive 4WD impacts to the bed, banks and associated flats of Ashburton Creek within the council title

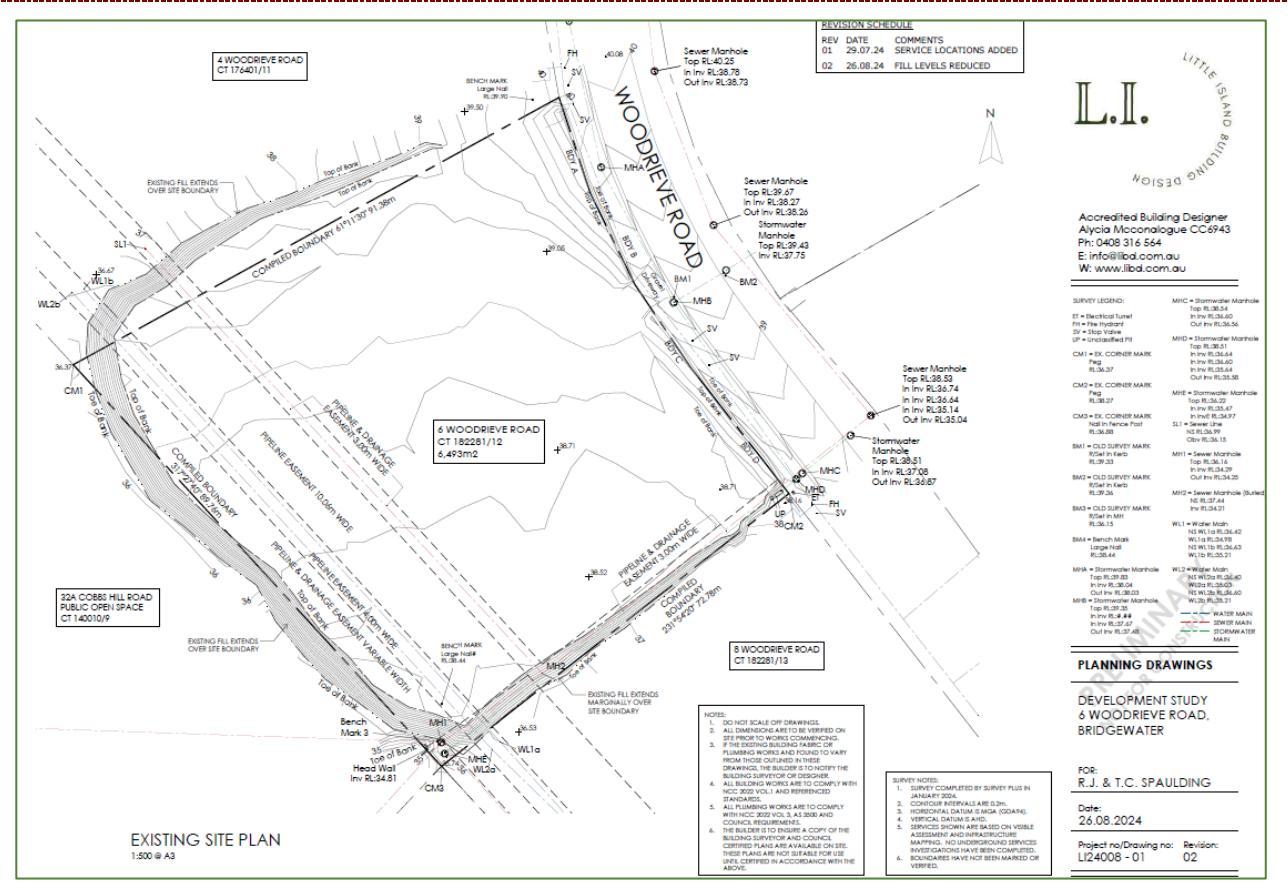
Figure 8a. Existing site plan [source: Little Island Building Design]

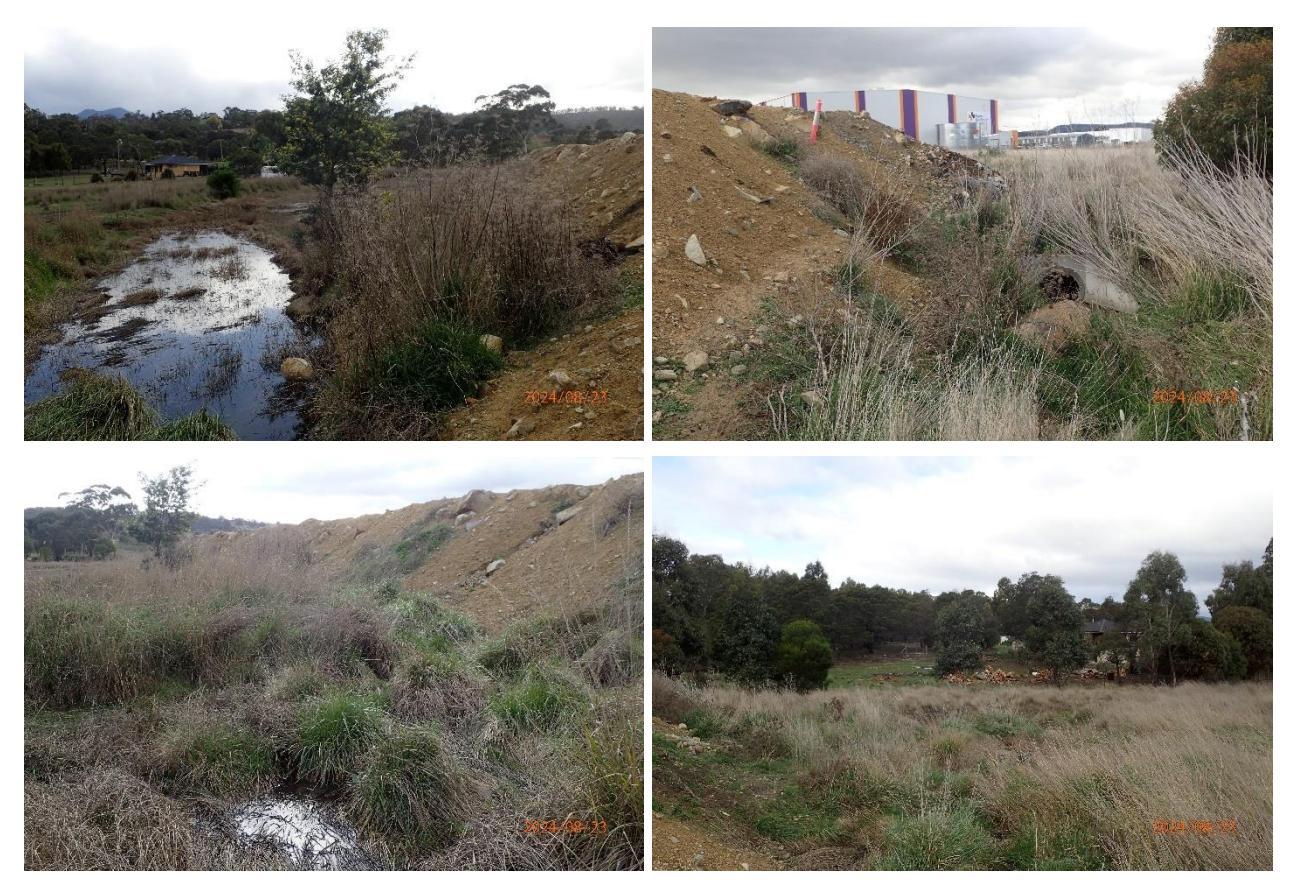
Plates 13-16. Weed-infested strip between eastern "bank" of Ashburton Creek and southwestern boundary of title

the key management recommendation is to pull this fill back and revegetate the disturbed area. The fringe of vegetation between the subject title and the eastern "bank" of Ashburton Creek is heavily infested with weeds (Plates 13-16) dominated by *Foeniculum vulgare* (fennel), *Rubus* sp. (blackberry), *Rosa rubiginosa* (sweet briar), *Phalaris* spp. (canarygrass) and *Dactylis glomerata* (cocksfoot), such that a narrow strip could be classified as a weed infestation (TASVEG code: FWU). That is, it is likely that the overspill was largely across what was best considered as FWU (but certainly not a native vegetation community). Note that a revised vegetation map is not provided for this area because this would be most appropriately undertaken following rehabilitation of the narrow strip described above.

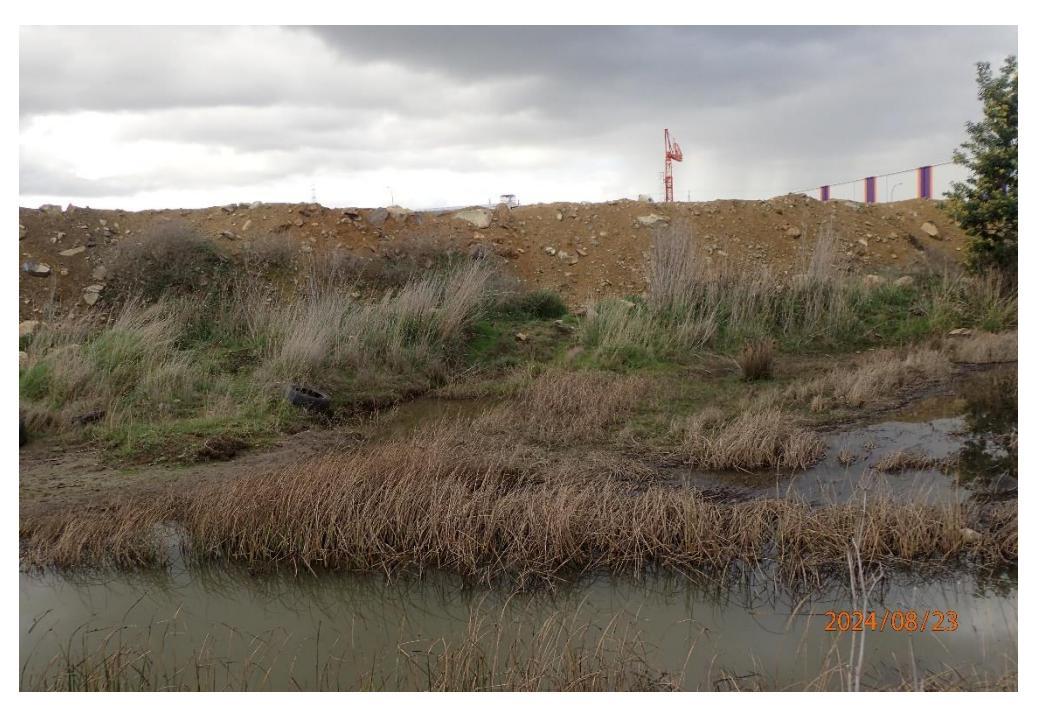
Plate 17. View from western side of Ashburton Creek looking towards overspill – *Bolboschoenus medianus* is the browned-off sedge growing in the water and extending to the edge of (but not beyond) the shallow bank

At this site, *B. medianus* occurs along the fringes of Ashburton Creek as well as occupying the main part of the shallower parts of the creek itself. It extends on to the associated flats. The species likes its "feet wet" (i.e. grows in mud) so does not extend beyond the very low "banks" of Ashburton Creek where these are associated with even a minor change in elevation. It appears highly unlikely that the overspill physically covered any part of the extent of the population of *Bolboschoenus medianus* (Plate 17). If future works include removing the overspill, this should be conducted in a manner that does not allow further spoil to roll into the watercourse.
